# Kansas Incident Investigations

Investigation Techniques & Lessons Learned

# 728 Minnesota, Wichita KS

- 12-KGSG-490-GIG
- House fire and explosion
  - 3 victims burned, house destroyed.
- Staff determined break in low pressure cast iron piping led to house explosion.

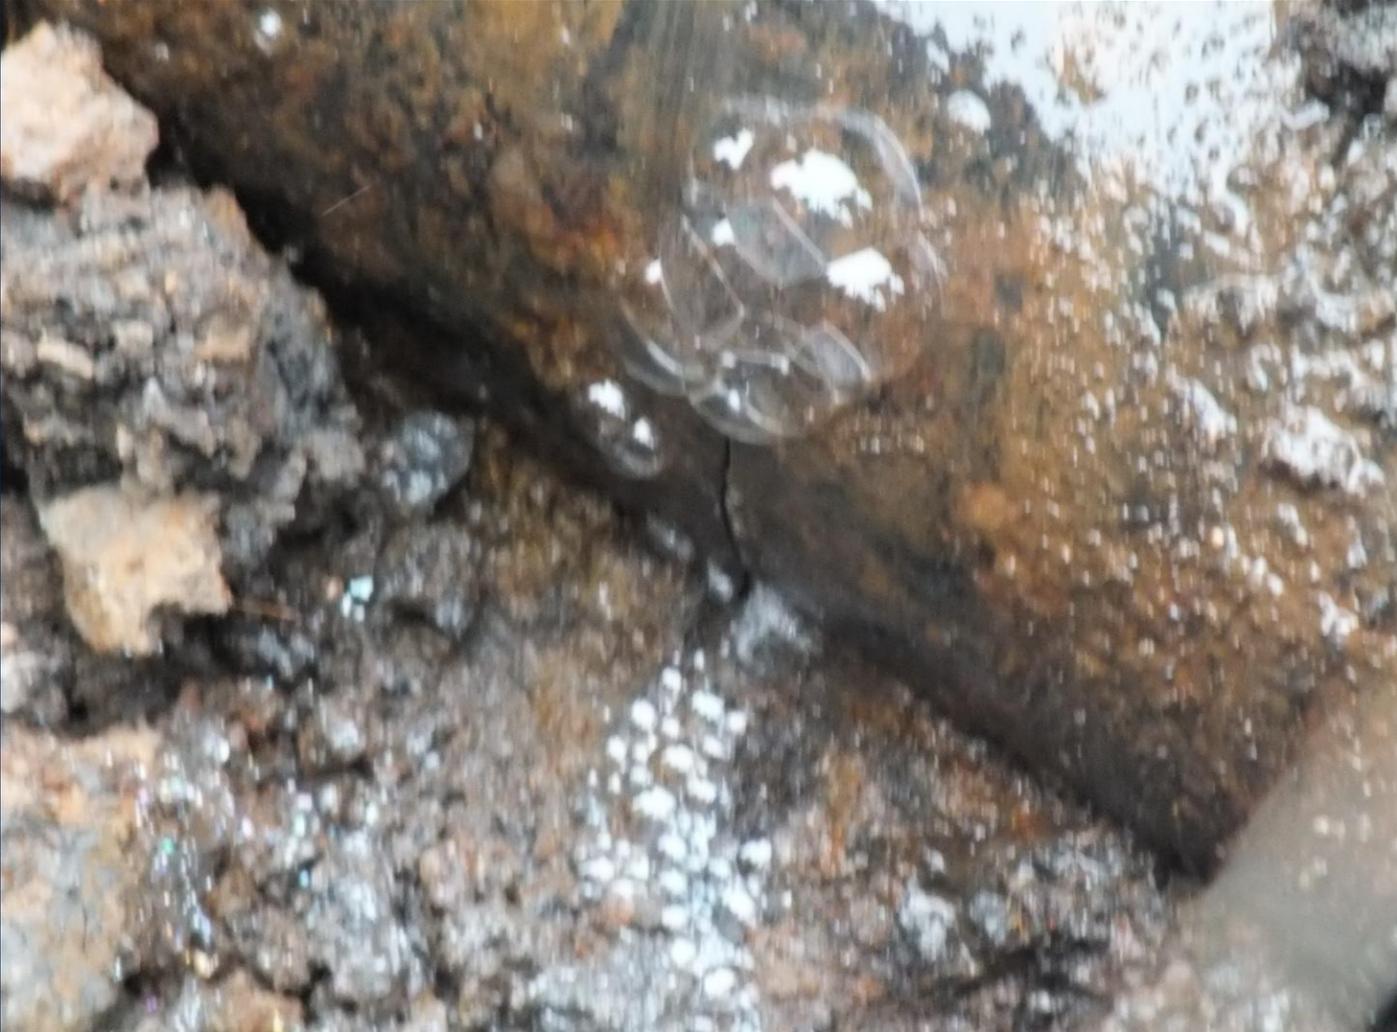
No vent to surface; pressure/flow test only way to determine leak

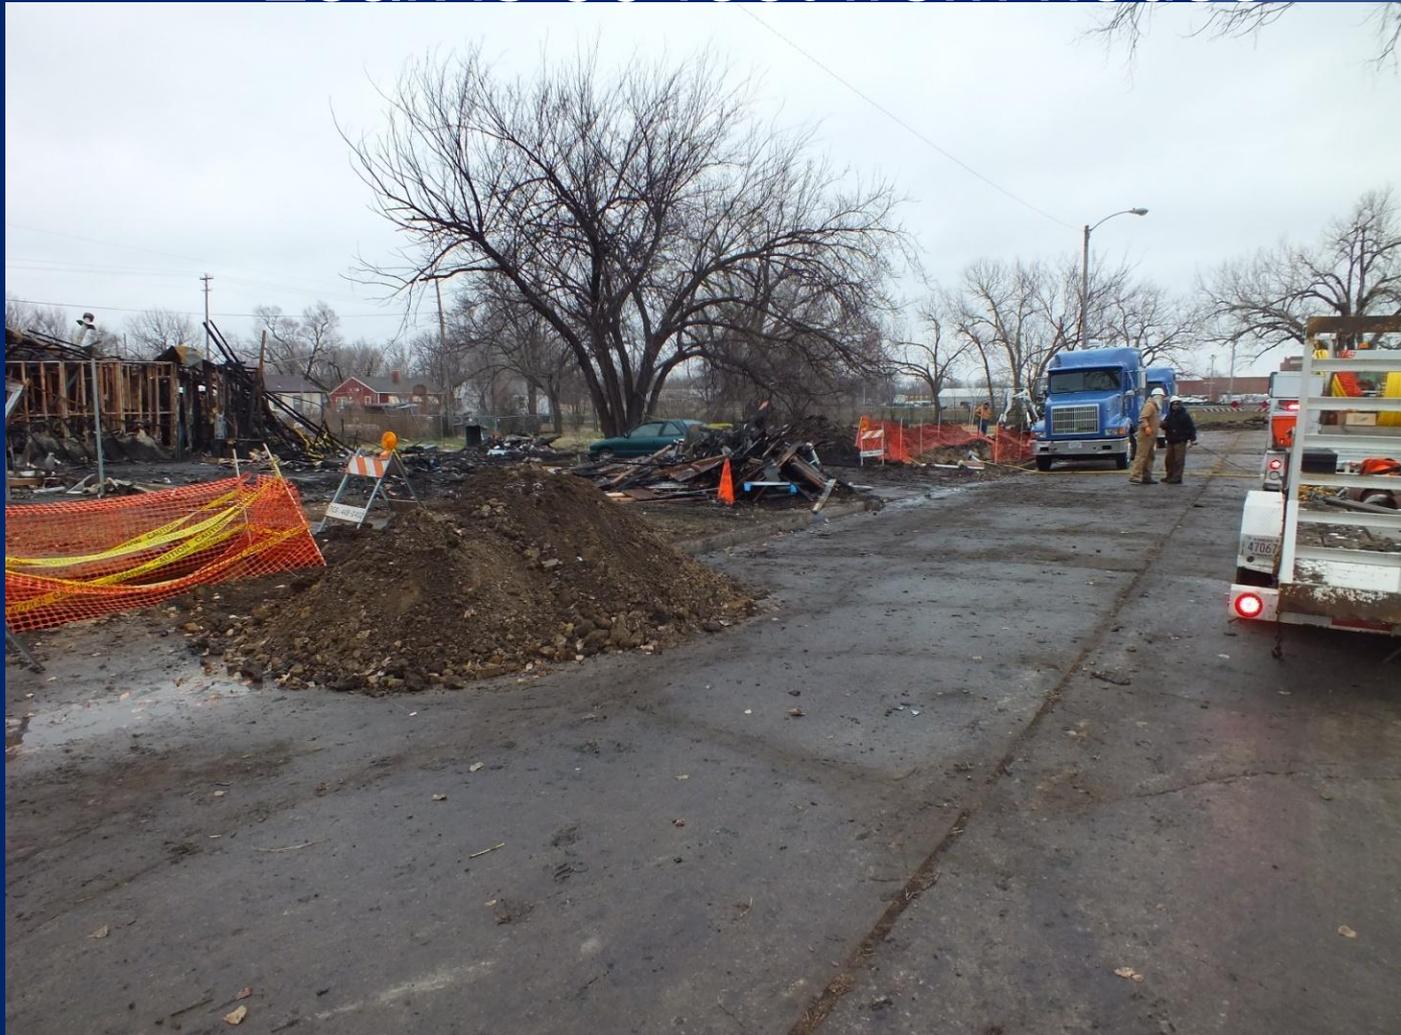
Incident site: One small gas detection site 20 feet from house;  
Leak is 90 feet from house

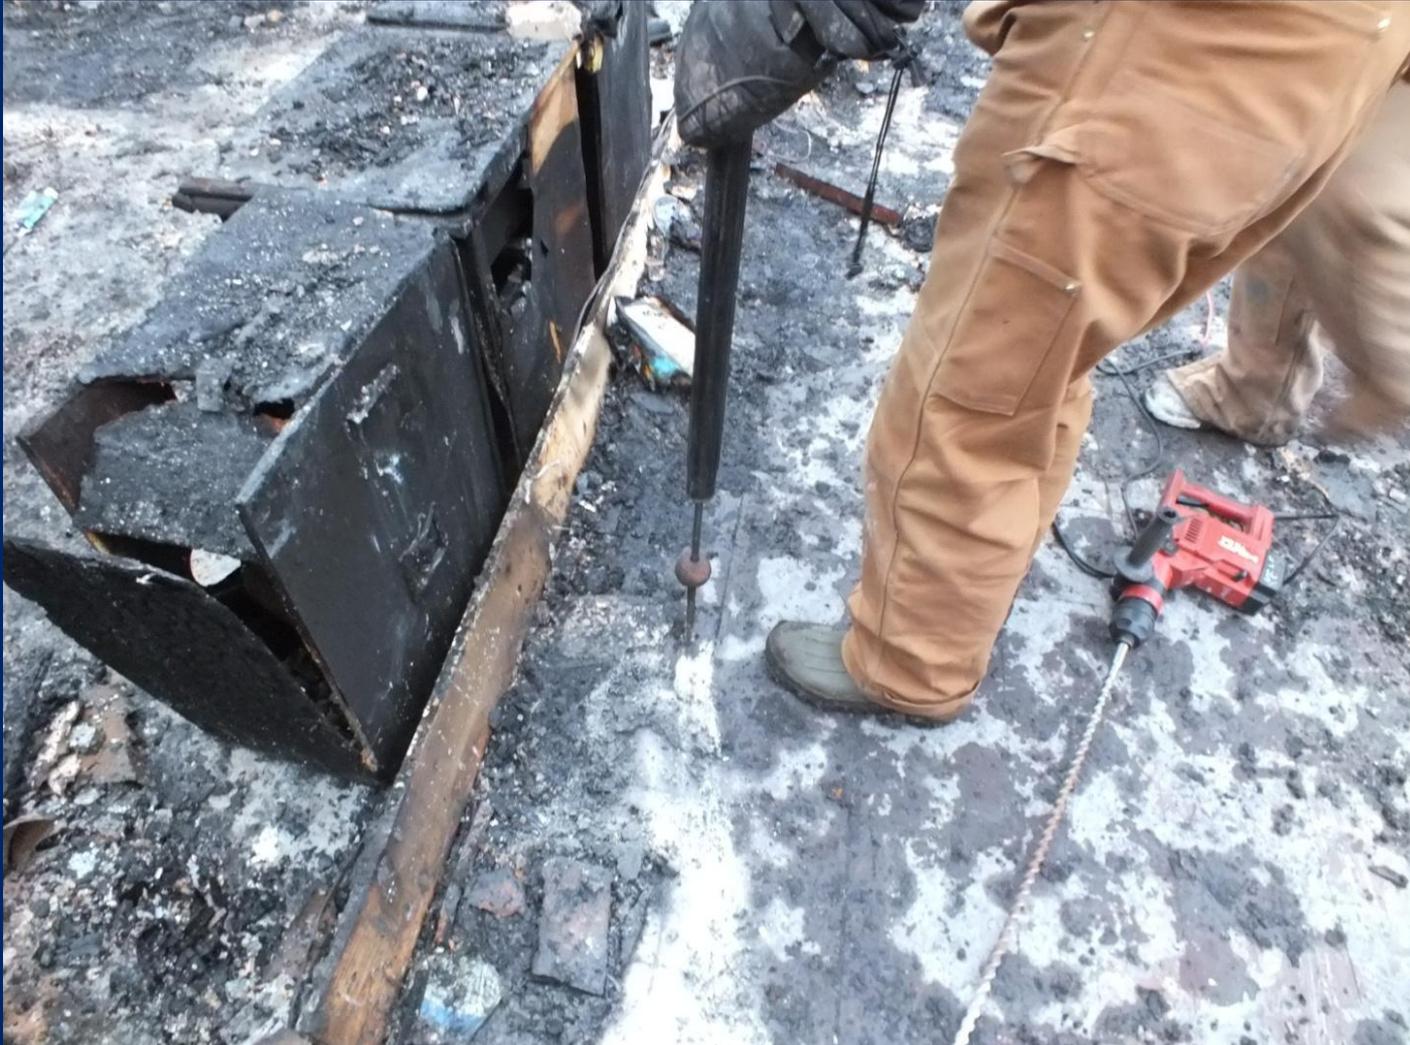
80% gas under slab

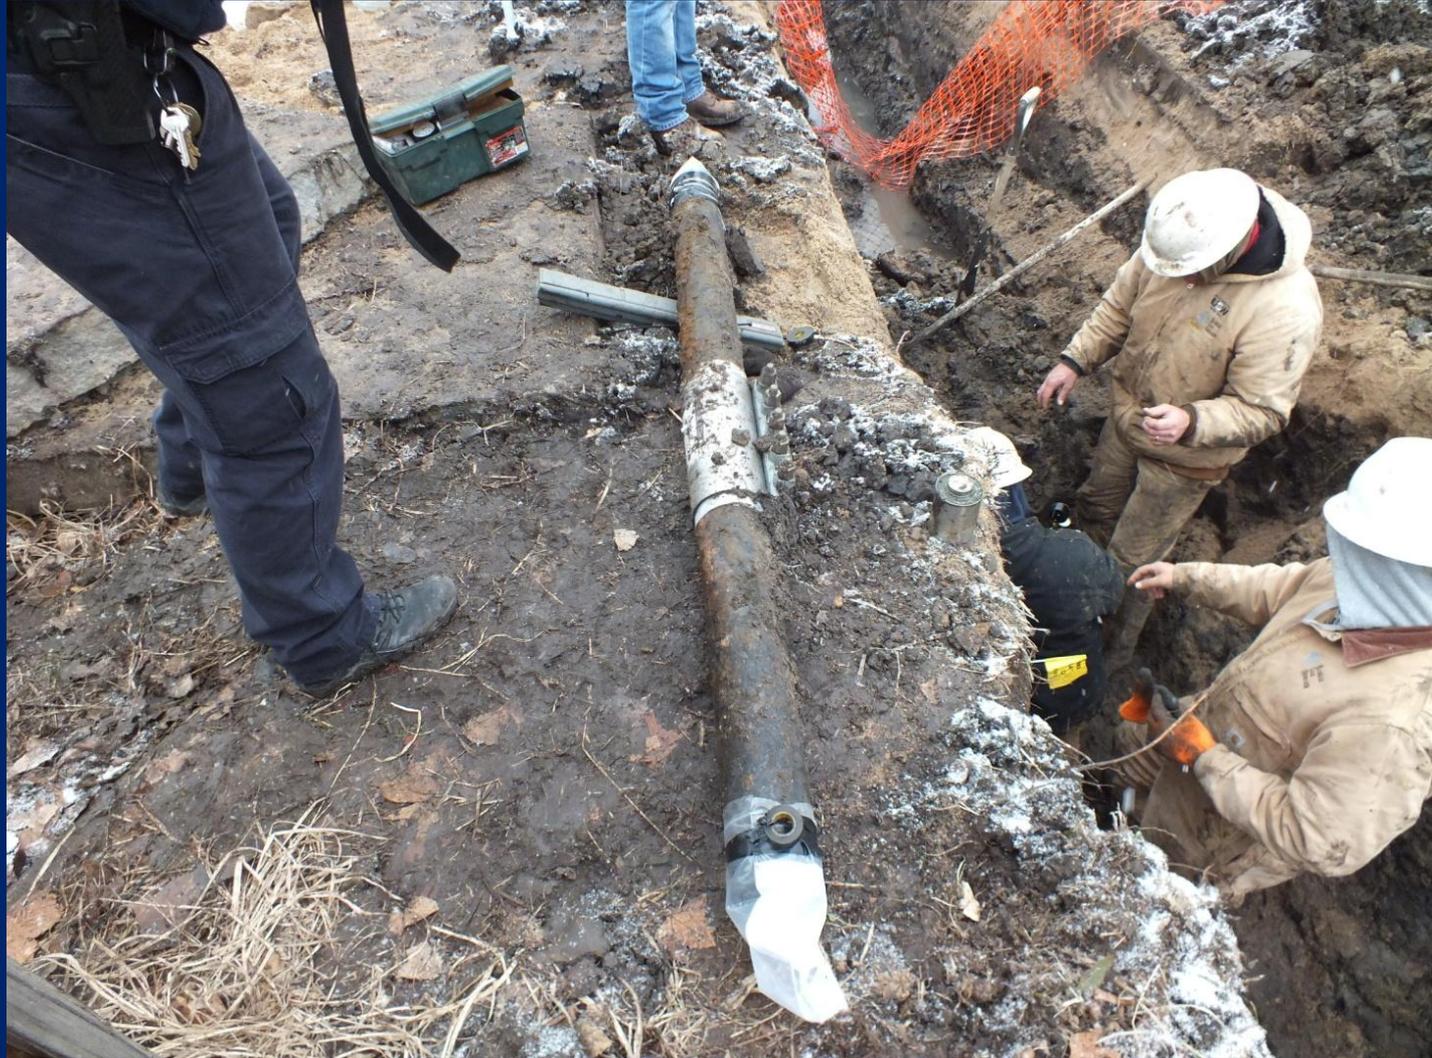
Not the best way to stabilize an artifact for later failure analysis.

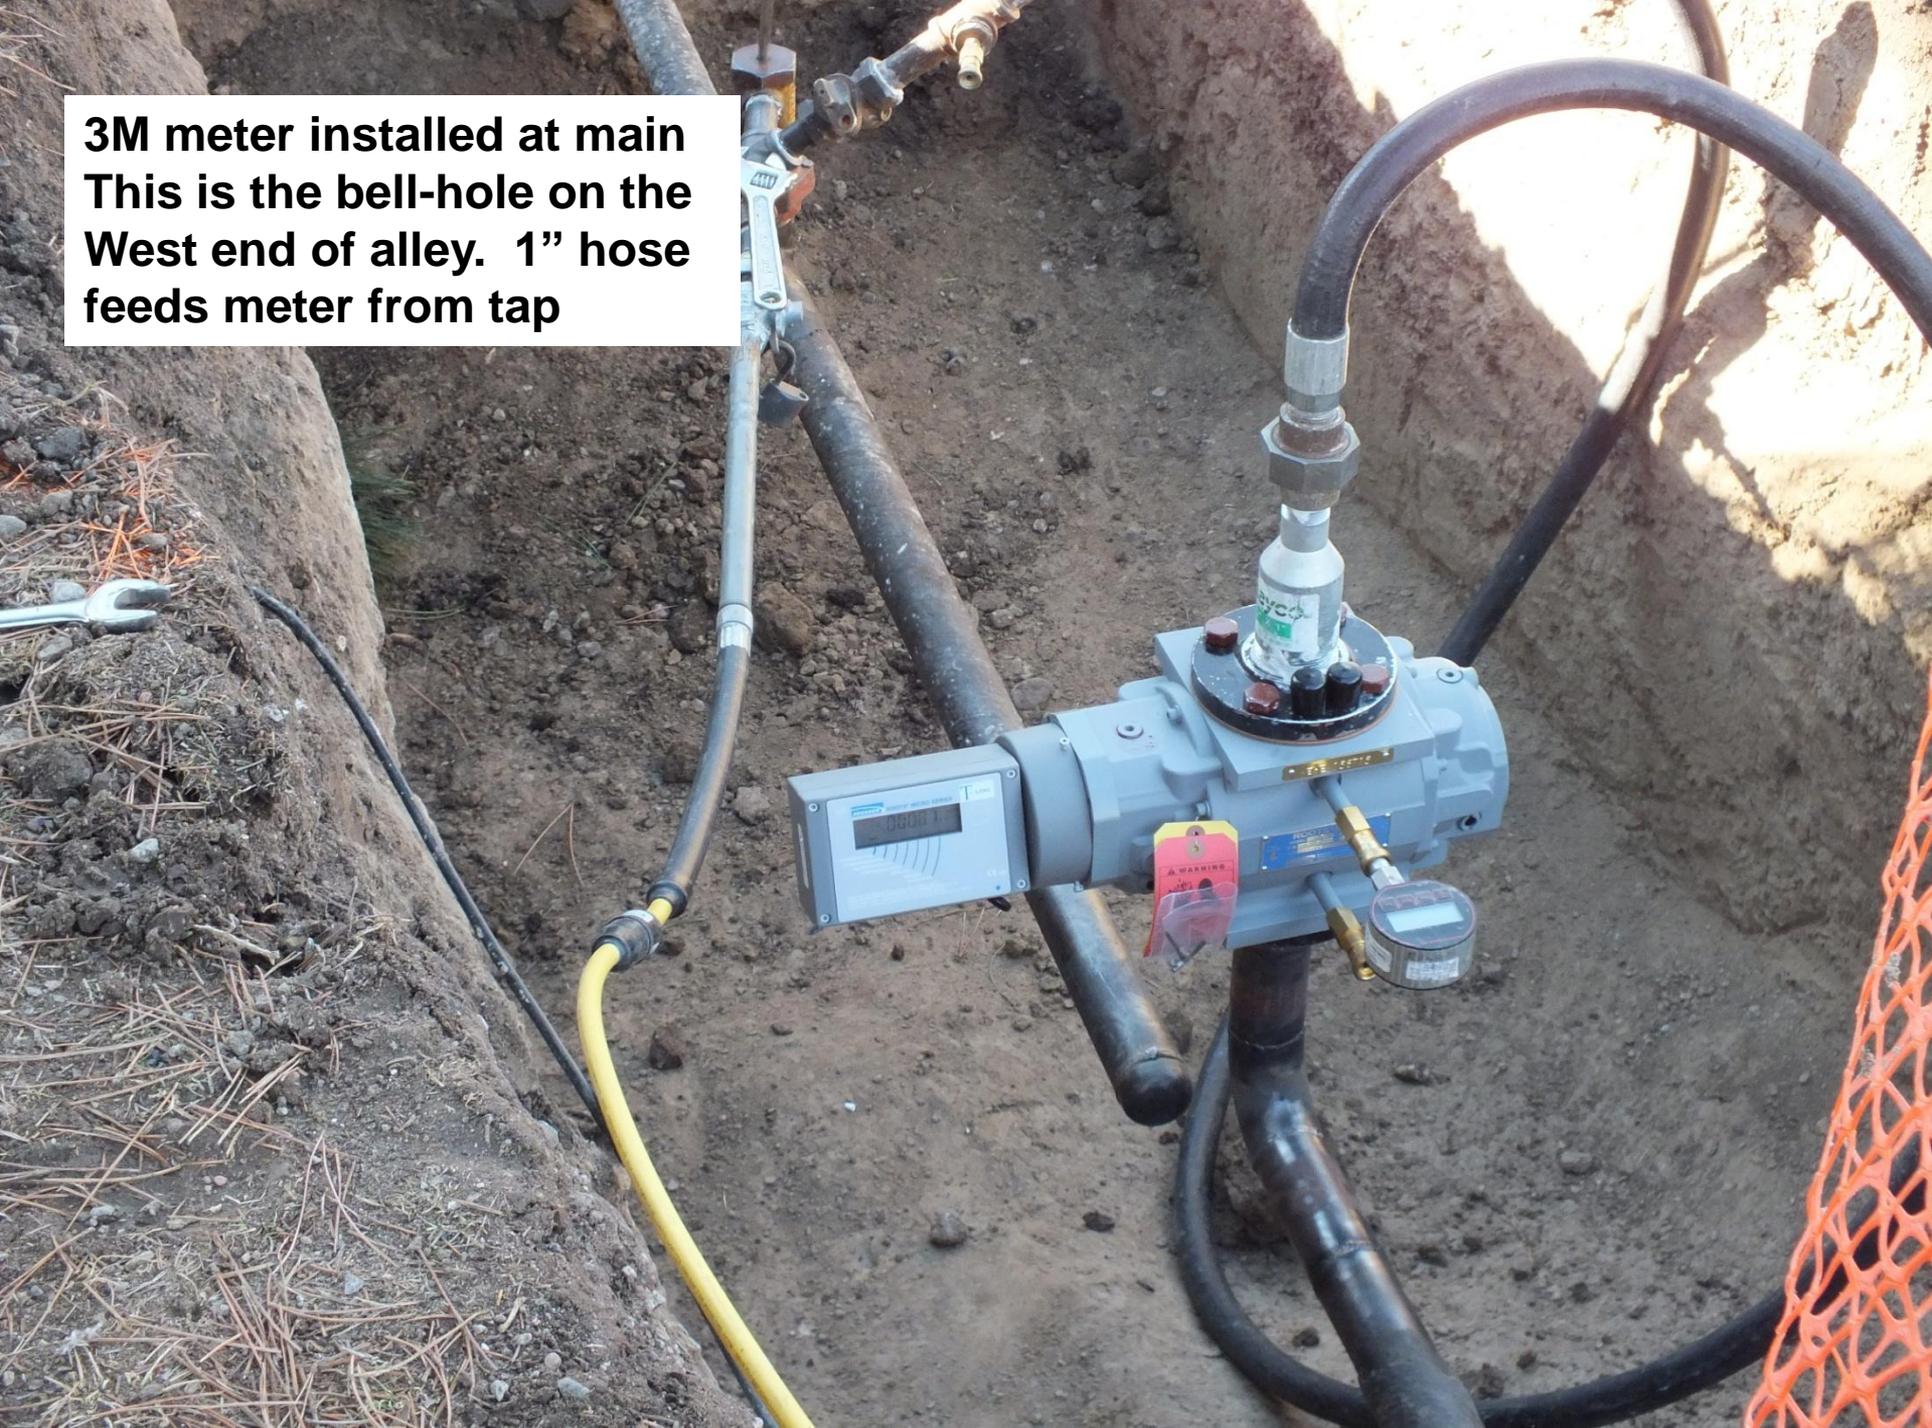
**3M meter installed at main  
This is the bell-hole on the  
West end of alley. 1" hose  
feeds meter from tap**

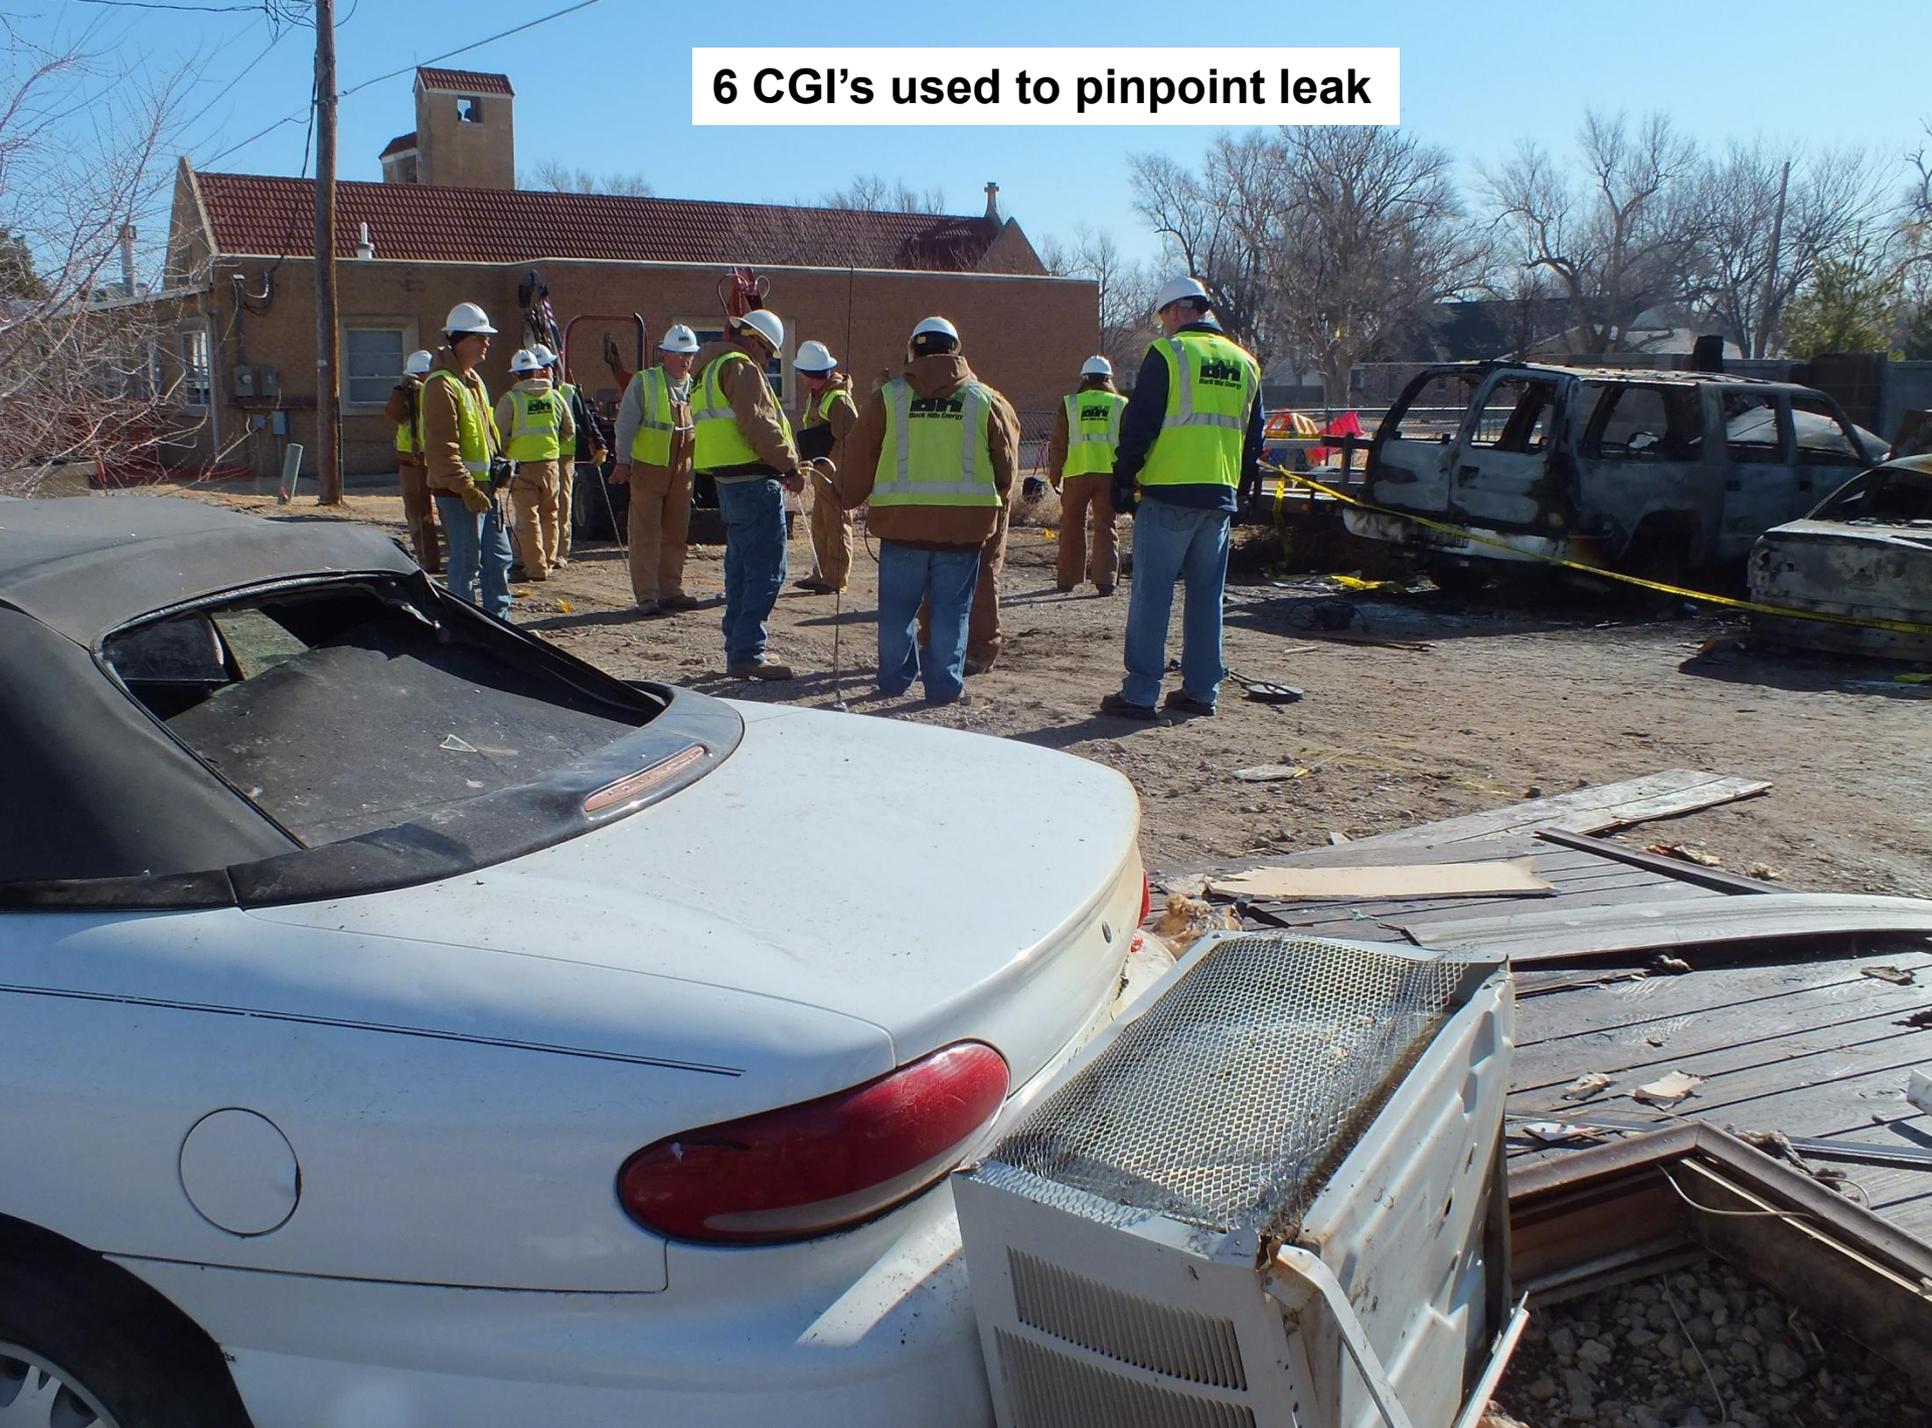
**6 CGI's used to pinpoint leak**

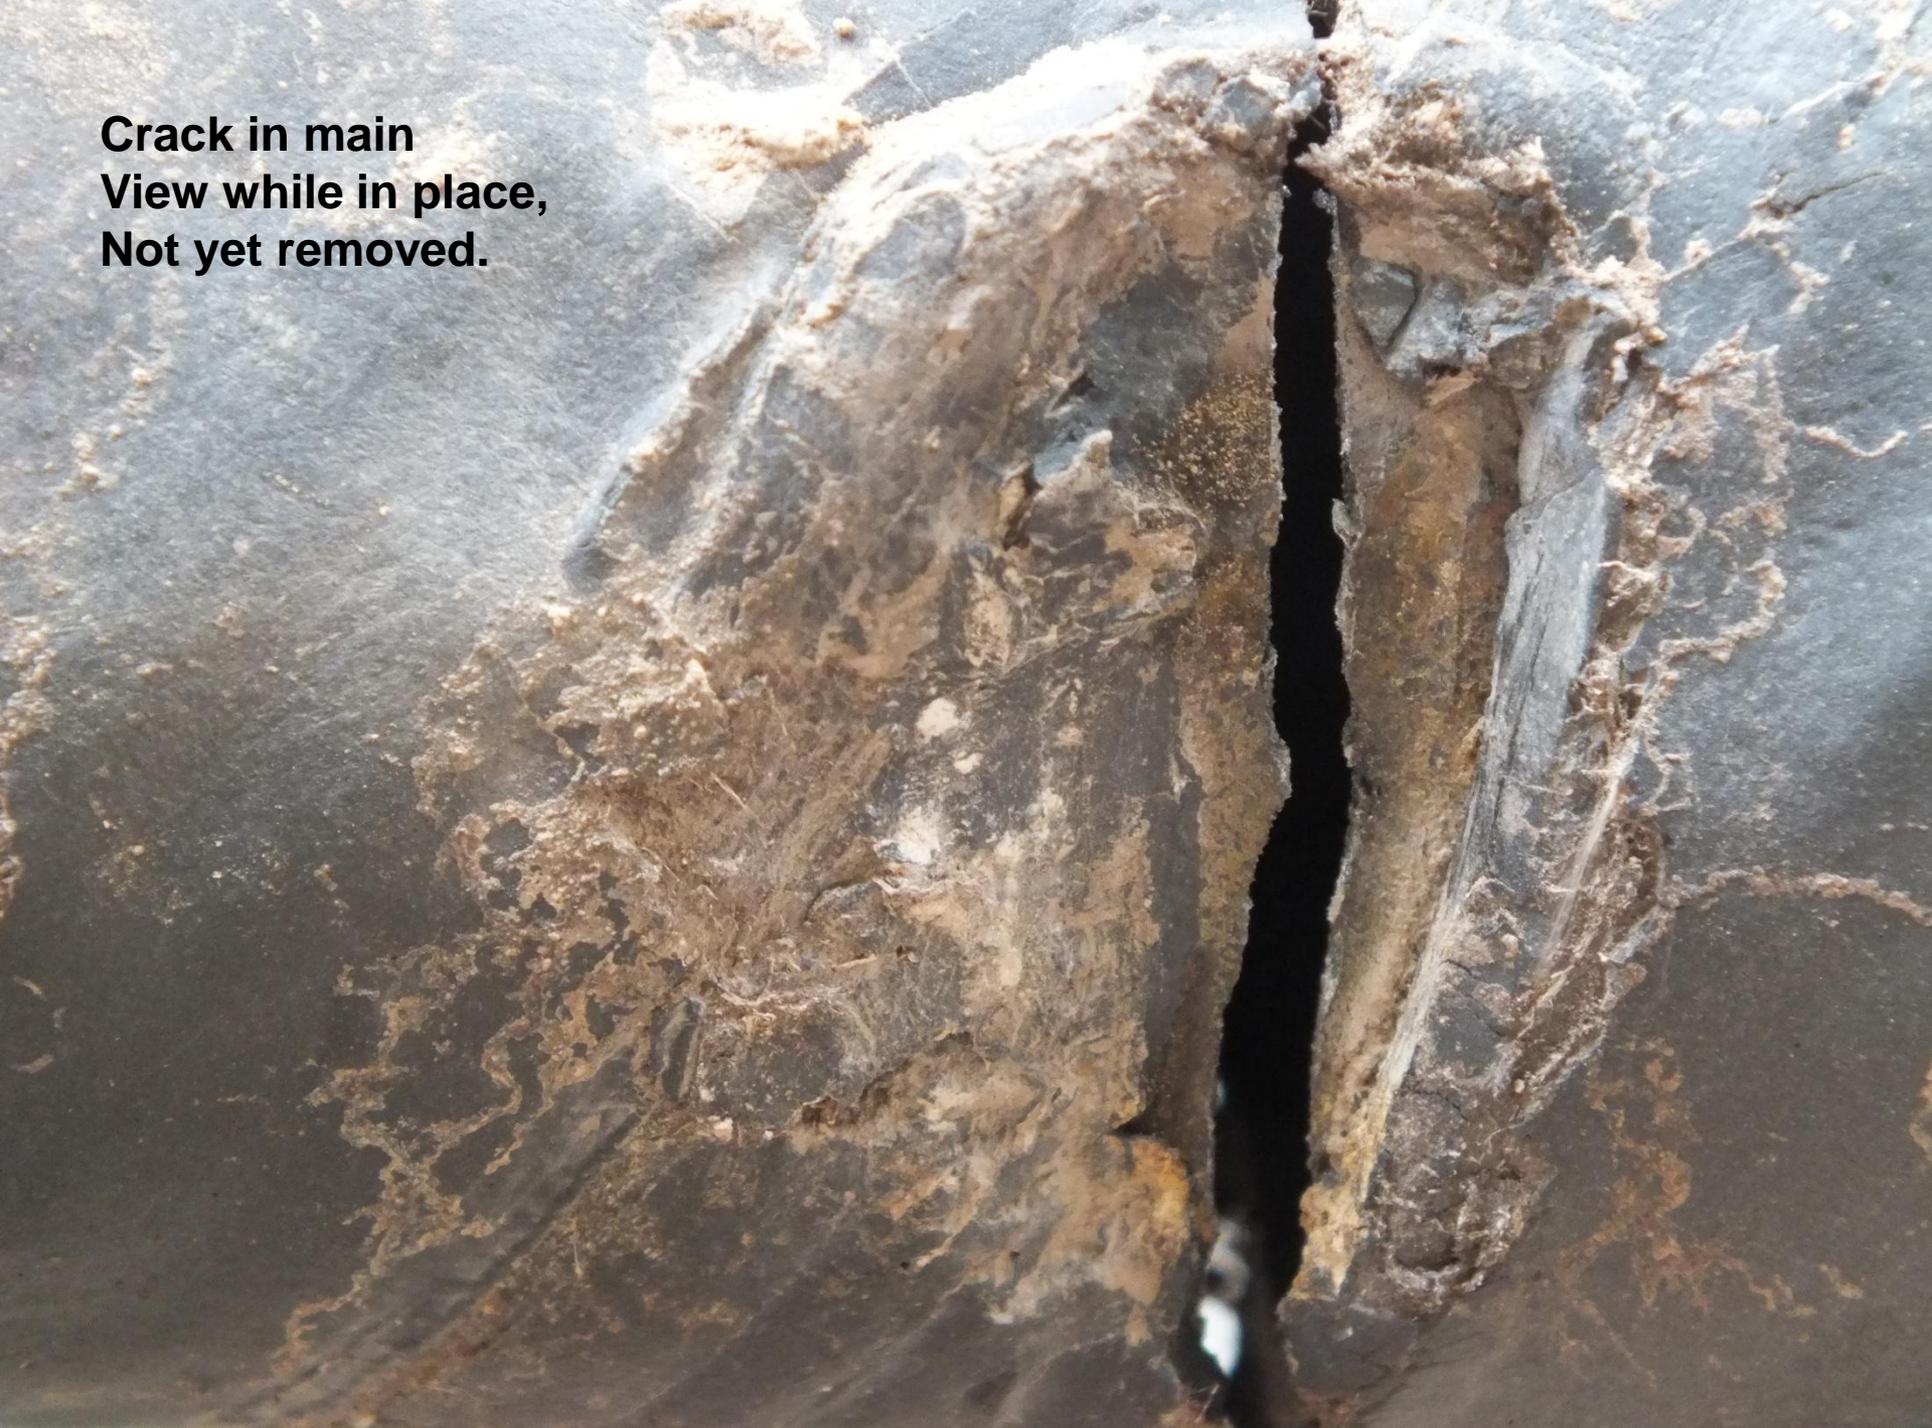
**Crack in main  
View while in place,  
Not yet removed.**

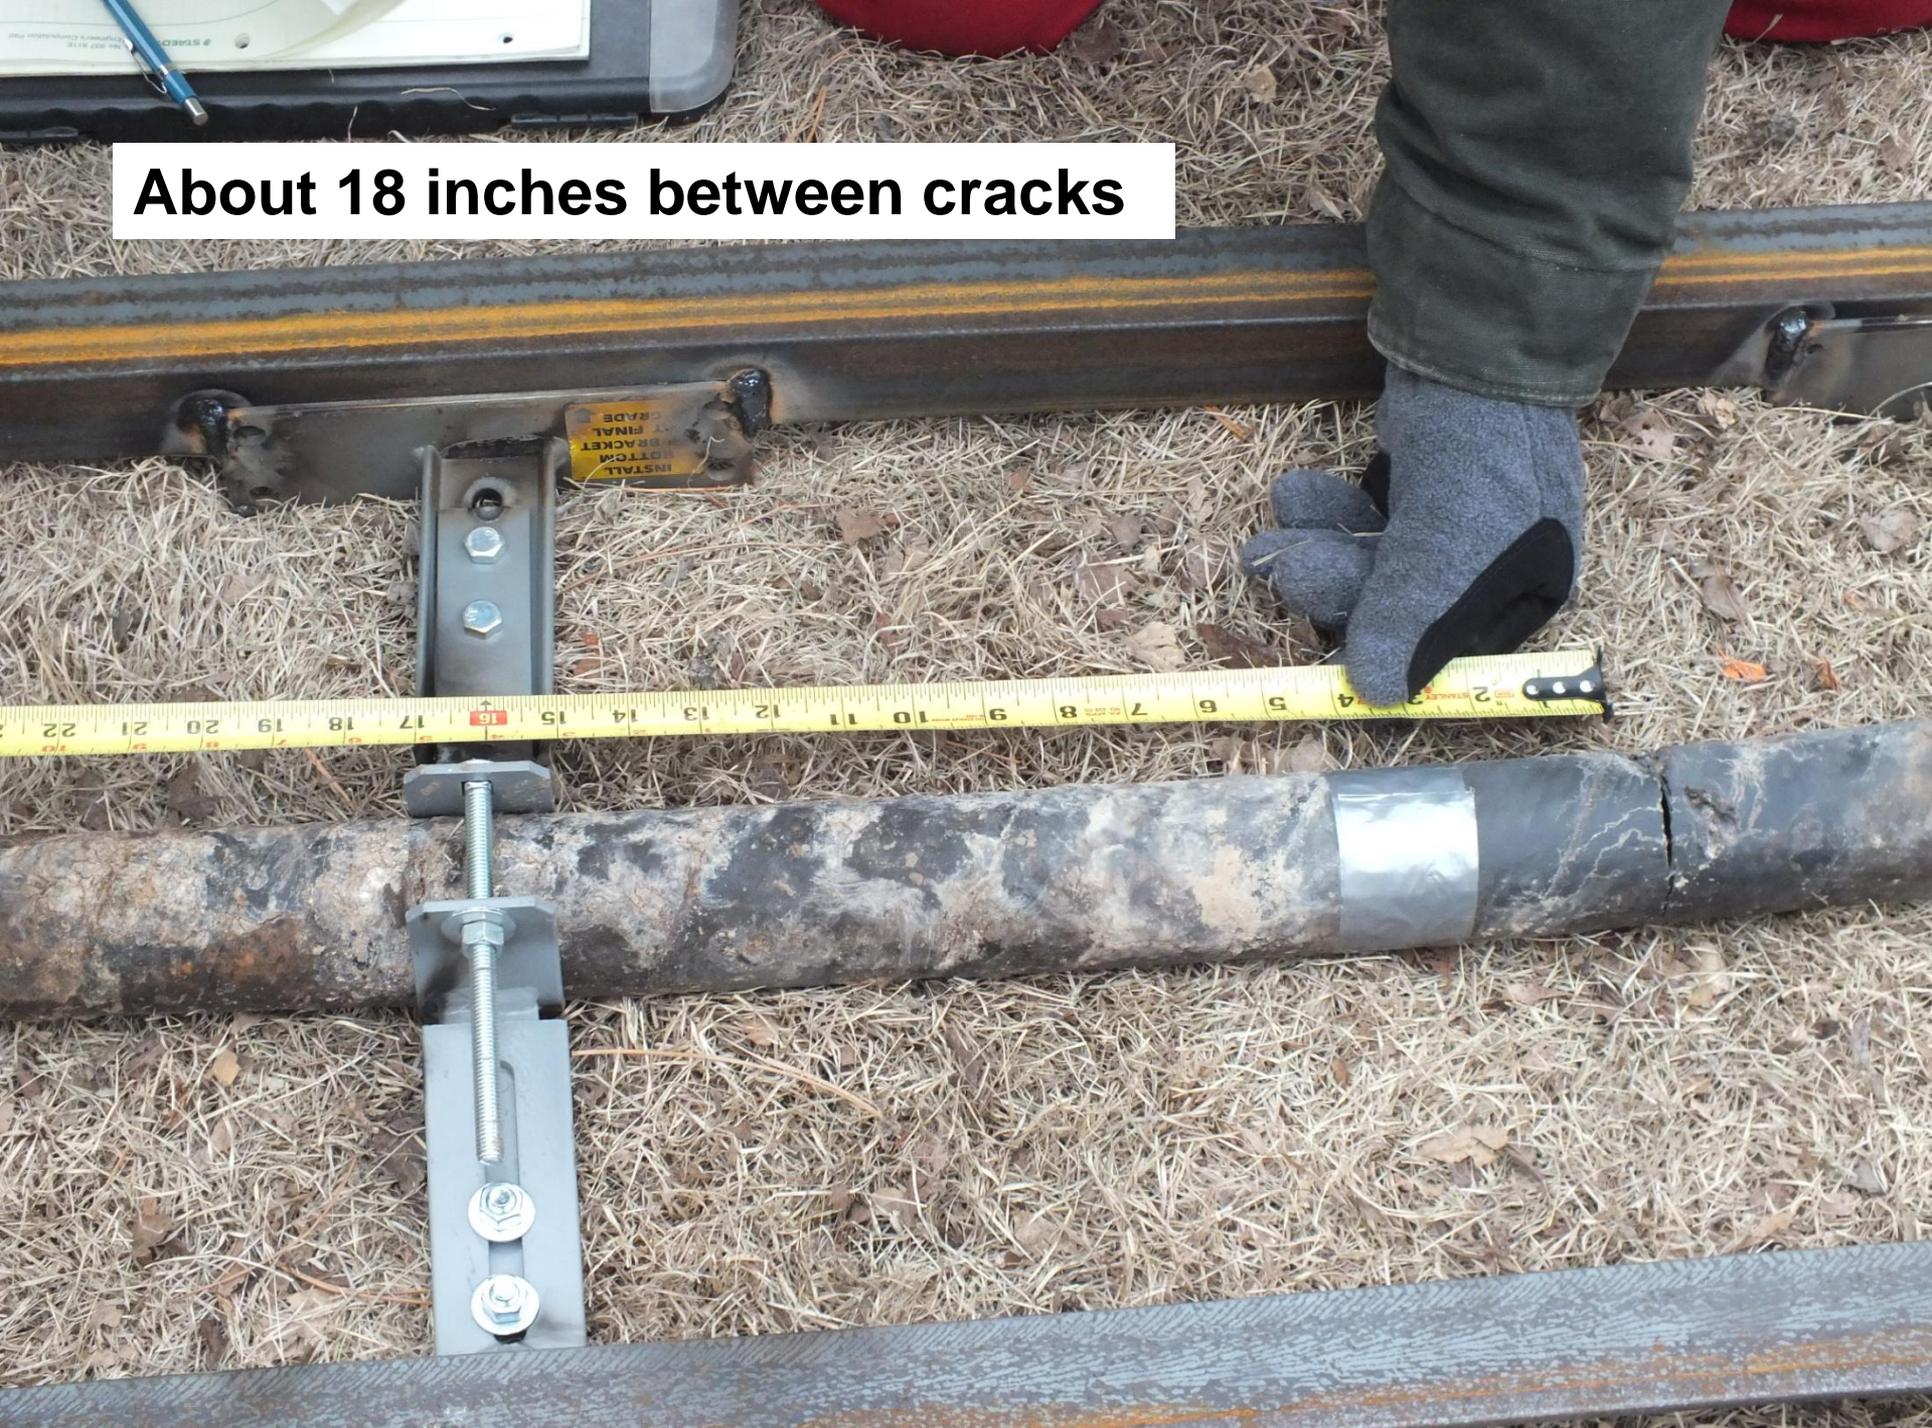
**About 18 inches between cracks**

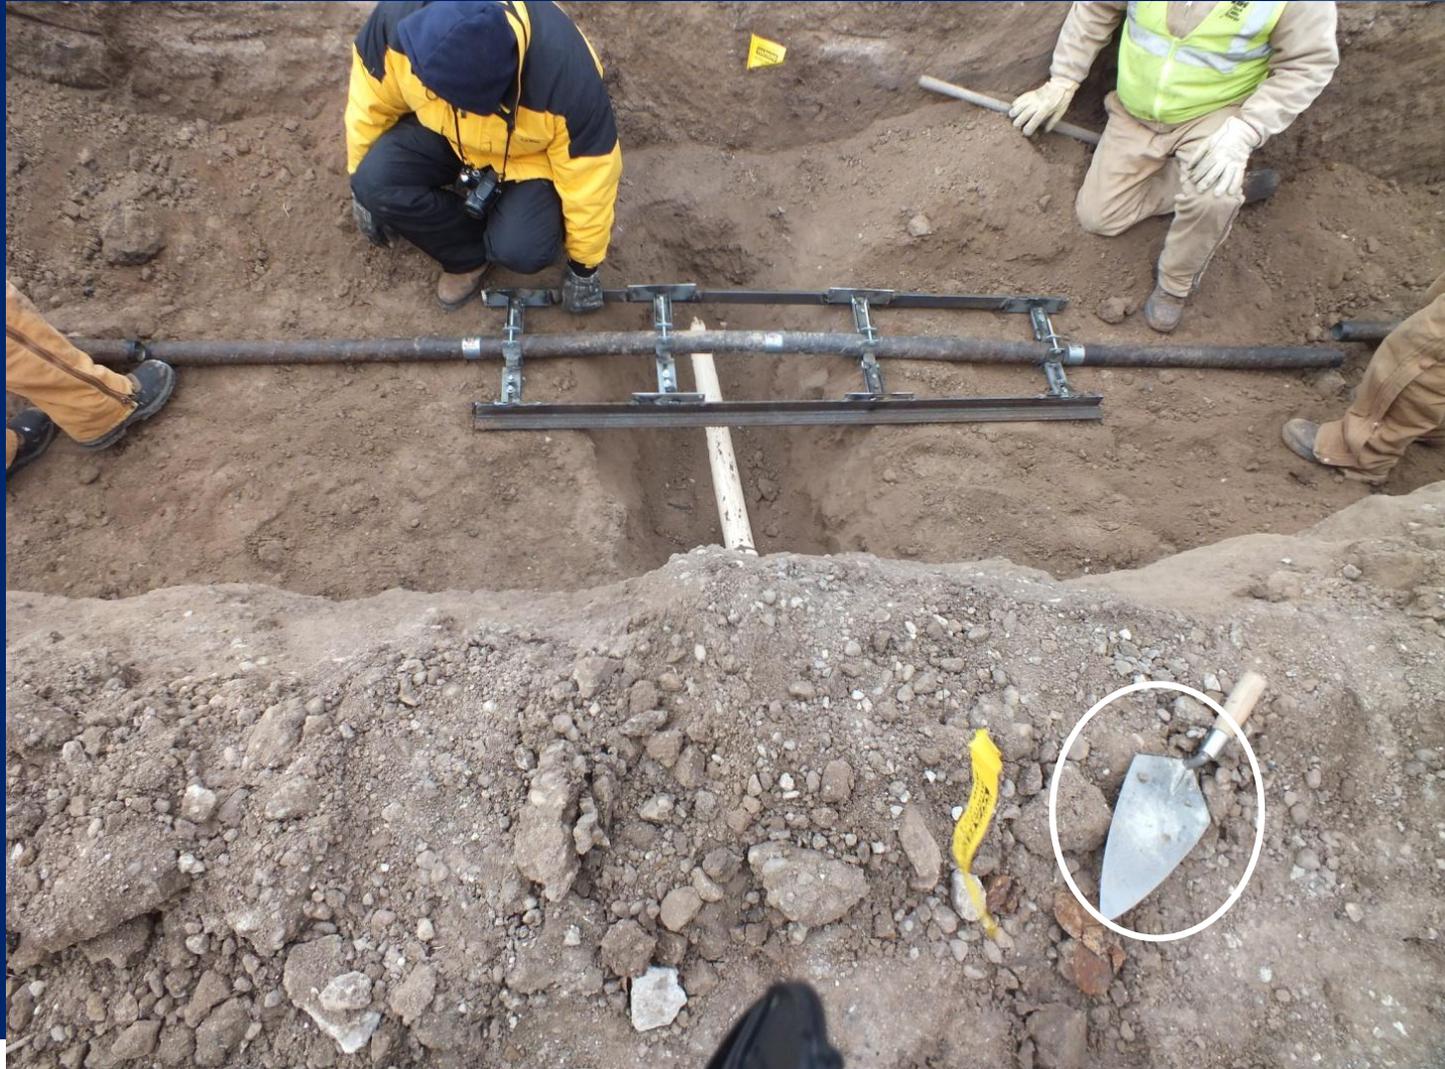
Failed artifact put back in place after uncovering sewer line installed 20 years ago.

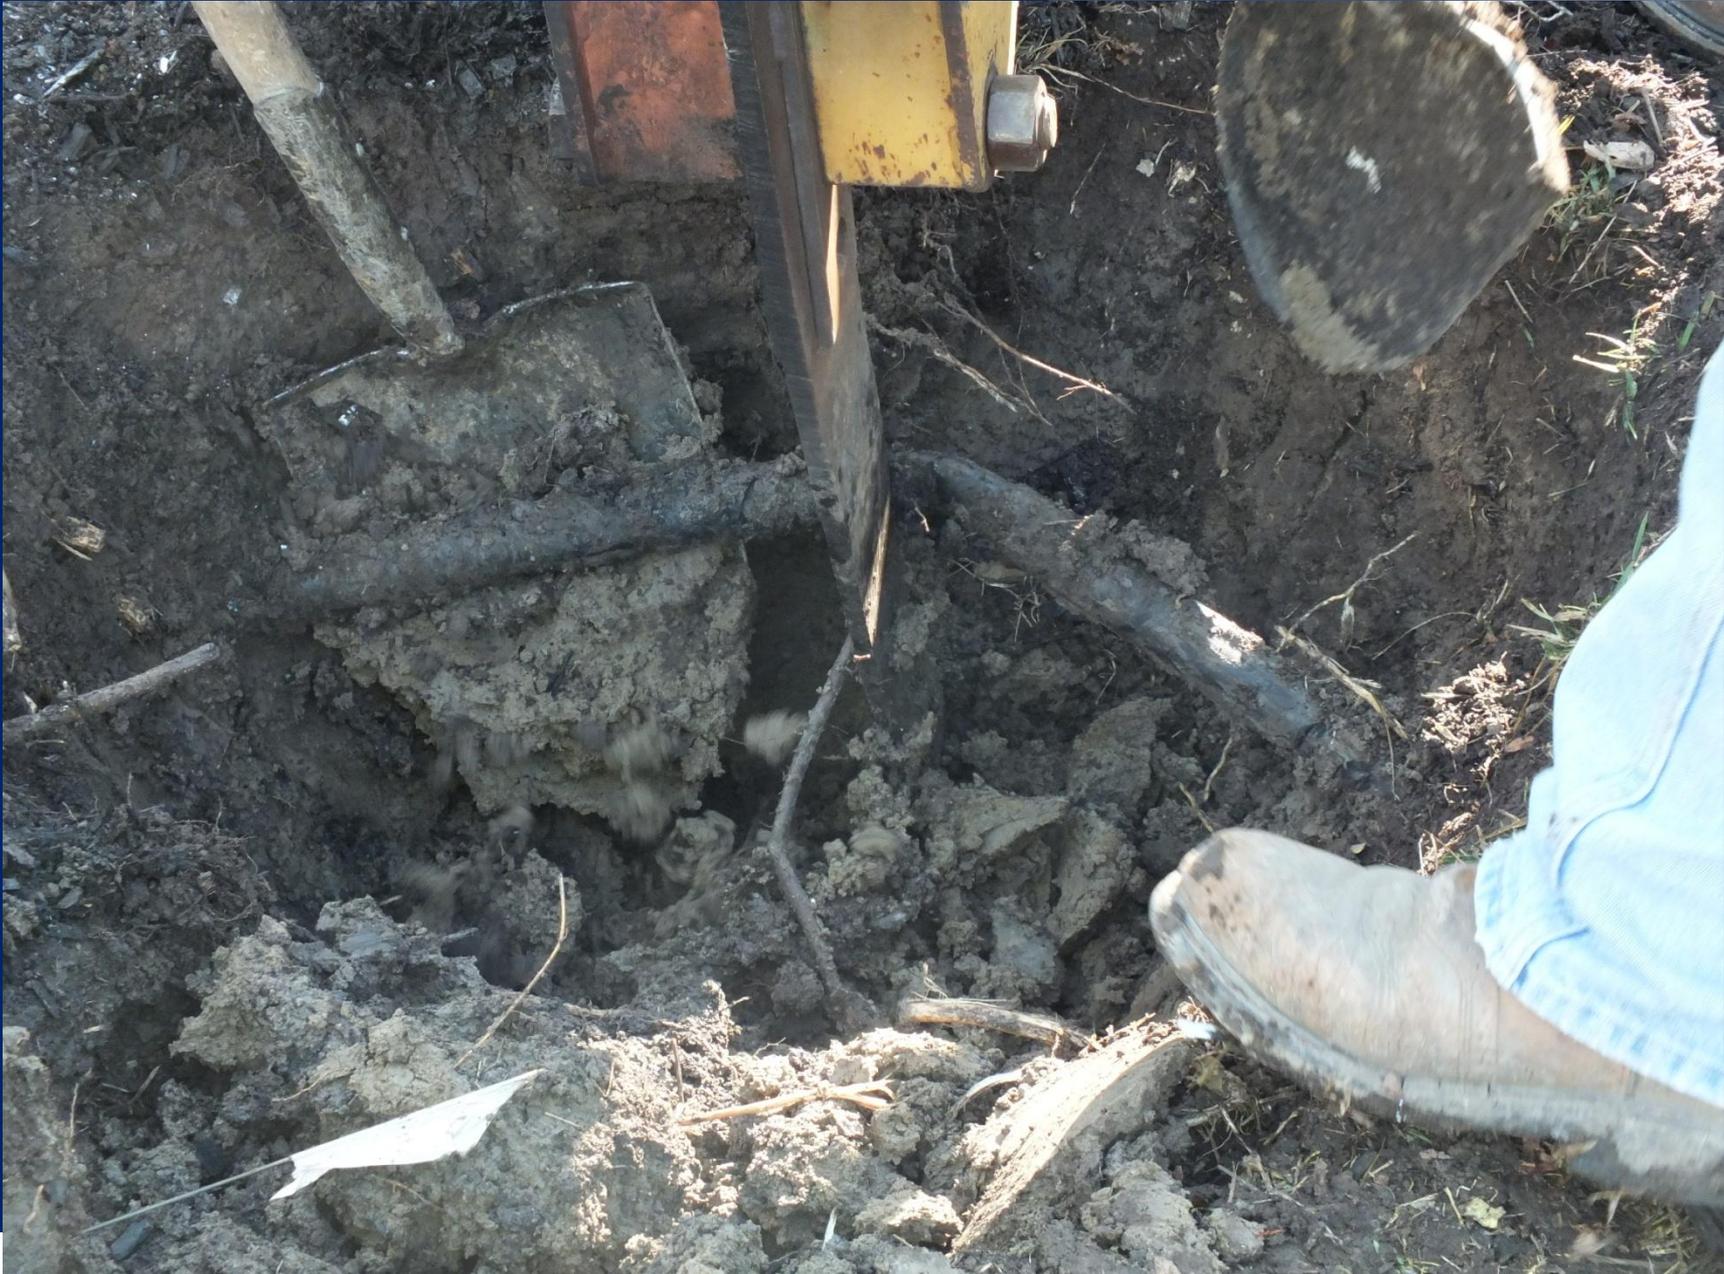
# Service Line Damage Caused by Vibratory Plow

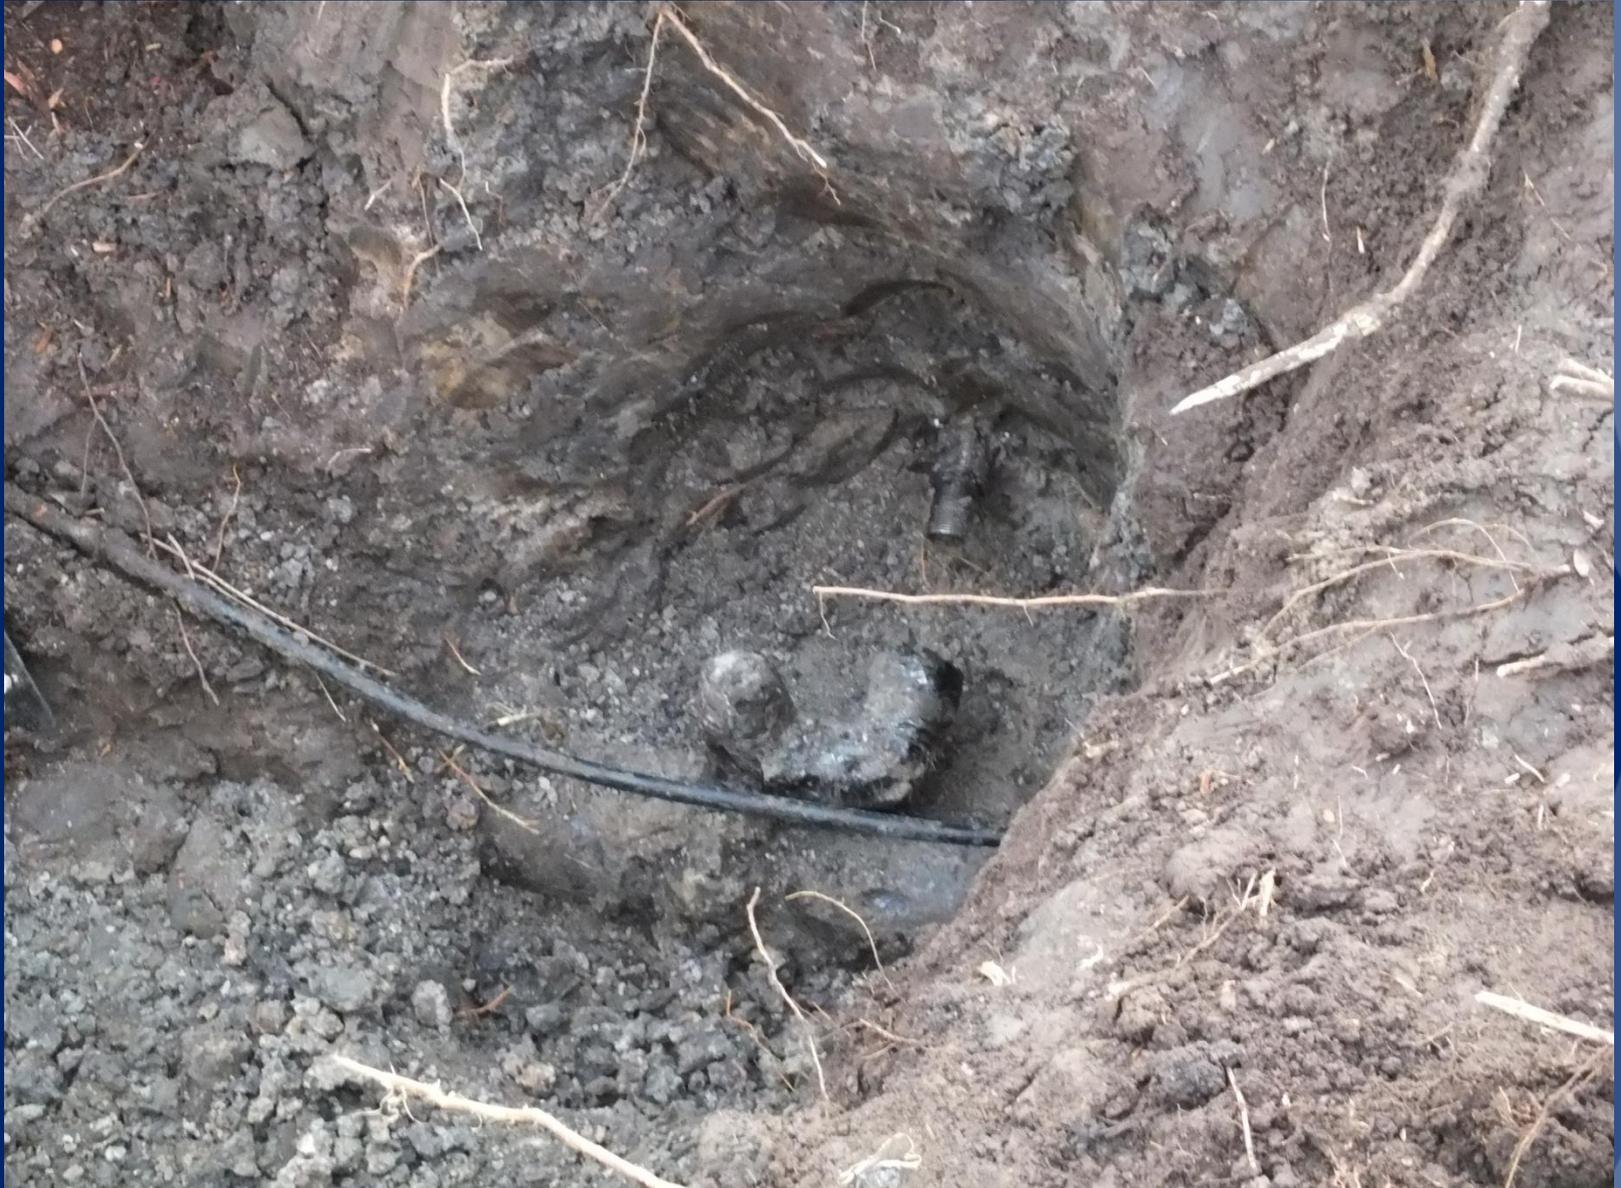
- 12-GIMG-584-GIP
- House destroyed; One fatality.
- Staff determined excavator damage caused explosion by pulling pipe out of compression fitting.
- Recommended excavator be cited for failure to call 9-1-1.
- Recommended operator be cited for ineffective emergency plan.

## Service Line Pulled out of Compression Fitting
