# Kansas Incident Investigations

Investigation Techniques & Lessons Learned

# 728 Minnesota, Wichita KS

- 12-KGSG-490-GIG
- House fire and explosion
  - 3 victims burned, house destroyed.
- Staff determined break in low pressure cast iron piping led to house explosion.

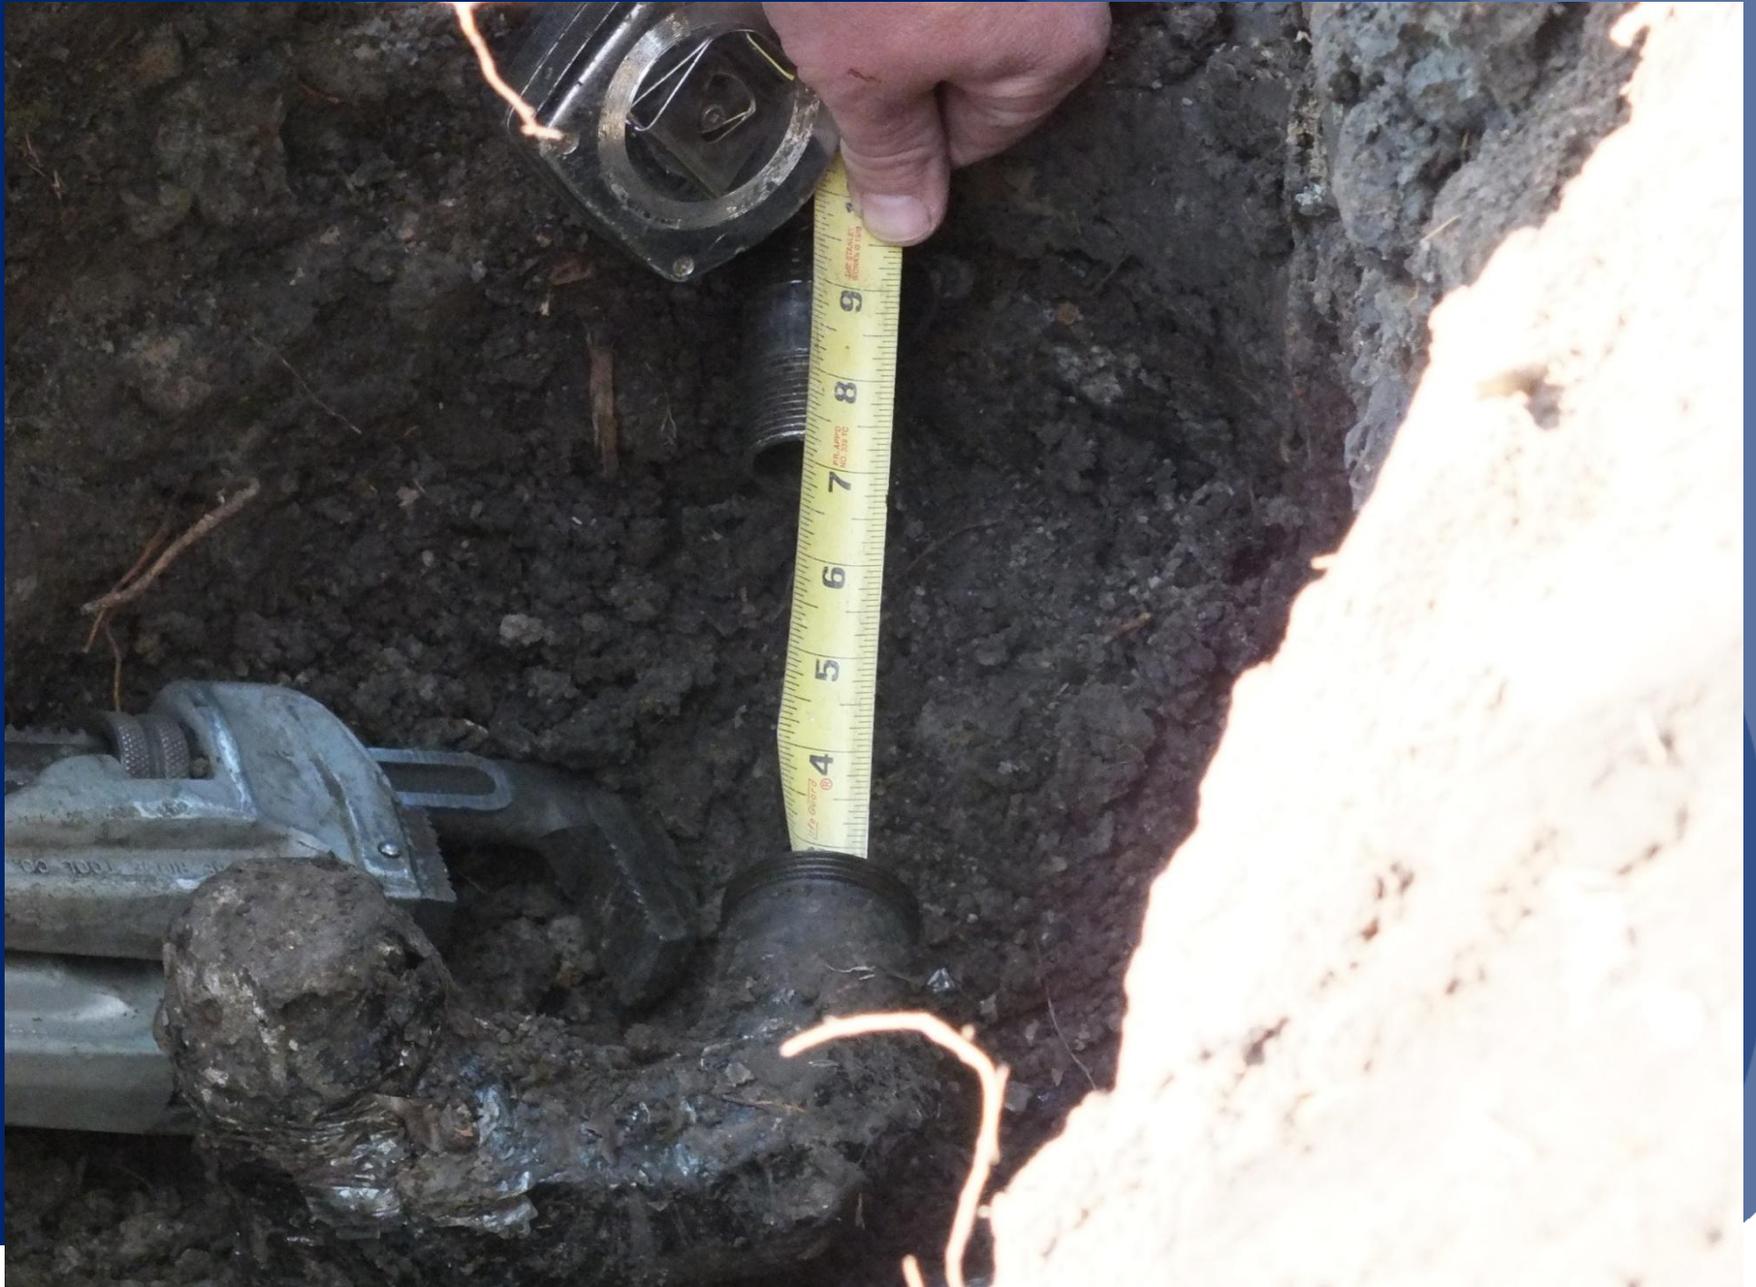
## Service Line Pulled from Compression Fitting

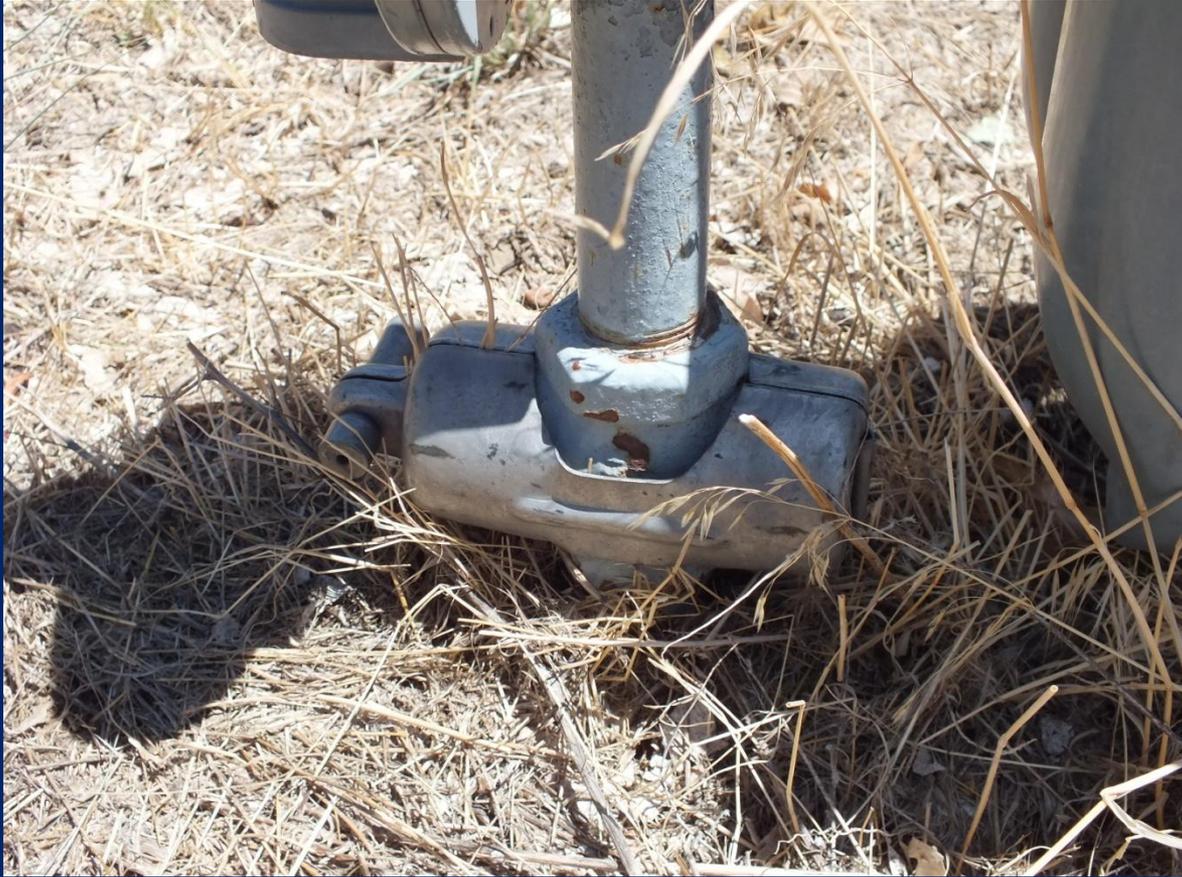
# Locked Valve

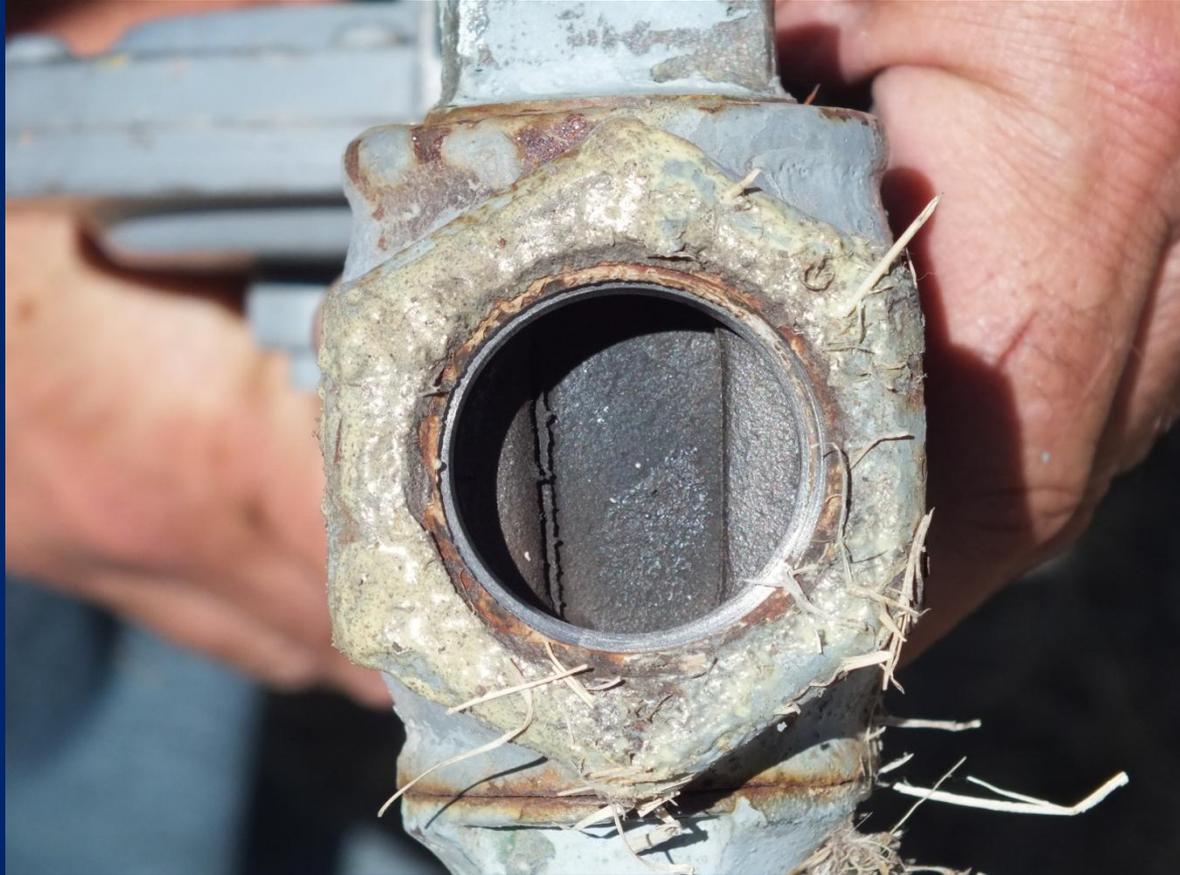
- Meter reading zero usage since locked off.
- Meter registered usage after fire.
- 192.727(d)(1): Valve that is closed to prevent flow of gas to a customer must be locked.

# Leaking Valve
