The Elephant in the Sewer:

Cross Bore Findings Through Sewer Investigation

Ron Thomann

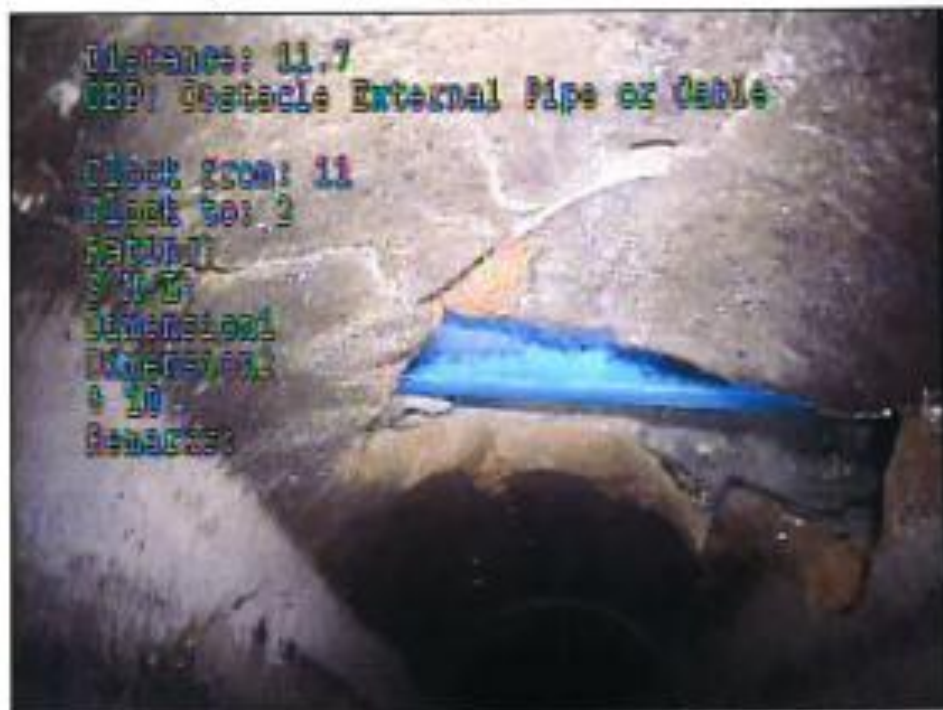
Project segment ref: MAPLE ST_MAIN	Project Name: NORTH Bend	Start date/time: 10/25/2012 9:35:04 AM	Number: 3	Surveyed by: TREKK/COLE
Upstream manhole No: MAPLE ST	Downstream manhole No: MAIN	Total length:		
Address info:

Distance	Length	Code	Reviewed	Check Pos.	Severity	Comment
16.0		OBP	No	11 / 2

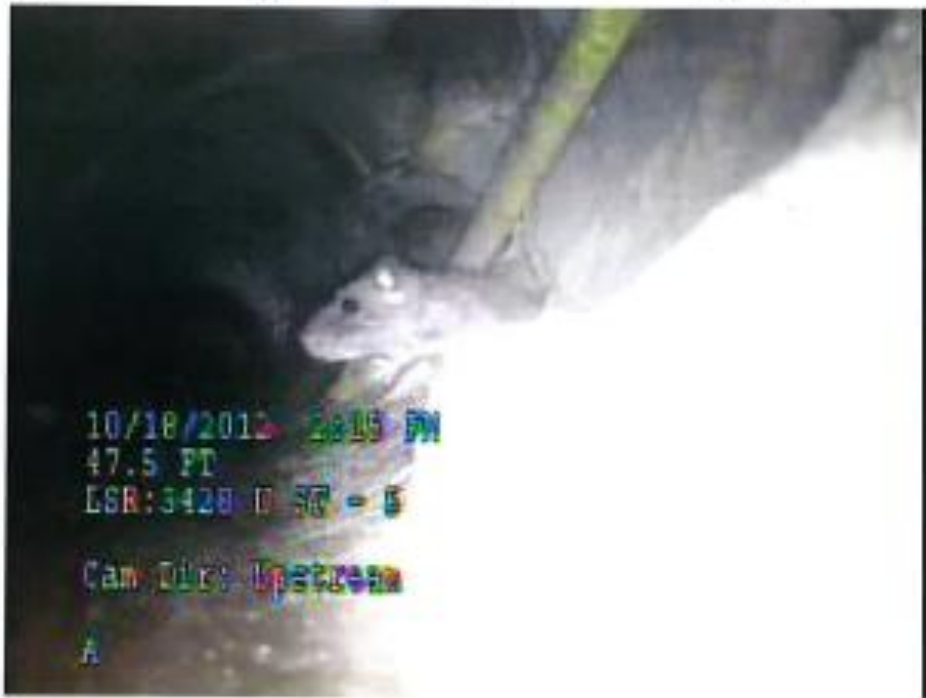
If Inspection Failed, Reason for Failure:	FOUND CABLE THROUGH SERVICE.
---	------------------------------

Distance	Length	Code	Reversed	Dock Pos.	Severity	Comment
47.5		OSP	Yes	9 /		CROSS BORE

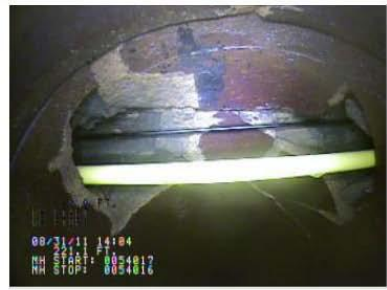
Upstream Manhole:	0054017	Downstream Manhole:	0054016	Building Photo:	24
-------------------	---------	---------------------	---------	-----------------	----

FOUND A CRSS BORE IN THE SERVICE.

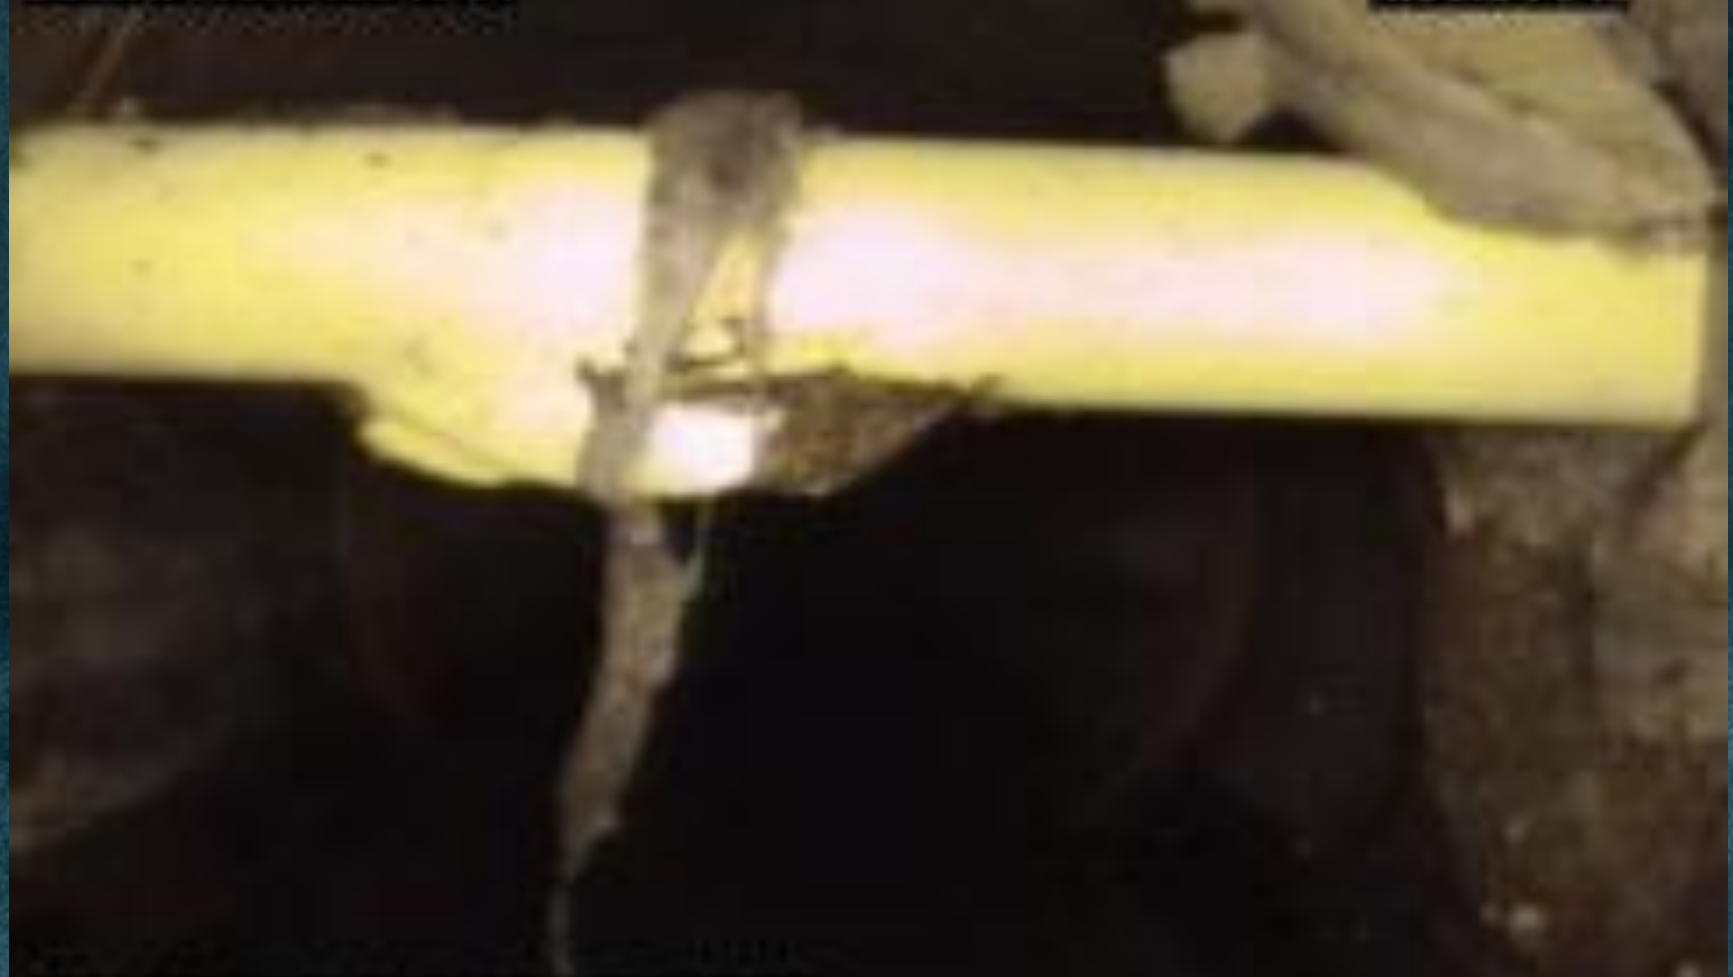
OBI - Obstacle Intruding Thru Wall
gas line hit

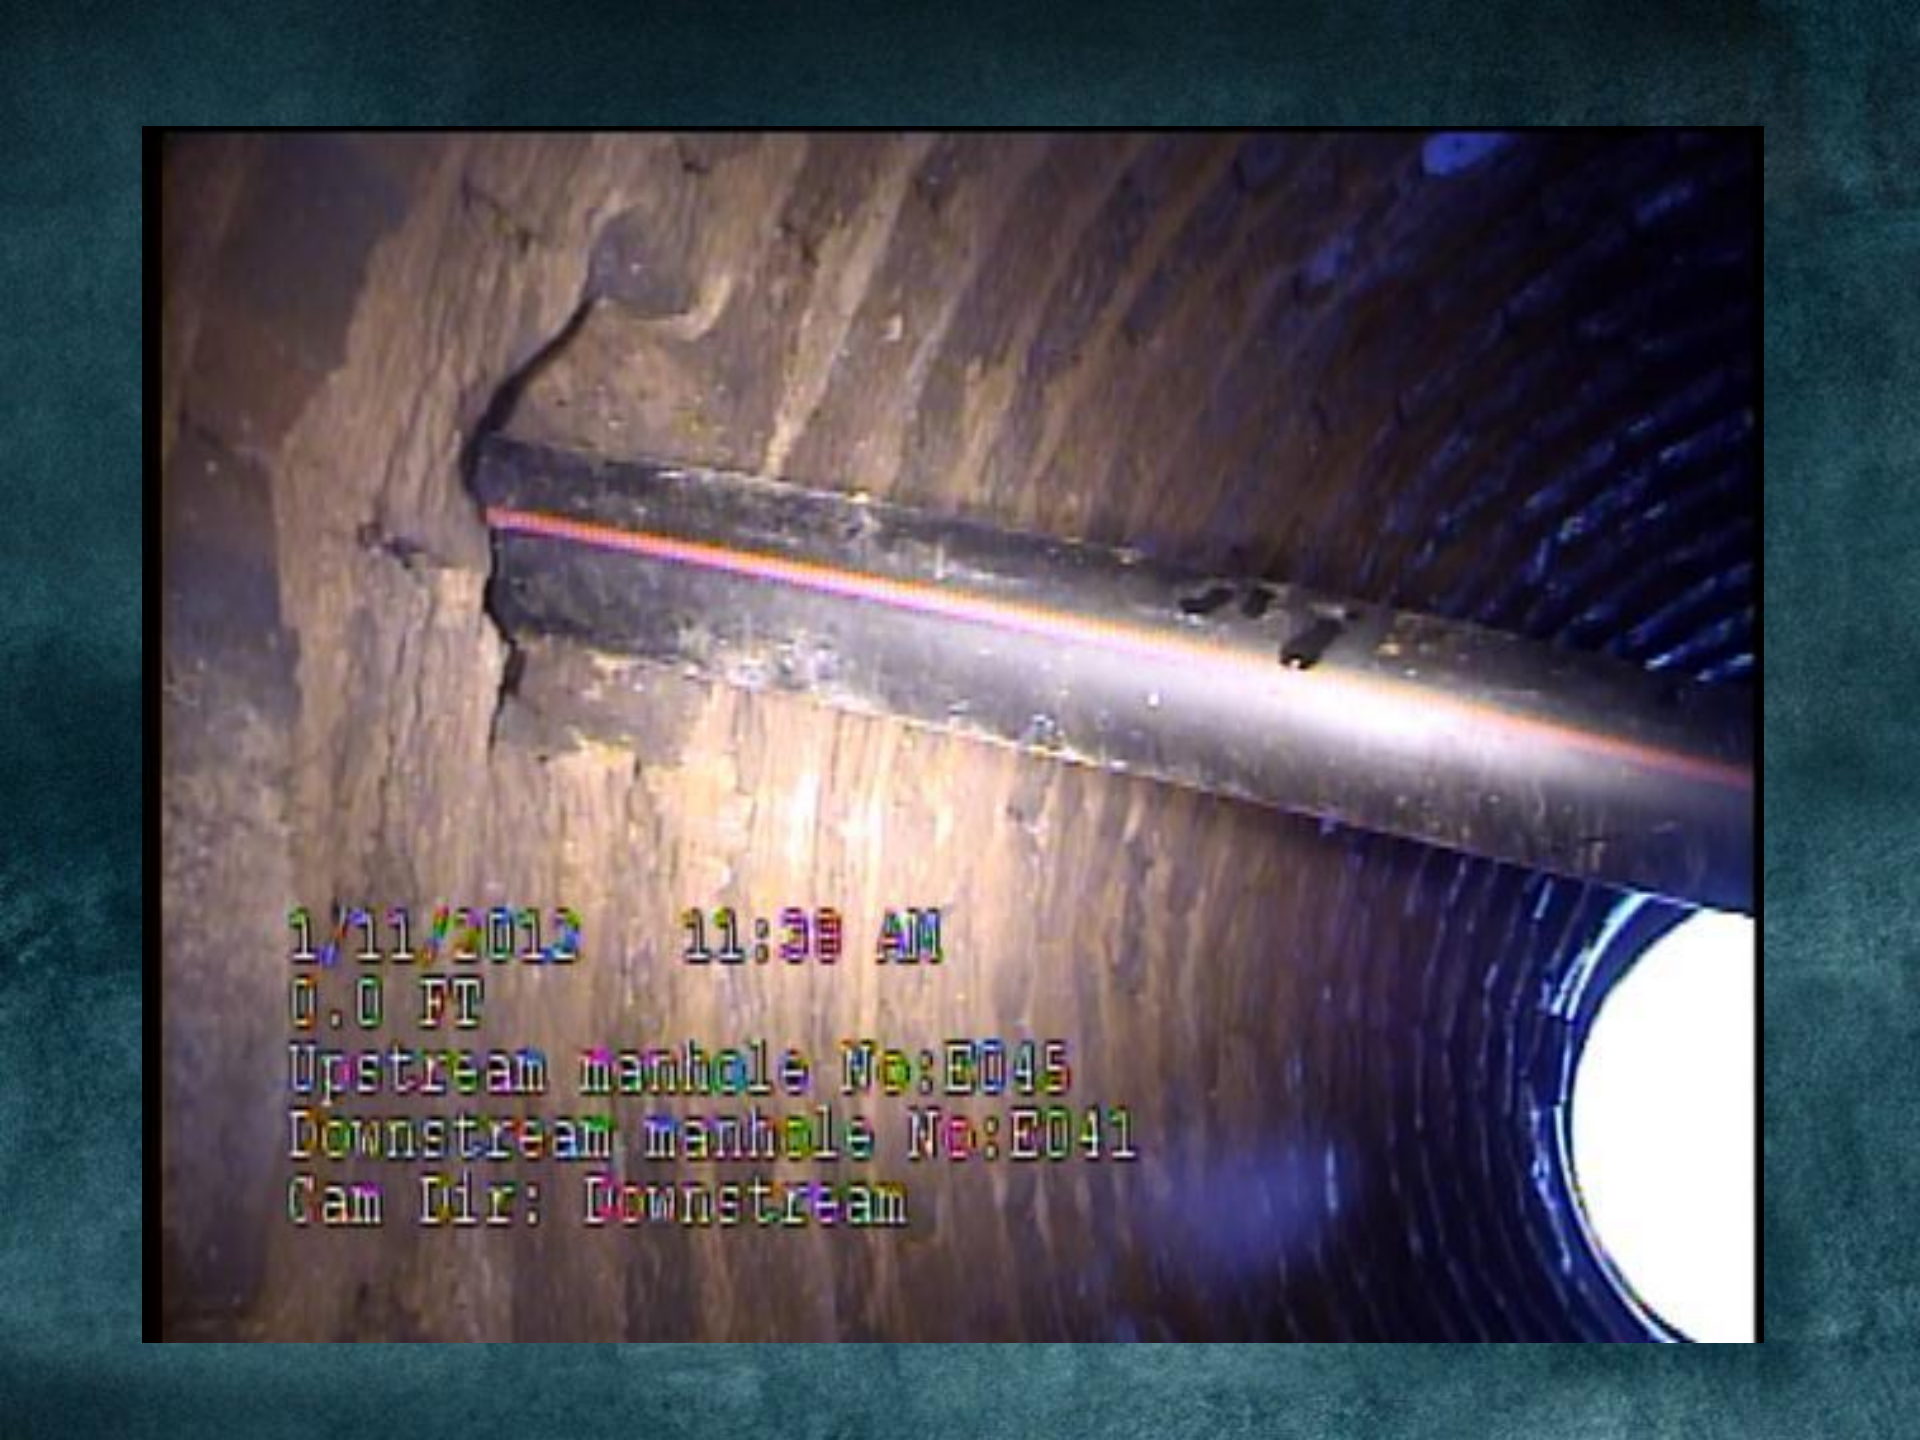
1/11/2013 11:38 AM
0.0 FT
Upstream manhole No: E045
Downstream manhole No: E041
Cam Dir: Downstream

Comments: LAT FAIL CROSS BORE
