AC Corrosion and Mitigation

Mike Ames
Director Technical Operations
Chapman Engineering
Oct 20/21, 2015
KCC Pipeline Safety Seminar
Manhattan, KS

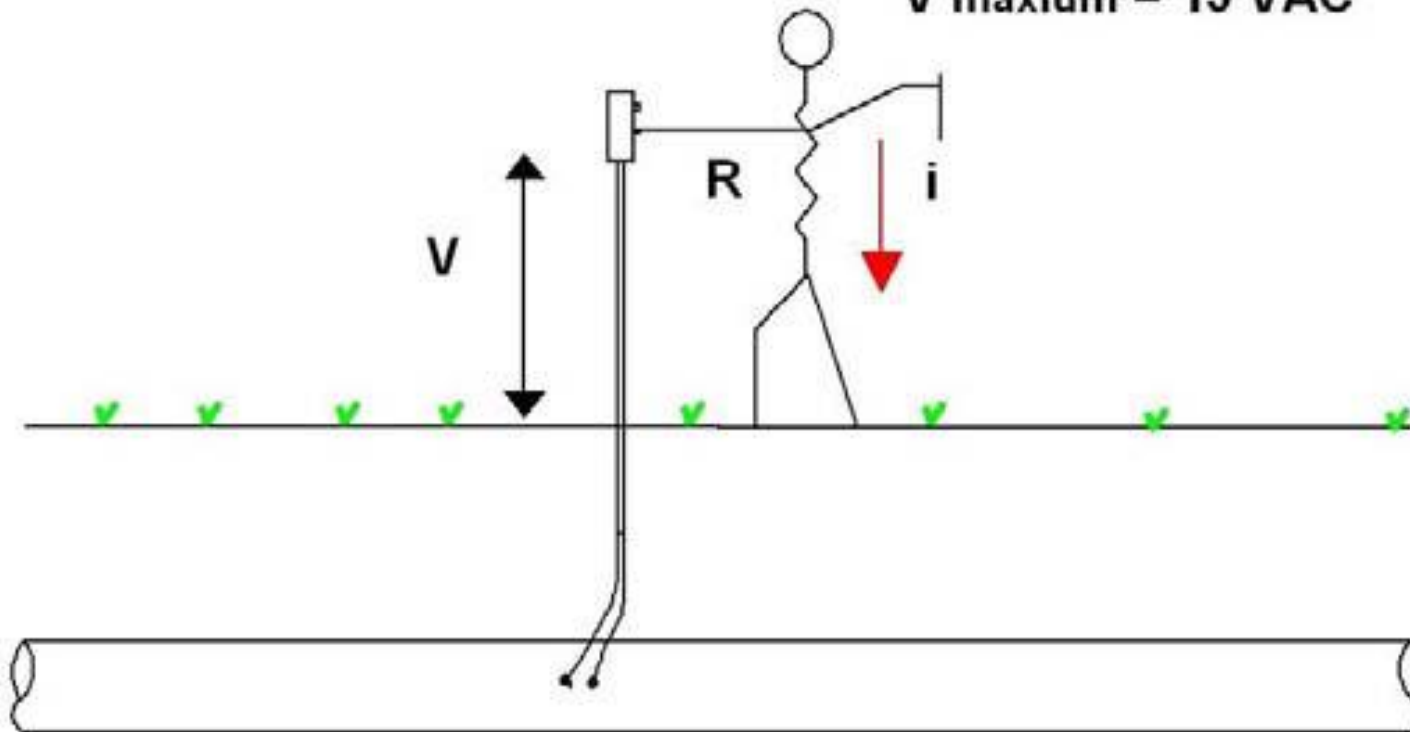
Touch Potentials

$i =$ Let go current = **10 mA**

$R = 1500$ Ohms

$V_{\text{maxium}} = 15$ VAC

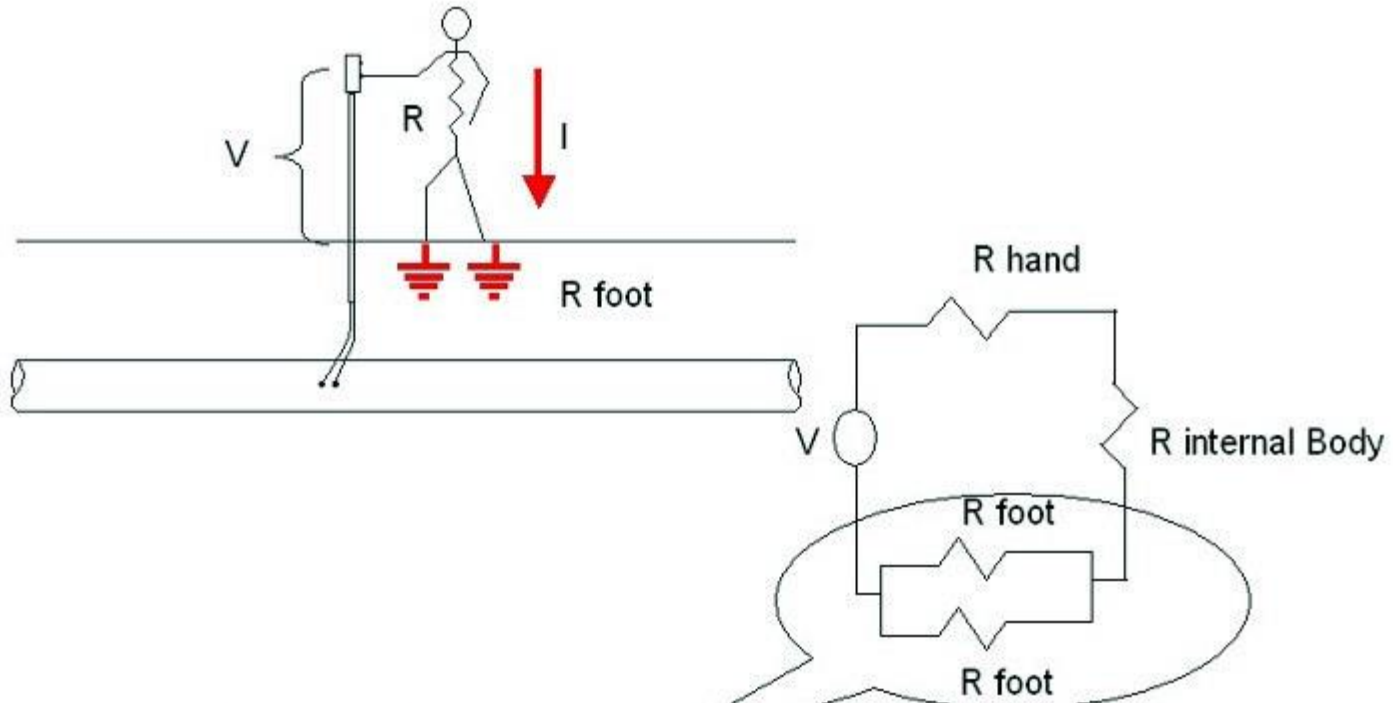
Step Potentials

Here the parallel resistance of the two feet to ground is calculated as
 $R (2 \text{ feet parallel}) = 1/2 (\rho)$
Where ρ = Soil Resistivity in Ohm-Meters

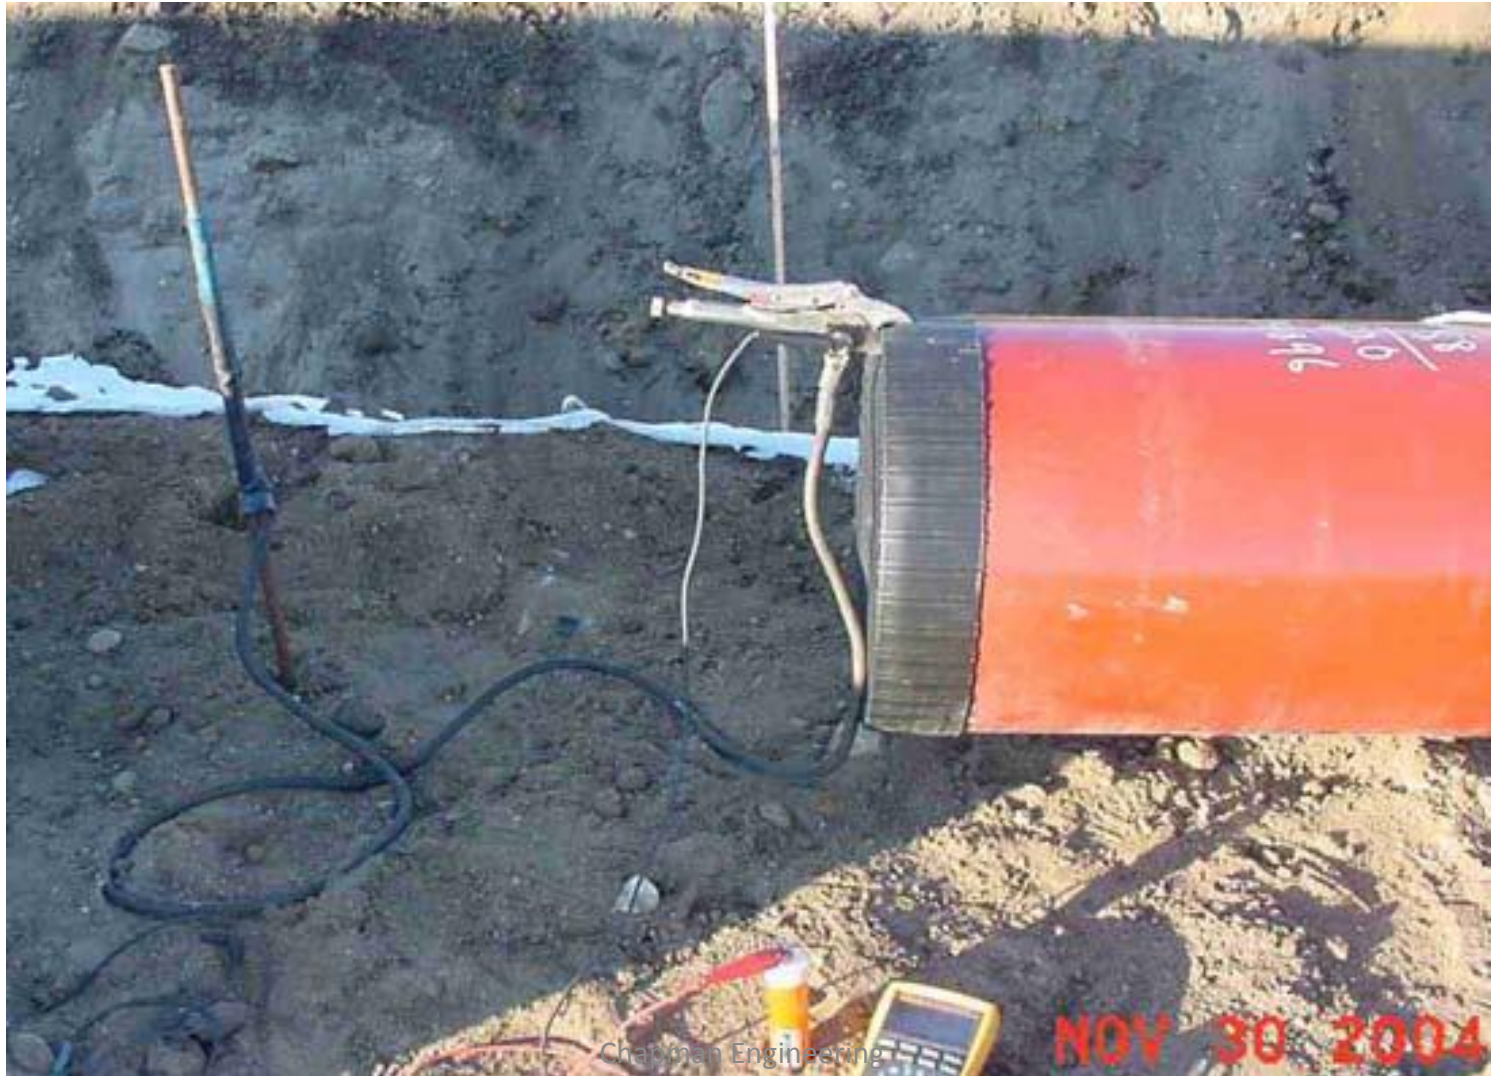
Temporary Grounding/Construction

Auxiliary grounding is recommended for this situation during construction.

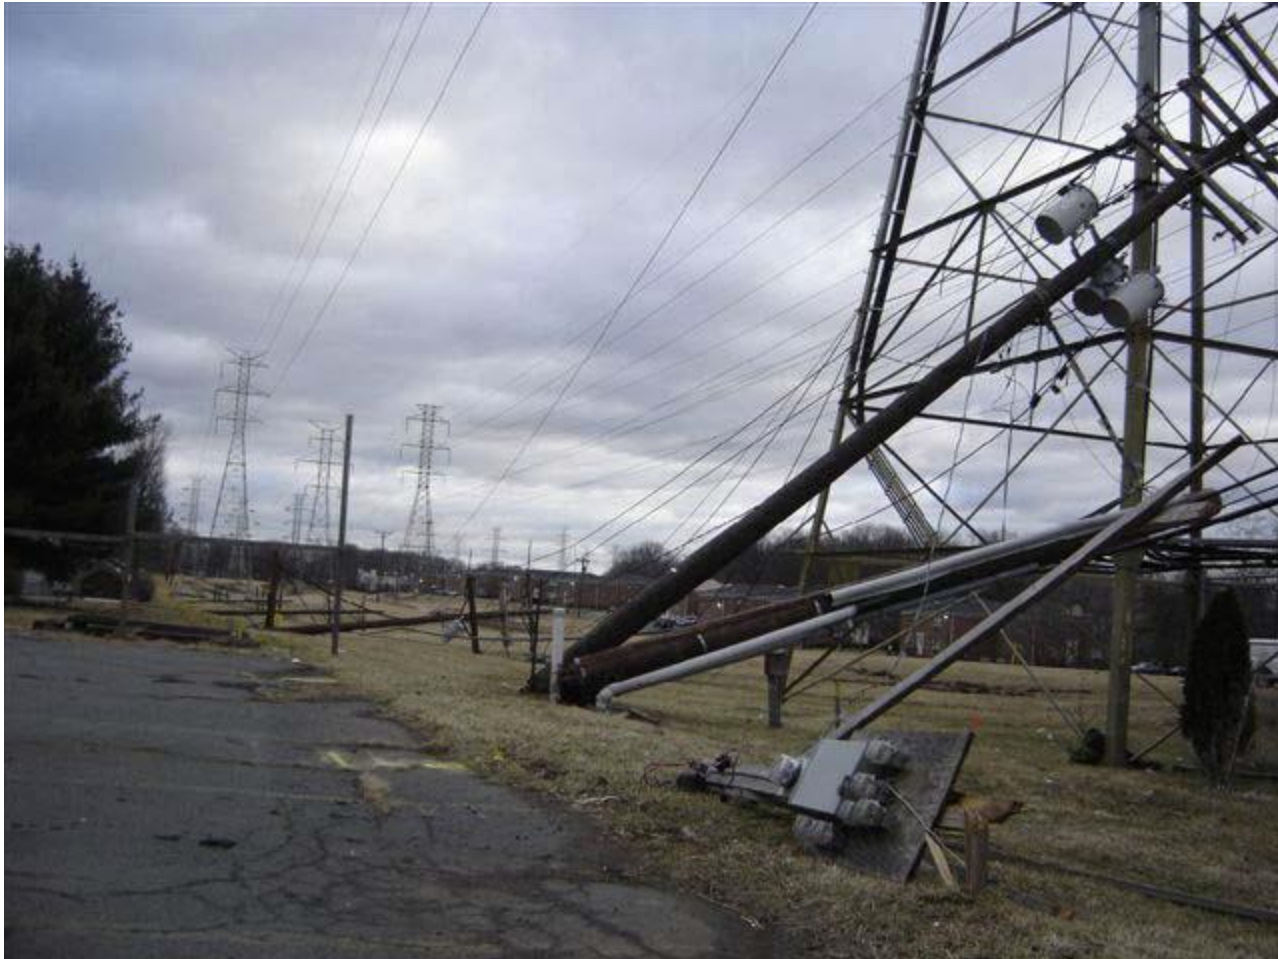
Power Line Fault Example

A rare condition normally associated with a short from the power line to the ground, or to the pipeline directly.

The major issue of this type of coupling may be significant coating damage from the high voltages and currents involved

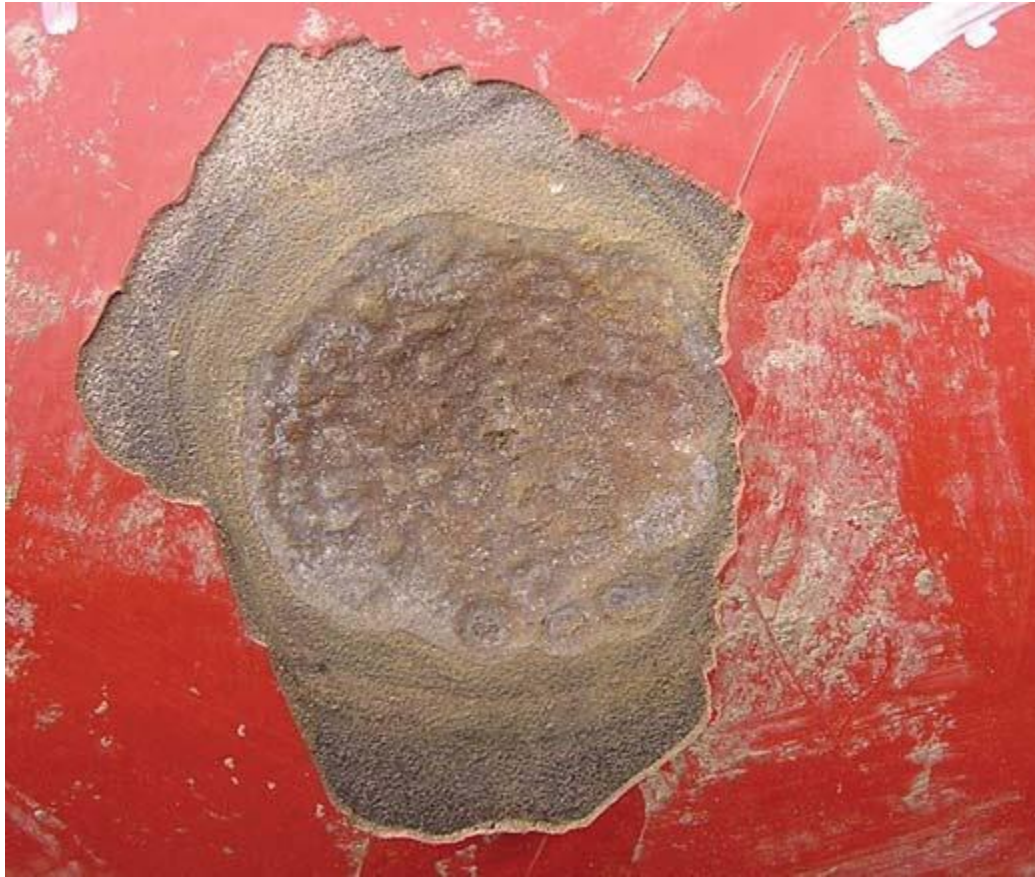
A “Classic” AC Corrosion Pit

- Major differences may be that with MIC there likely is a smooth bottom to the pit, while with AC corrosion, the bottom may be somewhat level with small circular dimples scattered in the bottom.

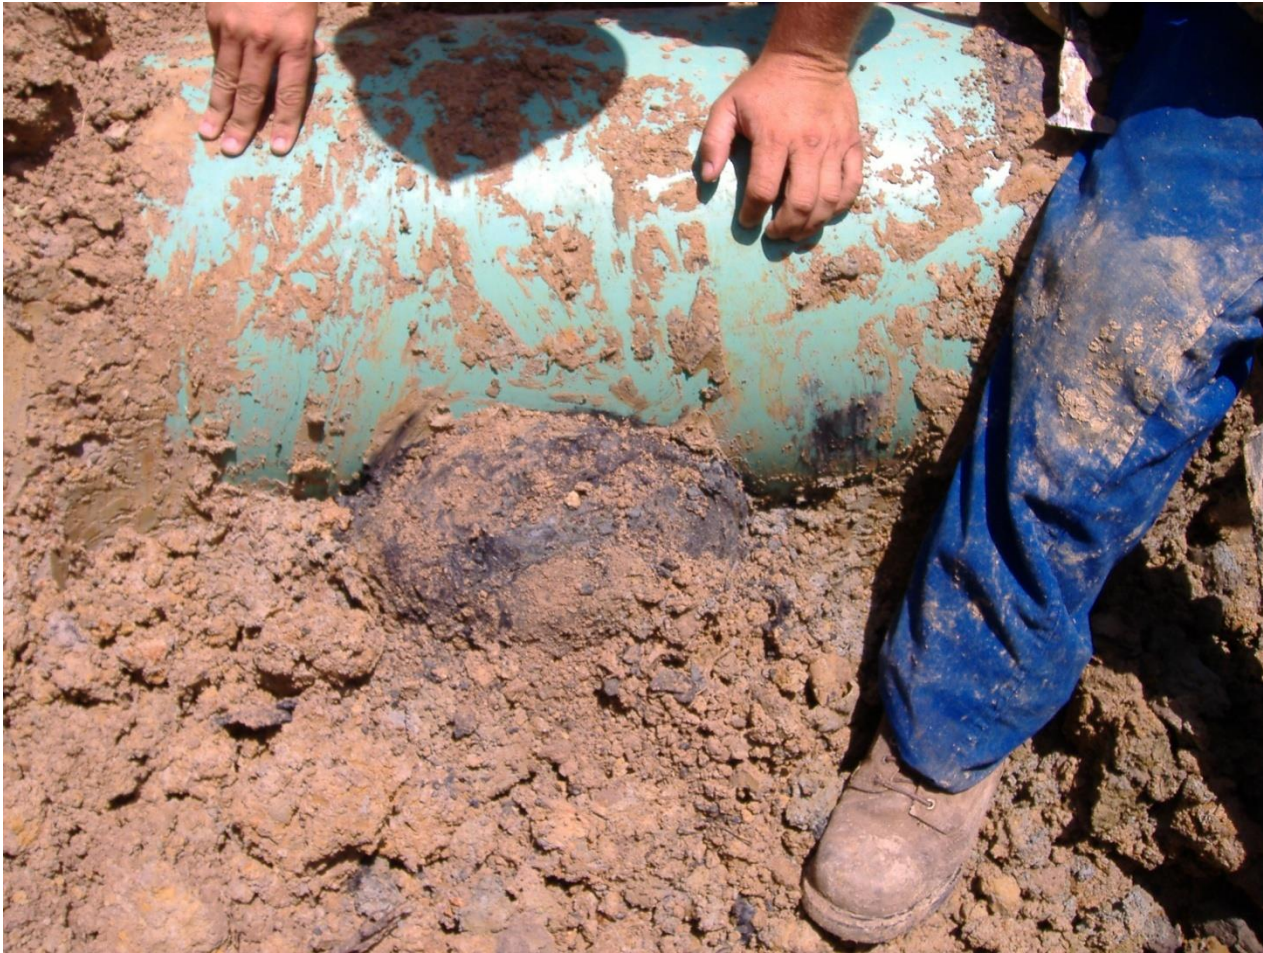
Upon Excavation

- Anomaly indications of CIS, DCVG, ACVG, and soil resistivity indicated the location as an excavation location.
- Upon excavation, a large anomalous ball of material was adhered to the pipe coating – much of the coating underneath was intact

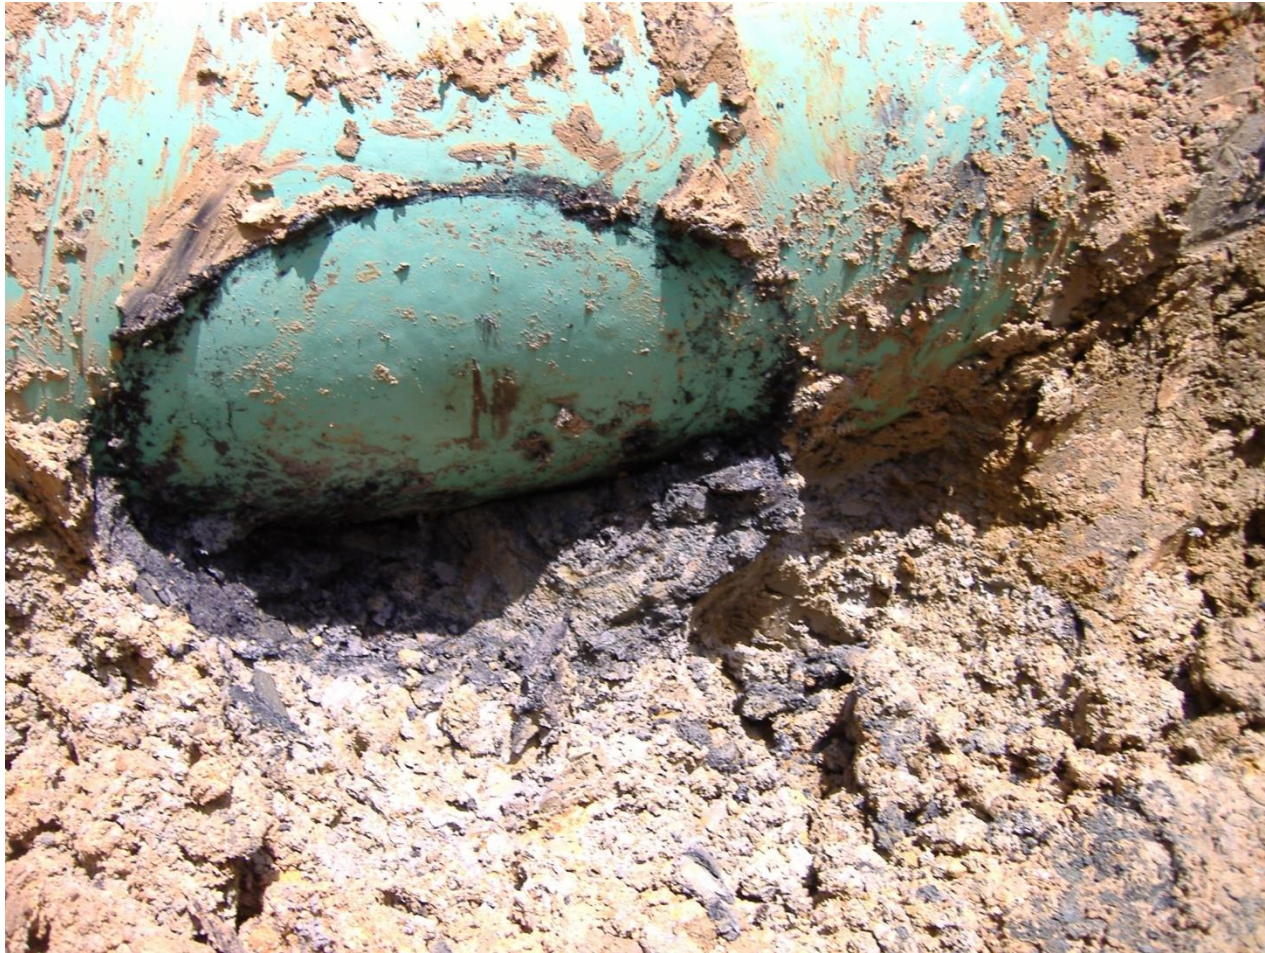
Area Under Corrosion Product

- The characteristic shapes of the AC corrosion are noted in the bottom of the pit.
- Layers of corrosion are evident in the pit outer walls, as well as indicated by rings in the corrosion product ball.
- Layers and rings of corrosion product are due to periods of higher current loads, and lower soil resistivity due to rains or soil moisture.
- The corrosion of .132" on a .403" wall indicates a corrosion loss of 32.8%. The time period is unknown.

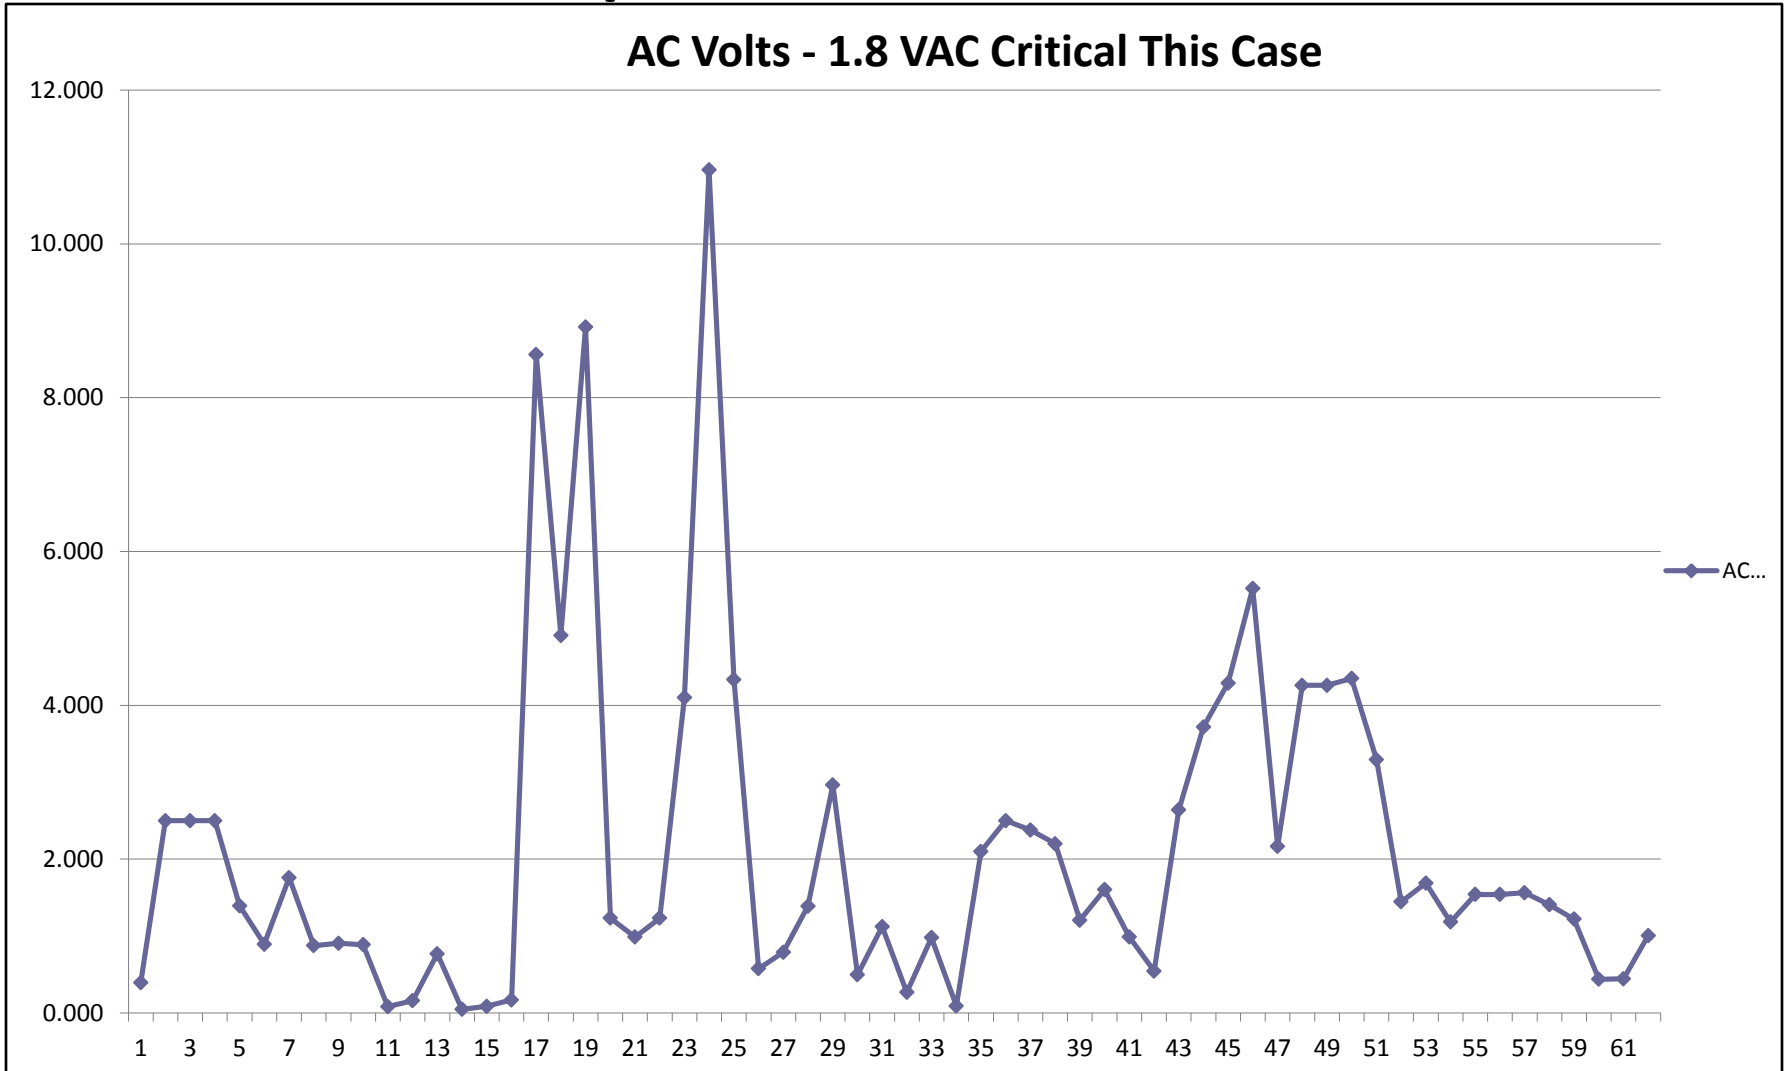
Graph AC Potentials

AC Volts - 1.8 VAC Critical This Case

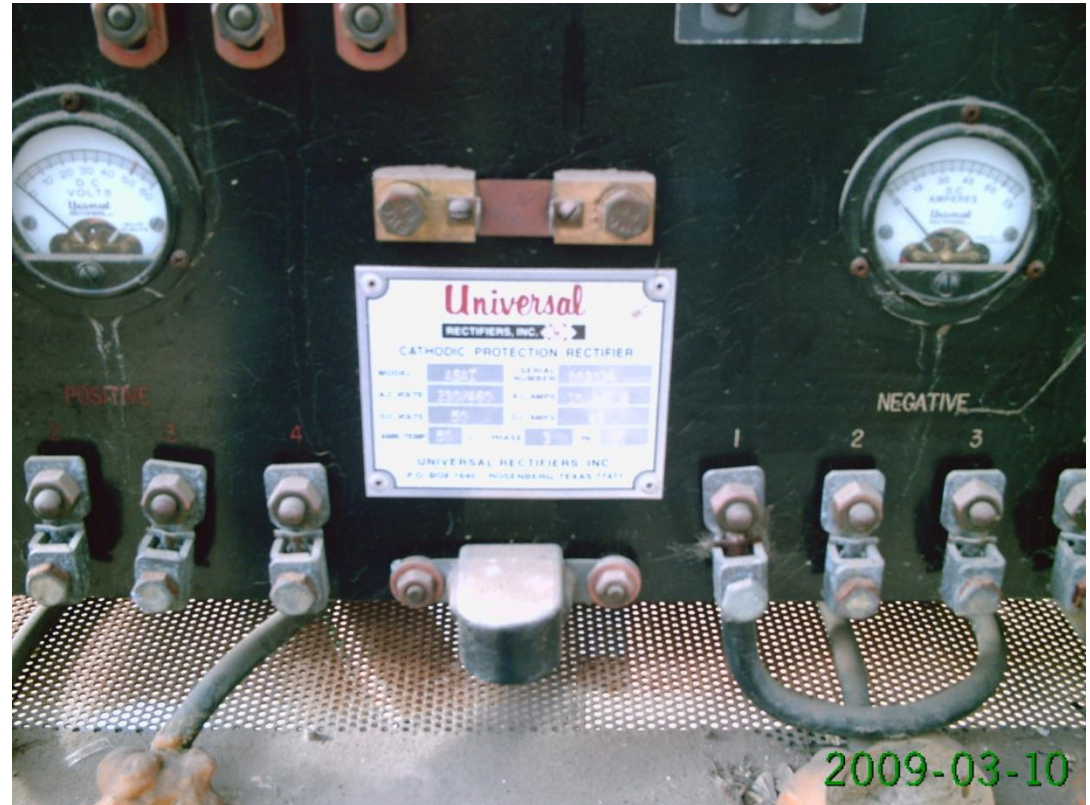
Rectifier

Negative Leads!

The negative lead connects to the pipeline and can have the same high AC Voltages present – they should be capped or taped to prevent contact.

Does it matter if the rectifier is off? No, as these voltages come from the pipeline, not the rectifier power source.

Does an equipotential mat protect the person? Possibly not, as the mat is not connected to the pipeline, and cannot be trusted to protect the worker from pipeline AC!

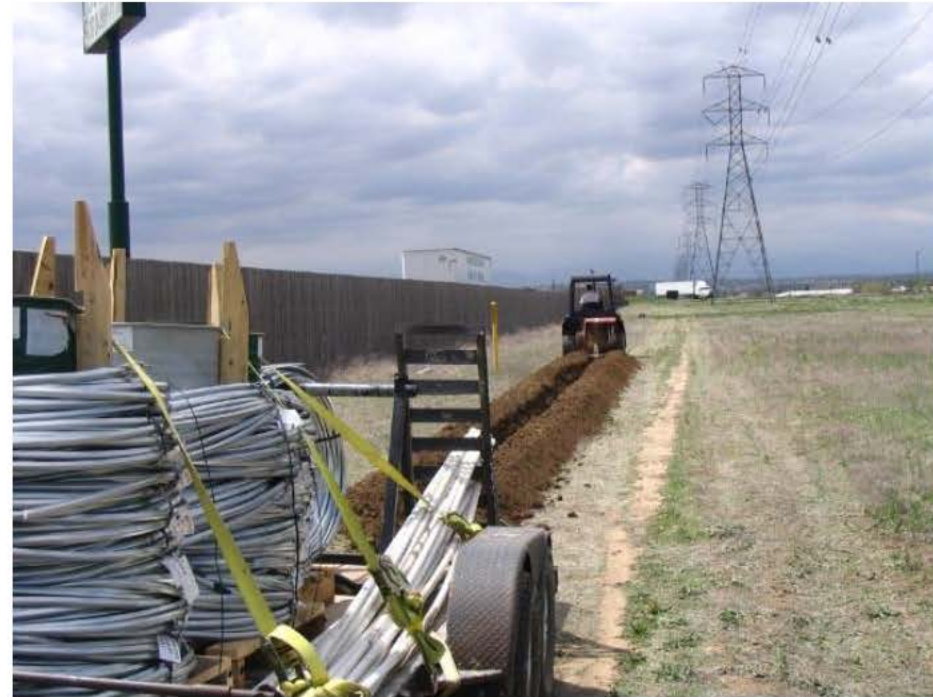
AC Mitigation – Modeling Defines What is Required and Where

- Mitigation wire provides a benefit in the mitigation of AC corrosion. For a coating holiday located in the vicinity of the mitigation wire, the effective resistance of the holiday is increased due to the mutual resistance between the holiday and the mitigation wire, thereby reducing the AC current density at the holiday.

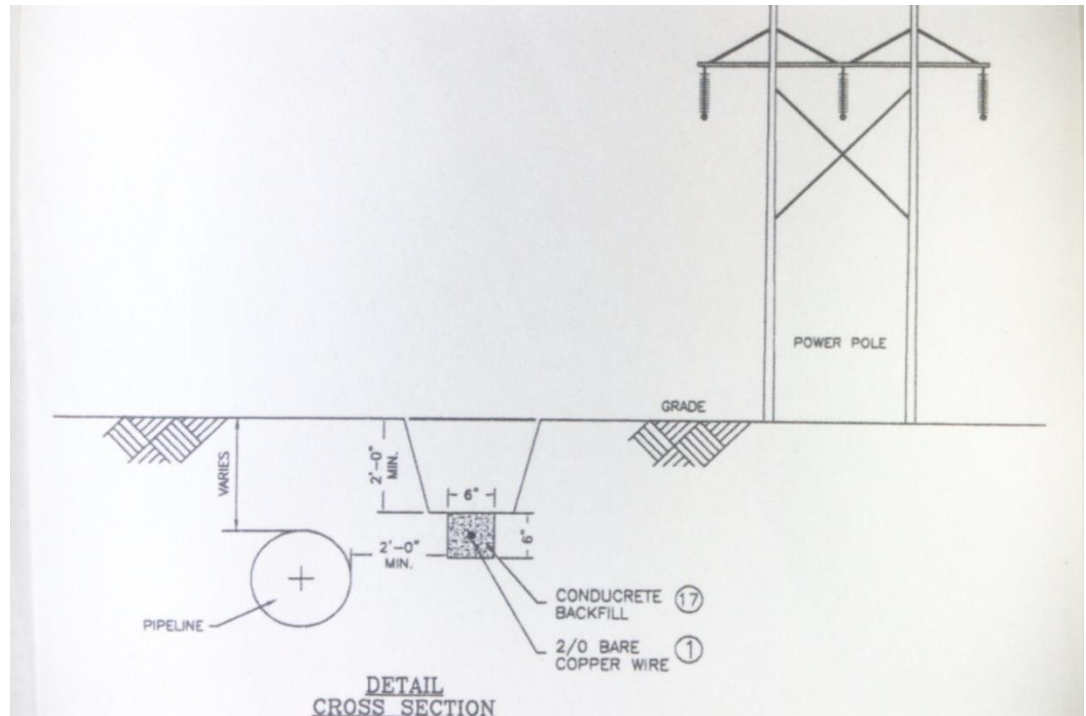
Typical Solid Media AC Mitigation – Single Linear

To the side of the pipe nearest the power line, a long trench is made for the installation of mitigation media. In this case a bare copper wire is used with a layer of conductive concrete.

The conductive concrete lowers the resistance of the system, protects the copper wire from corrosion, and lowers the impedance value of the wire to allow faster dissipation of fault currents.

Zinc wire or ribbon can also be used, but should have a surrounding prepared backfill .

Modeling will determine the length, location, wire size, and placement of these systems.

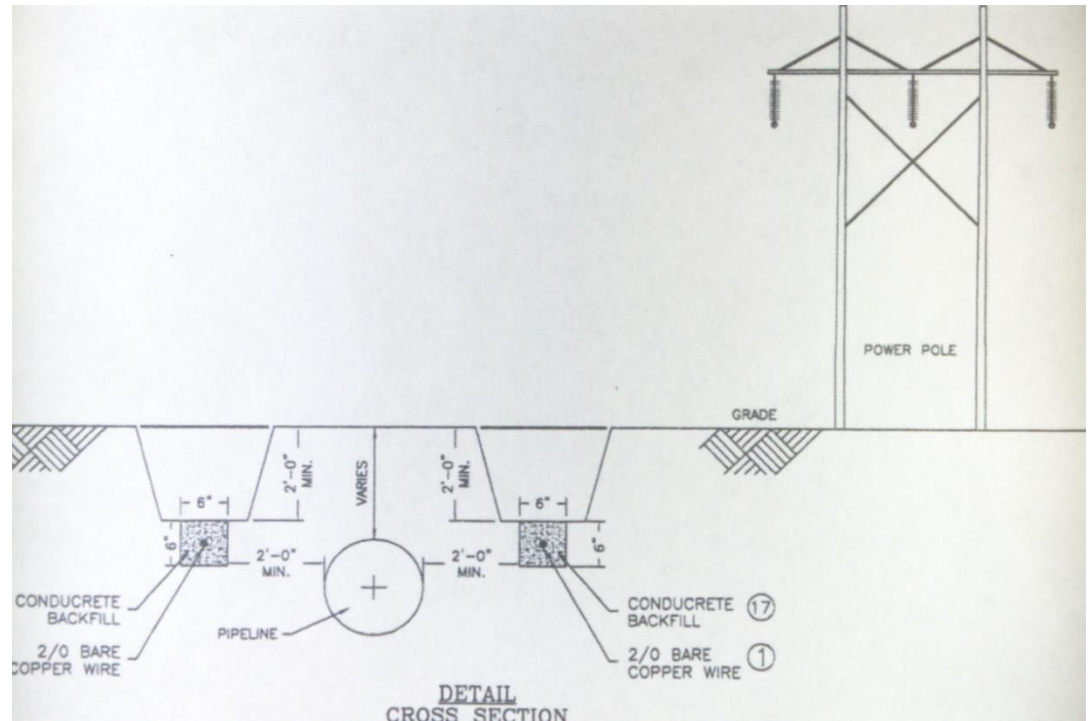
Solid Media AC Mitigation – dual run system

When the modeling demands even higher current dissipation, dual runs of media may be installed.

In locations where the pipeline may be centered between two High Voltage AC systems, the use of two runs may also be required.

The length and size of these systems is again determined by modeling to specifically fit the situation.

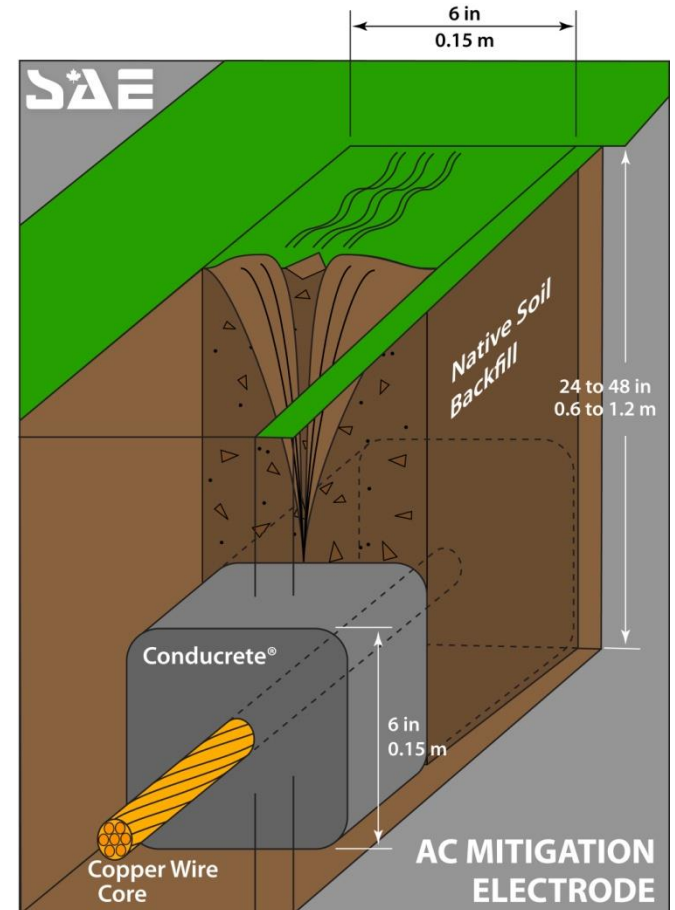
Solid Media Backfill – Ground Enhancement

- Diagram of a typical conductive concrete over copper AC Mitigation electrode as installed:
 - A large copper core is encapsulated in a conductive concrete backfill
 - The entire electrode sets up to provide a mean strength of 3000 psi
 - When set up, the AC Mitigation electrode becomes a single, solid conductor with a large surface area able to safely dissipate large amounts of current
 - The electrode system protects the copper core from corrosion and deterioration, thus extending the operational lifetime by 10 times normal

- Conductive concrete can have a resistivity of 3 ohm/cm
- It has the same porosity as bentonite
- It is hygroscopic and will retain moisture
- It has been used to enhance grounding systems for over 100 years (Marconites).
- It reduces impedance and resistance of AC mitigation systems and enhances their ability to pass current to the earth.
- It reduces the electrolytic corrosion process of copper by over 85% to 90%, extending copper life to 50 years or more in AC Mitigation service.
