OIL & GAS REMEDIATION SITE STATUS

ANNUAL REPORT | 2021

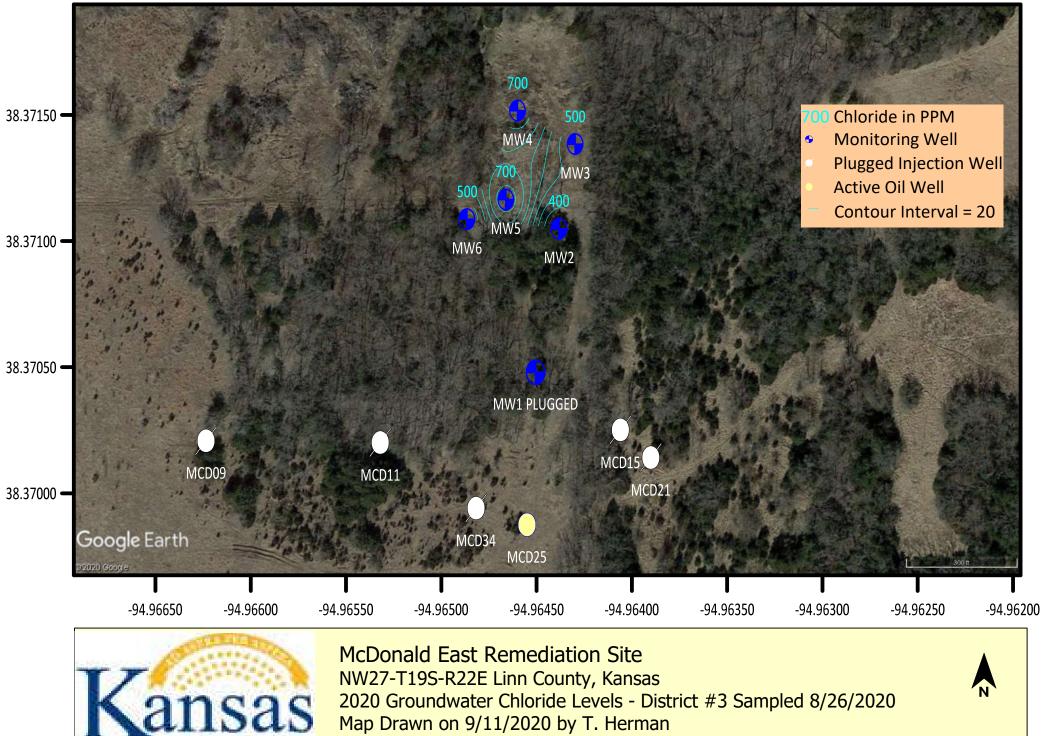
NW27-T19S-R22E Linn County, Kansas 2020 Groundwater Chloride Levels - District #3 Sampled 8/26/2020 Map Drawn on 9/11/2020 by T. Herman Project 970070-00
