OIL & GAS REMEDIATION SITE STATUS

ANNUAL REPORT | 2022

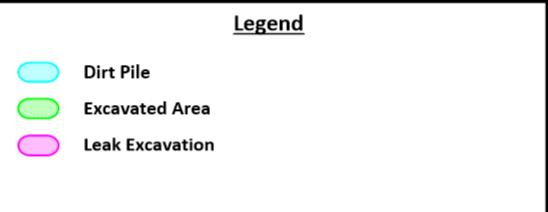
Geophysical Investigation Survey
GATHERING LINE RELEASE SITE
JENNINGS, KANSAS
EM-31 QUADRATURE MAP
VERTICAL DIPOLE: 0' - 18'

SCALE 1 INCH = 50 FEET
