2025

**OIL AND GAS
REMEDIATION SITE STATUS**

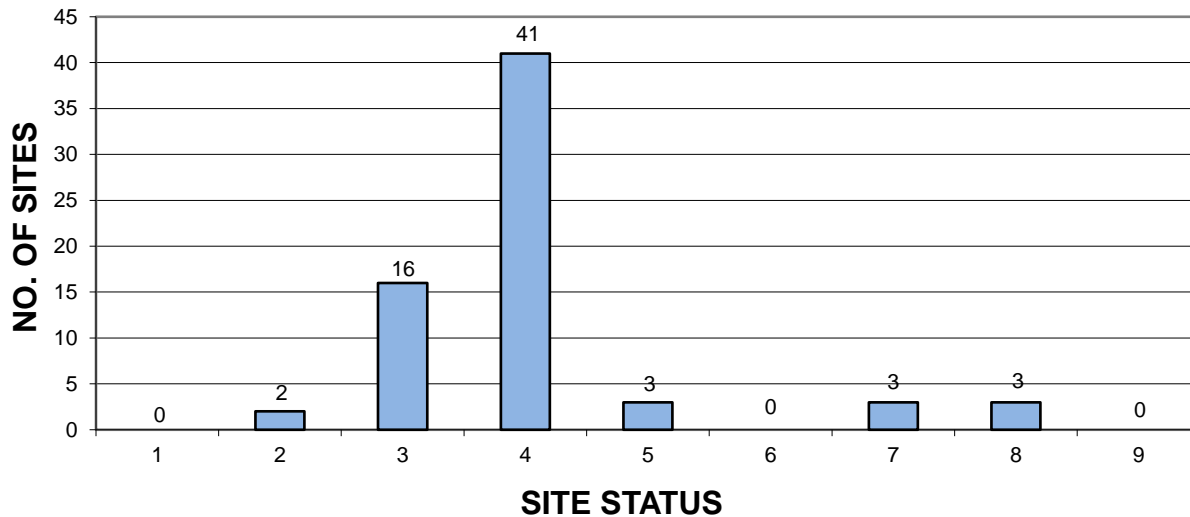
STATEWIDE DISTRIBUTION OF SITES BY STATUS

In general, each contamination site has a definable life cycle. This cycle begins with, then follows a sequence of investigatory and possible remedial activities which move the site towards ultimate resolution. The first phase of the cycle is the site assessment. This phase defines general site parameters and conditions forming the basis for additional efforts at the site. Once the assessment is complete the site moves on to a new phase. This next phase may be short term or long term monitoring followed by resolution of the site. Another scenario might include an extensive investigation phase followed by the installation of a monitoring system whose sample results may indicate the necessity for certain remedial activities and additional post remediation monitoring prior to resolution of the site. The following graphs depict the current status of the 47 listed sites on a statewide and KCC District basis.

1. SITE ASSESSMENT	2. SHORT TERM MONITORING	3. INVESTIGATION
4. LONG TERM MONITORING	5. REMEDIATION PLAN	6. INSTALLATION
7. REMEDIATION	8. POST REMEDIATION MONITORING	9. RESOLVED

Note: Sites may have more than one status.

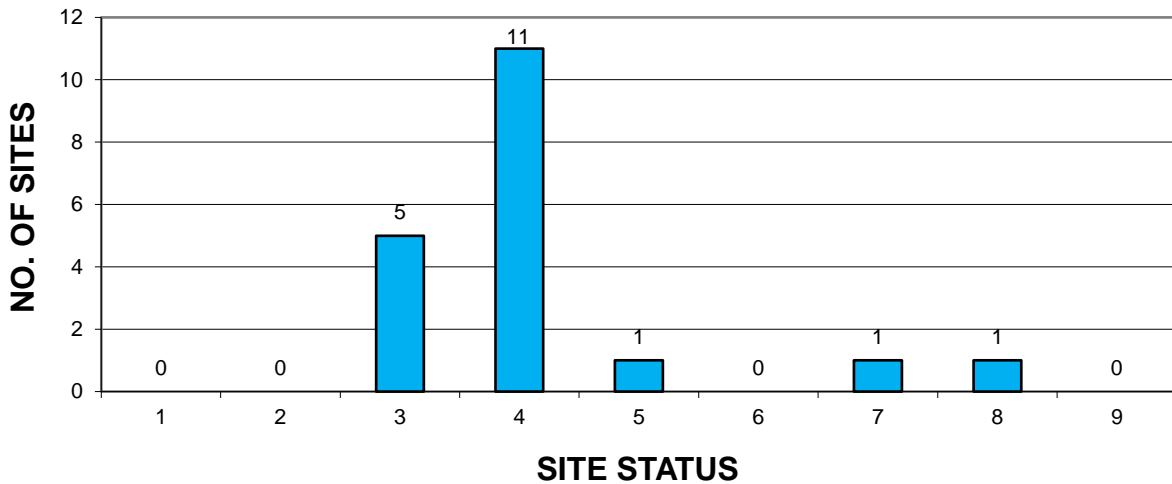
DISTRICT 1

Note: Sites may have more than one status.

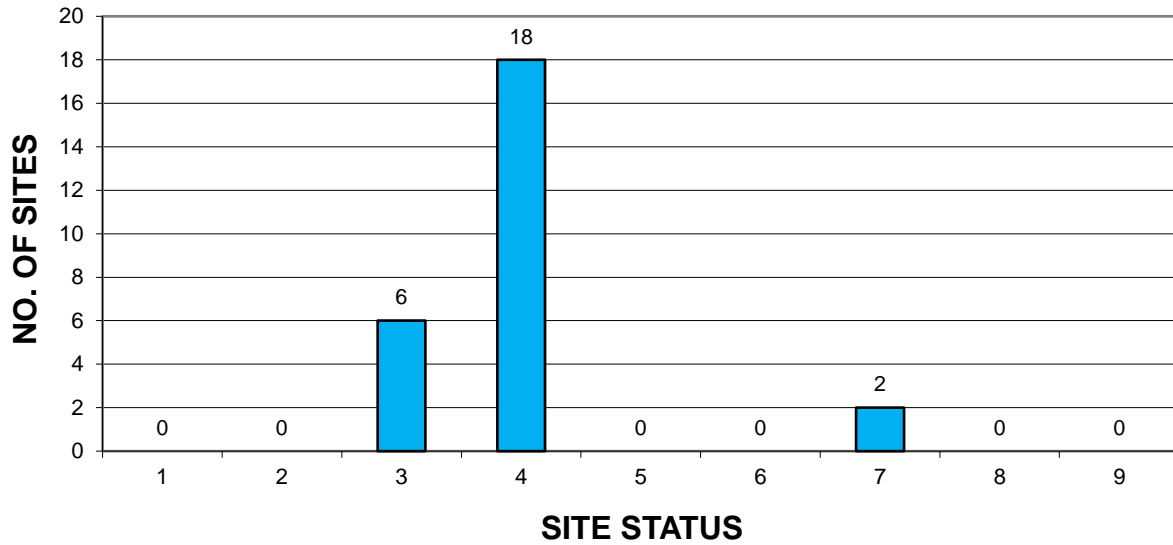
DISTRICT 2

1. SITE ASSESSMENT	2. SHORT TERM MONITORING	3. INVESTIGATION
4. LONG TERM MONITORING	5. REMEDIATION PLAN	6. INSTALLATION
7. REMEDIATION	8. POST REMEDIATION MONITORING	9. RESOLVED

Note: Sites may have more than one status.

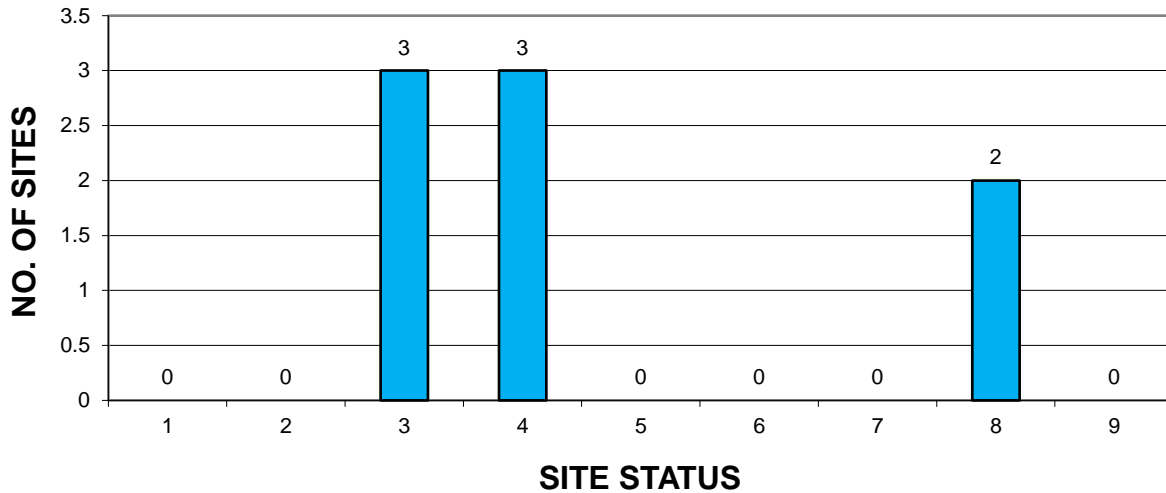
DISTRICT 3

1. SITE ASSESSMENT	2. SHORT TERM MONITORING	3. INVESTIGATION
4. LONG TERM MONITORING	5. REMEDIATION PLAN	6. INSTALLATION
7. REMEDIATION	8. POST REMEDIATION MONITORING	9. RESOLVED

Note: Sites may have more than one status.

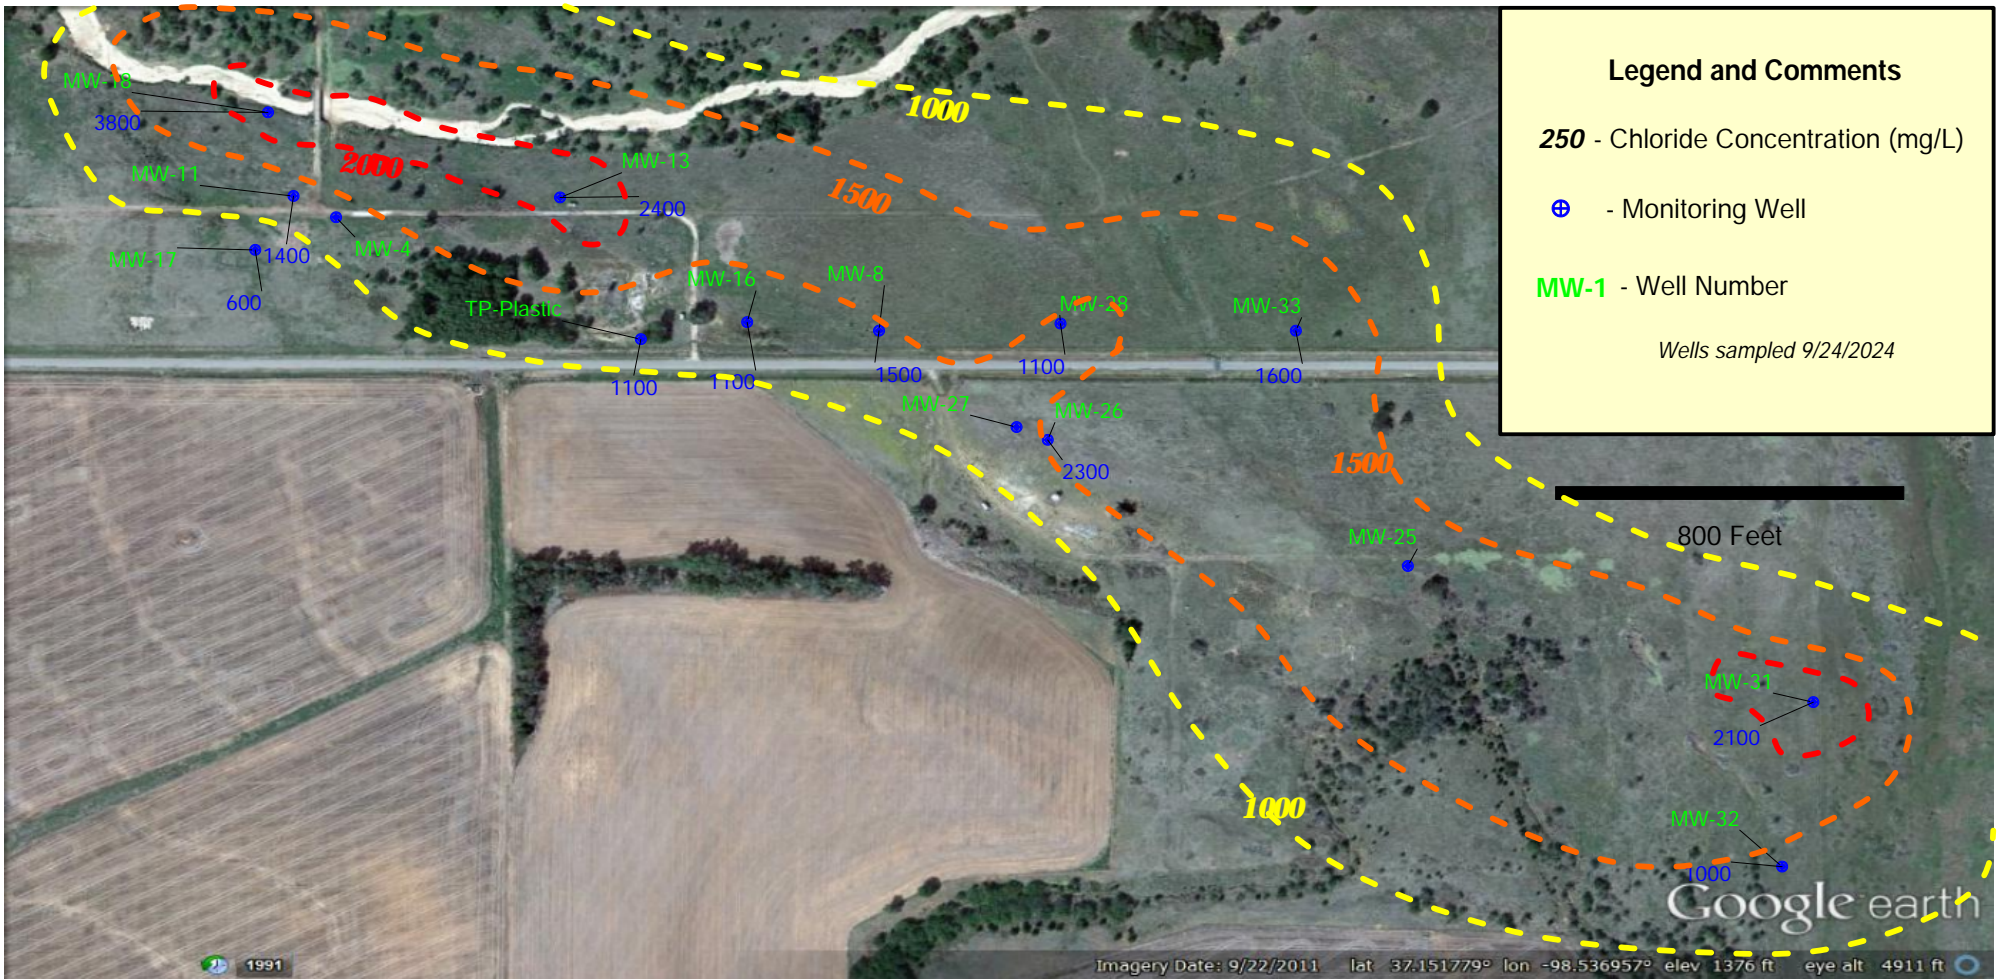
Harbaugh Site
 Sections 20/29-T-33S-R11W
 Barber County, Kansas
2024 Area Map with Monitoring Well Chlorides
 KCC Control # 970049-00 District 1
 N. Feldkamp 10/1/2024

Control No.	Staff Hours/Expenditures	Fund Expenditures	
		FY 2024/25	Total
970049-00	11 Hrs. / \$354.95	\$ 2,960.00	\$713,213.92
Current Contaminate Level: 500 ppm Cl- to 3,800 ppm Cl-			
Status:			
<input type="checkbox"/> 1. Site Assessment	<input type="checkbox"/> 2. Short Term Monitoring	<input checked="" type="checkbox"/> 3. Investigation	
<input checked="" type="checkbox"/> 4. Long Term Monitoring	<input type="checkbox"/> 5. Remediation Plan	<input type="checkbox"/> 6. Installation	
<input type="checkbox"/> 7. Remediation	<input type="checkbox"/> 8. Post Rem. Monitoring	<input type="checkbox"/> 9. Resolved

Recommendation for Future Work: Make the necessary repairs to return the recovery system back to operation, or the plugging of the recovery system. Review the data to continue taking a targeted approach at remediating the site. The plugging of more monitoring wells that are outside of the plume as well as recovery wells that are unusable will be evaluated for plugging. Repair wells MW-4, MW-25, and MW-27.

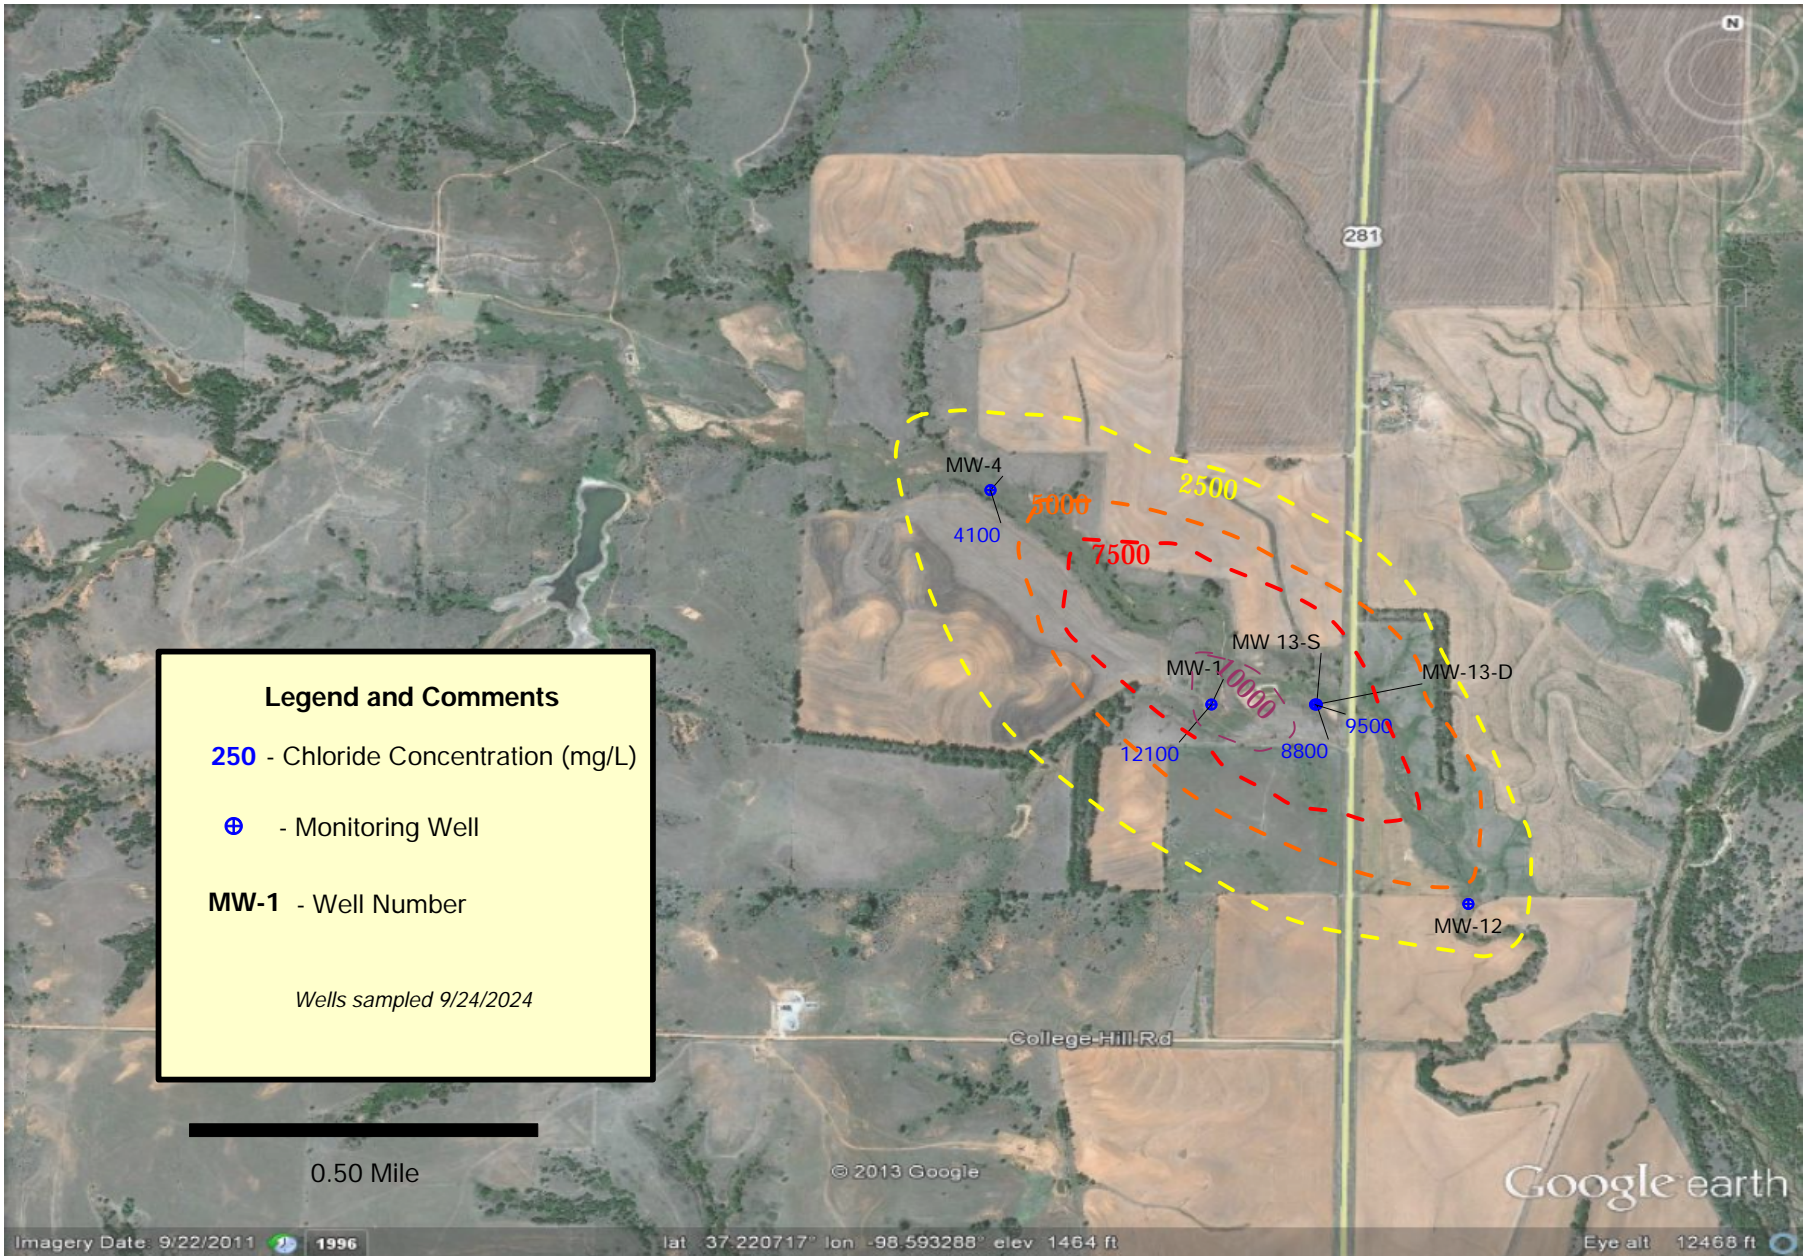
Hrencher Site
 Sections 26/35/36-T-32S-R12W
 Barber County, Kansas
2024 Area Map with Chlorides
 KCC Control # 970051-00 District 1
 N. Feldkamp 10/1/2024

Control No.	Staff Hours/Expenditures	Fund Expenditures	
		FY 2024/25	Total
970051-00	4 Hrs. / \$140.95		\$189.94
Current Contaminate Level: 4,100 ppm Cl- to 12,100 ppm Cl-			
Status:			
<input type="checkbox"/> 1. Site Assessment	<input type="checkbox"/> 2. Short Term Monitoring	<input checked="" type="checkbox"/> 3. Investigation	
<input checked="" type="checkbox"/> 4. Long Term Monitoring	<input type="checkbox"/> 5. Remediation Plan	<input type="checkbox"/> 6. Installation	
<input type="checkbox"/> 7. Remediation	<input type="checkbox"/> 8. Post Rem. Monitoring	<input type="checkbox"/> 9. Resolved

Recommendation for Future Work: Continue sampling on an annual basis. As chloride levels have continued to increase down gradient, it may be necessary to design and install a remedial system for this site. Additional monitoring wells need to be drilled to define the toe of the plume. Further investigation and sampling will continue to determine if a remedial system is appropriate for this site.

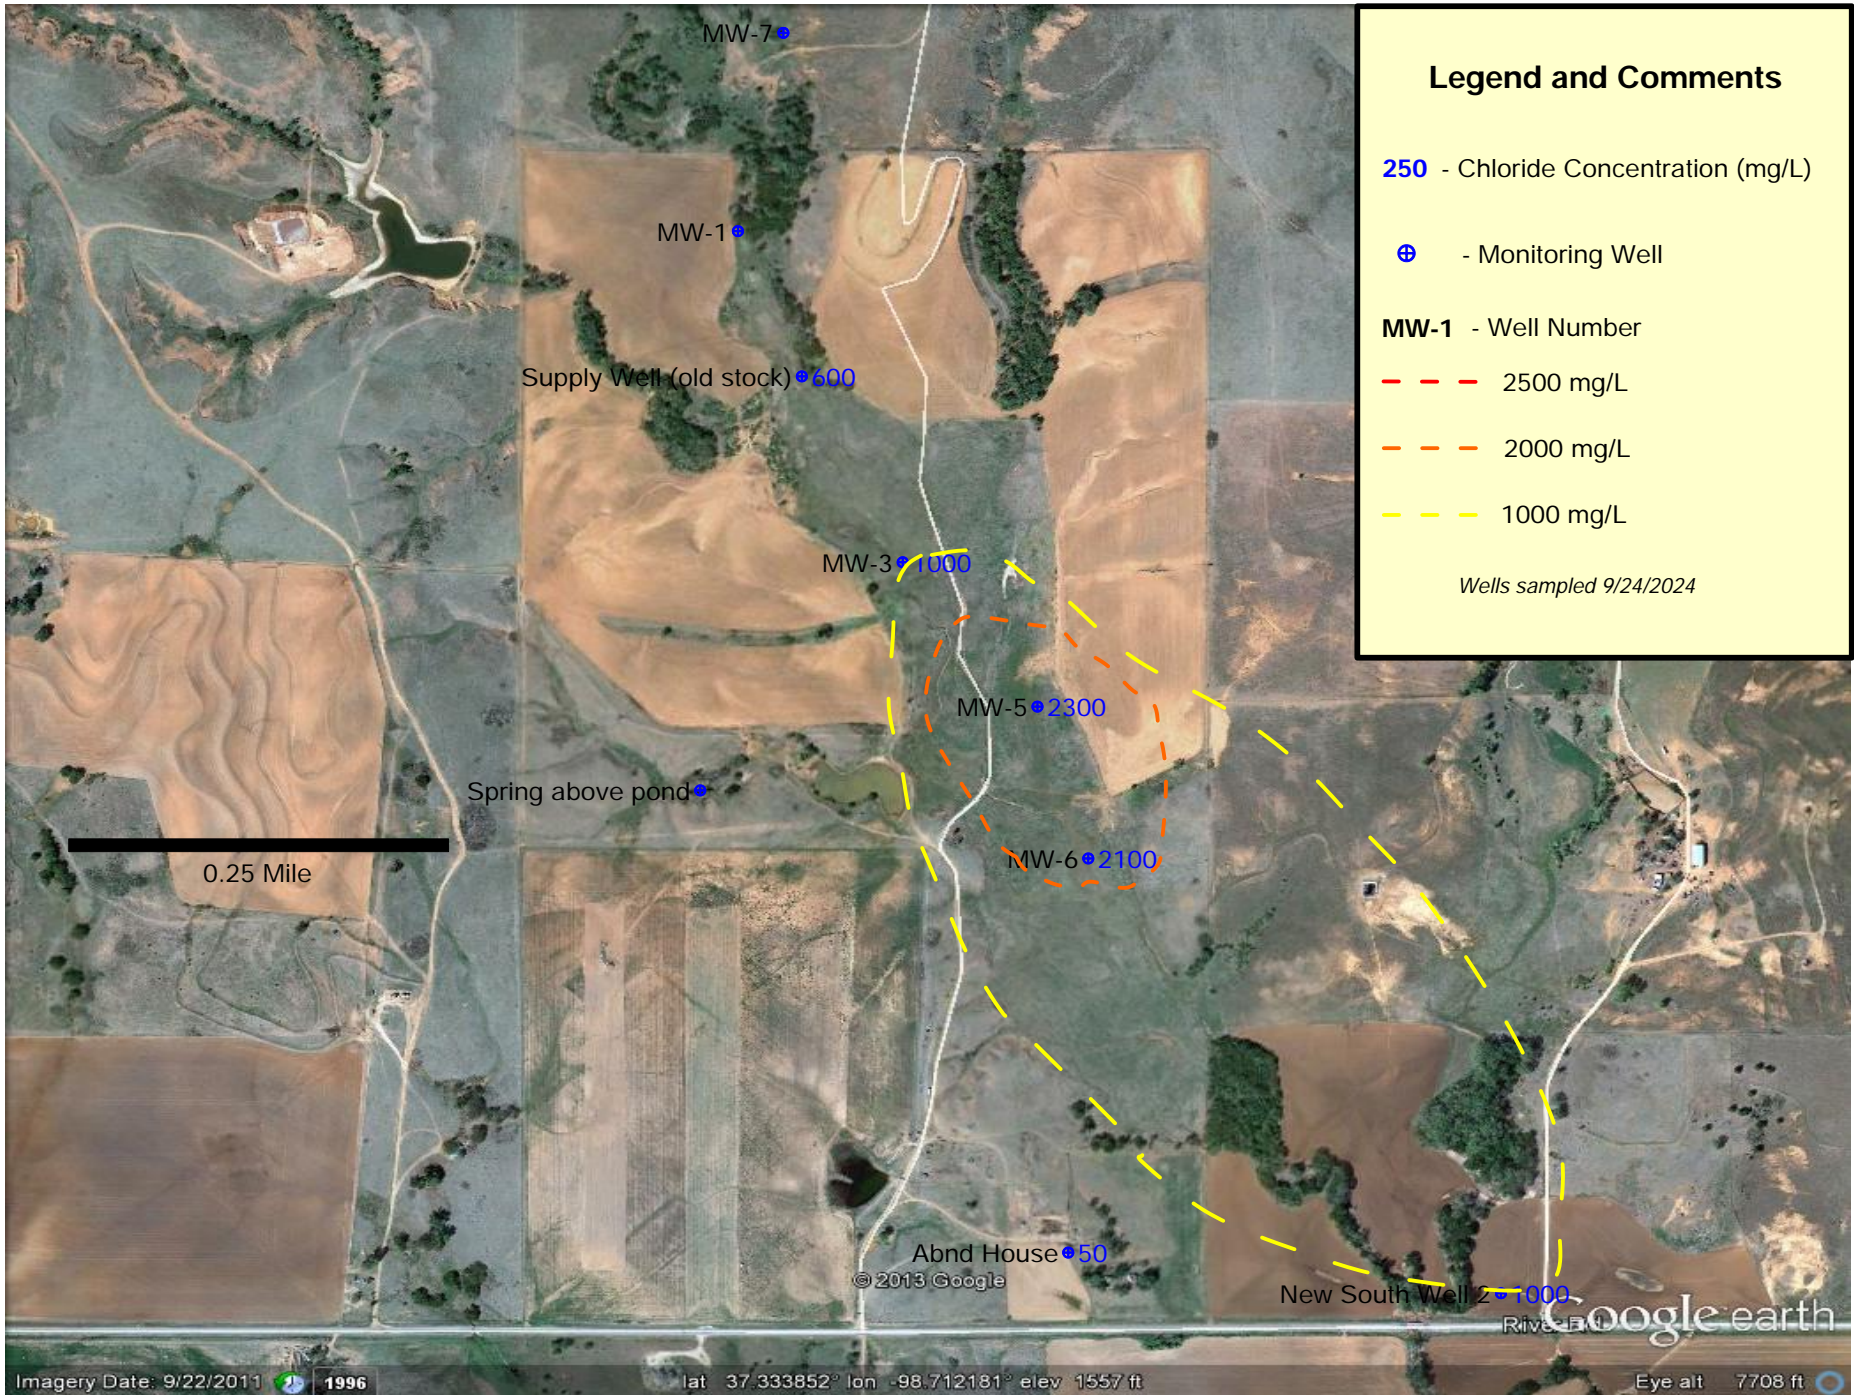
Packard Contamination Site
 Sections 15/22/23-T31S-R13W
 Barber, County Kansas
 2024 Area Map with Chlorides
 KCC Control # 970075-00 District1-N. Feldkamp 10/1/24

Site Description: The salt-water plume is moving to the south away from the Packard #1 oil well. It has contaminated the water supply well and could possibly damage the domestic well at the abandoned house, the supply well in the SE/4 of section 23, and the spring to the southwest.

Control No.	Staff Hours/Expenditures	Fund Expenditures	
		FY 2024/25	Total
970075-00	5.5 Hrs. / \$188.43		\$310.09
Current Contaminate Level: 50 ppm Cl- to 2300 ppm Cl-			
Status:			
<input type="checkbox"/> 1. Site Assessment	<input type="checkbox"/> 2. Short Term Monitoring	<input type="checkbox"/> 3. Investigation	
<input checked="" type="checkbox"/> 4. Long Term Monitoring	<input type="checkbox"/> 5. Remediation Plan	<input type="checkbox"/> 6. Installation	
<input type="checkbox"/> 7. Remediation	<input type="checkbox"/> 8. Post Rem. Monitoring	<input type="checkbox"/> 9. Resolved

Recommendation for Future Work: Monitoring will continue on an annual basis as the area continues to be remediated by natural attenuation. As the groundwater in this area is relatively shallow, several holes may be augured in order to gather more comprehensive data on the size and location of the chlorides. Depending on the information gathered, additional permanent monitoring wells may need to be installed. Analysis may need to be run on the new south supply well in order to determine if the chlorides are of a natural source, or from oilfield activities.

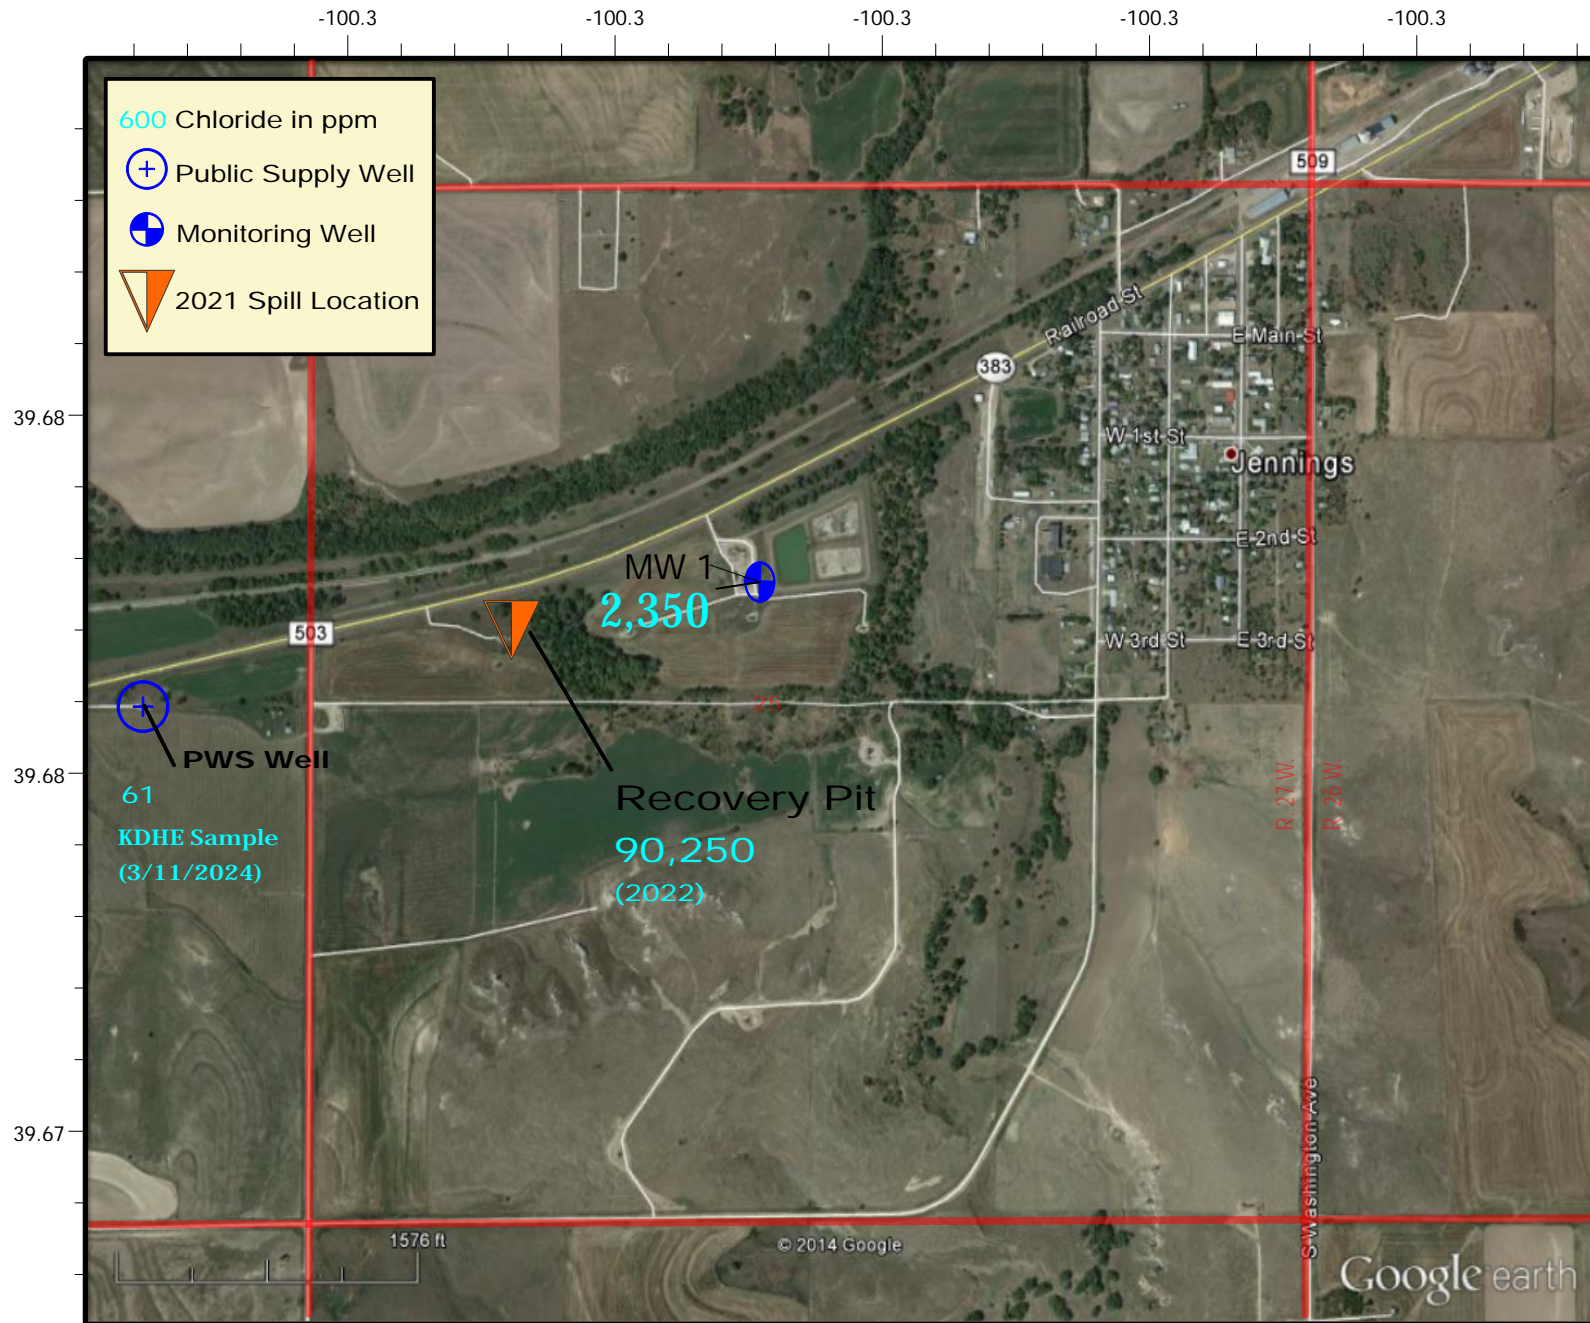
Jennings Groundwater Monitoring Site

Impact/Immediacy: Groundwater contaminated by poor oil field practices including discharges and spills. Domestic water wells to the east and northeast of the Jennings Unit, including two former public water supply wells (PWS) have been impacted. A recent spill, and the observed increase in the chloride levels at the spill location and monitoring well, have fundamentally changed the site. Immediacy level is rated moderate to high.

Control No.	Staff Hours/Expenditures	Fund Expenditures	
		FY 2024/25	Total
970054-00	5 Hrs. / \$178.64		
Current Contaminate Level: 2,350 ppm Cl⁻			
Status:			
<input type="checkbox"/> 1. Site Assessment	<input type="checkbox"/> 2. Short Term Monitoring	<input type="checkbox"/> 3. Investigation	
<input type="checkbox"/> 4. Long Term Monitoring	<input checked="" type="checkbox"/> 5. Remediation Plan	<input type="checkbox"/> 6. Installation	
<input type="checkbox"/> 7. Remediation	<input type="checkbox"/> 8. Post Rem. Monitoring	<input type="checkbox"/> 9. Resolved

Recommendations for Future Work: Bach Oil Production is the responsible party for contamination on the site. Due to the proximity of the recent spill to the PWS well, KDHE assumed the lead for the remedial efforts at this western portion of the site. Bach has entered the State Cooperative Program with the KDHE and has retained the services of geologic consultants and soil remediation companies. A geophysical survey was conducted to delineate the extent of the groundwater contamination at the spill location. This demonstrated that there is a discrete plume corresponding to the spill, and a separate source responsible for the pollution noted near the brine transfer station. Additional geophysics will be conducted, and the RP will be required to remediate the groundwater.

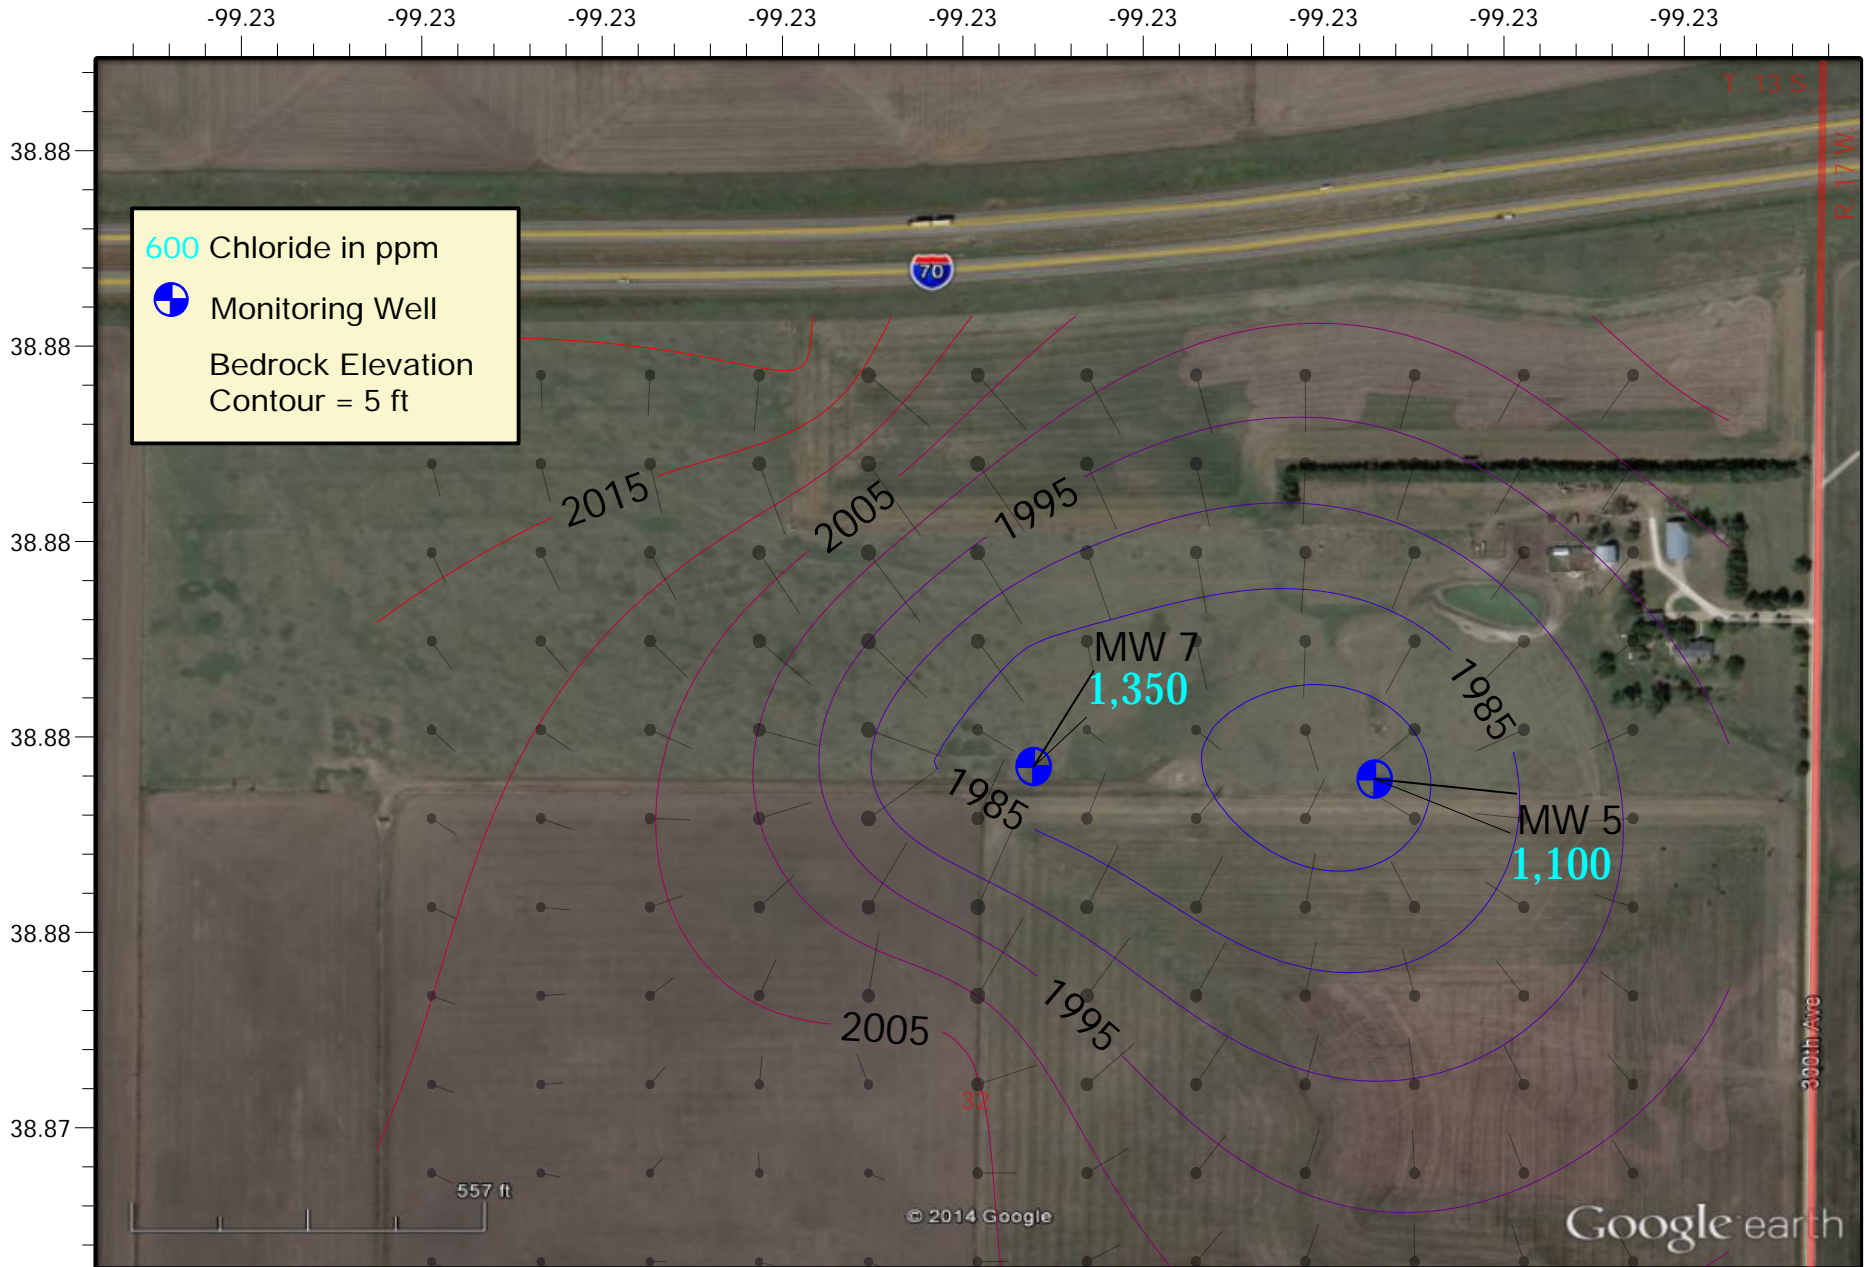
Dinkel Groundwater Monitoring Site

Section 32 of Township 13 South, Range 17 West, Ellis County, Kansas
 2024 Groundwater Chloride Levels
 District #4 - Sampled 10/7/24 - Map Drawn on 10/14/2024 by C. Neeley

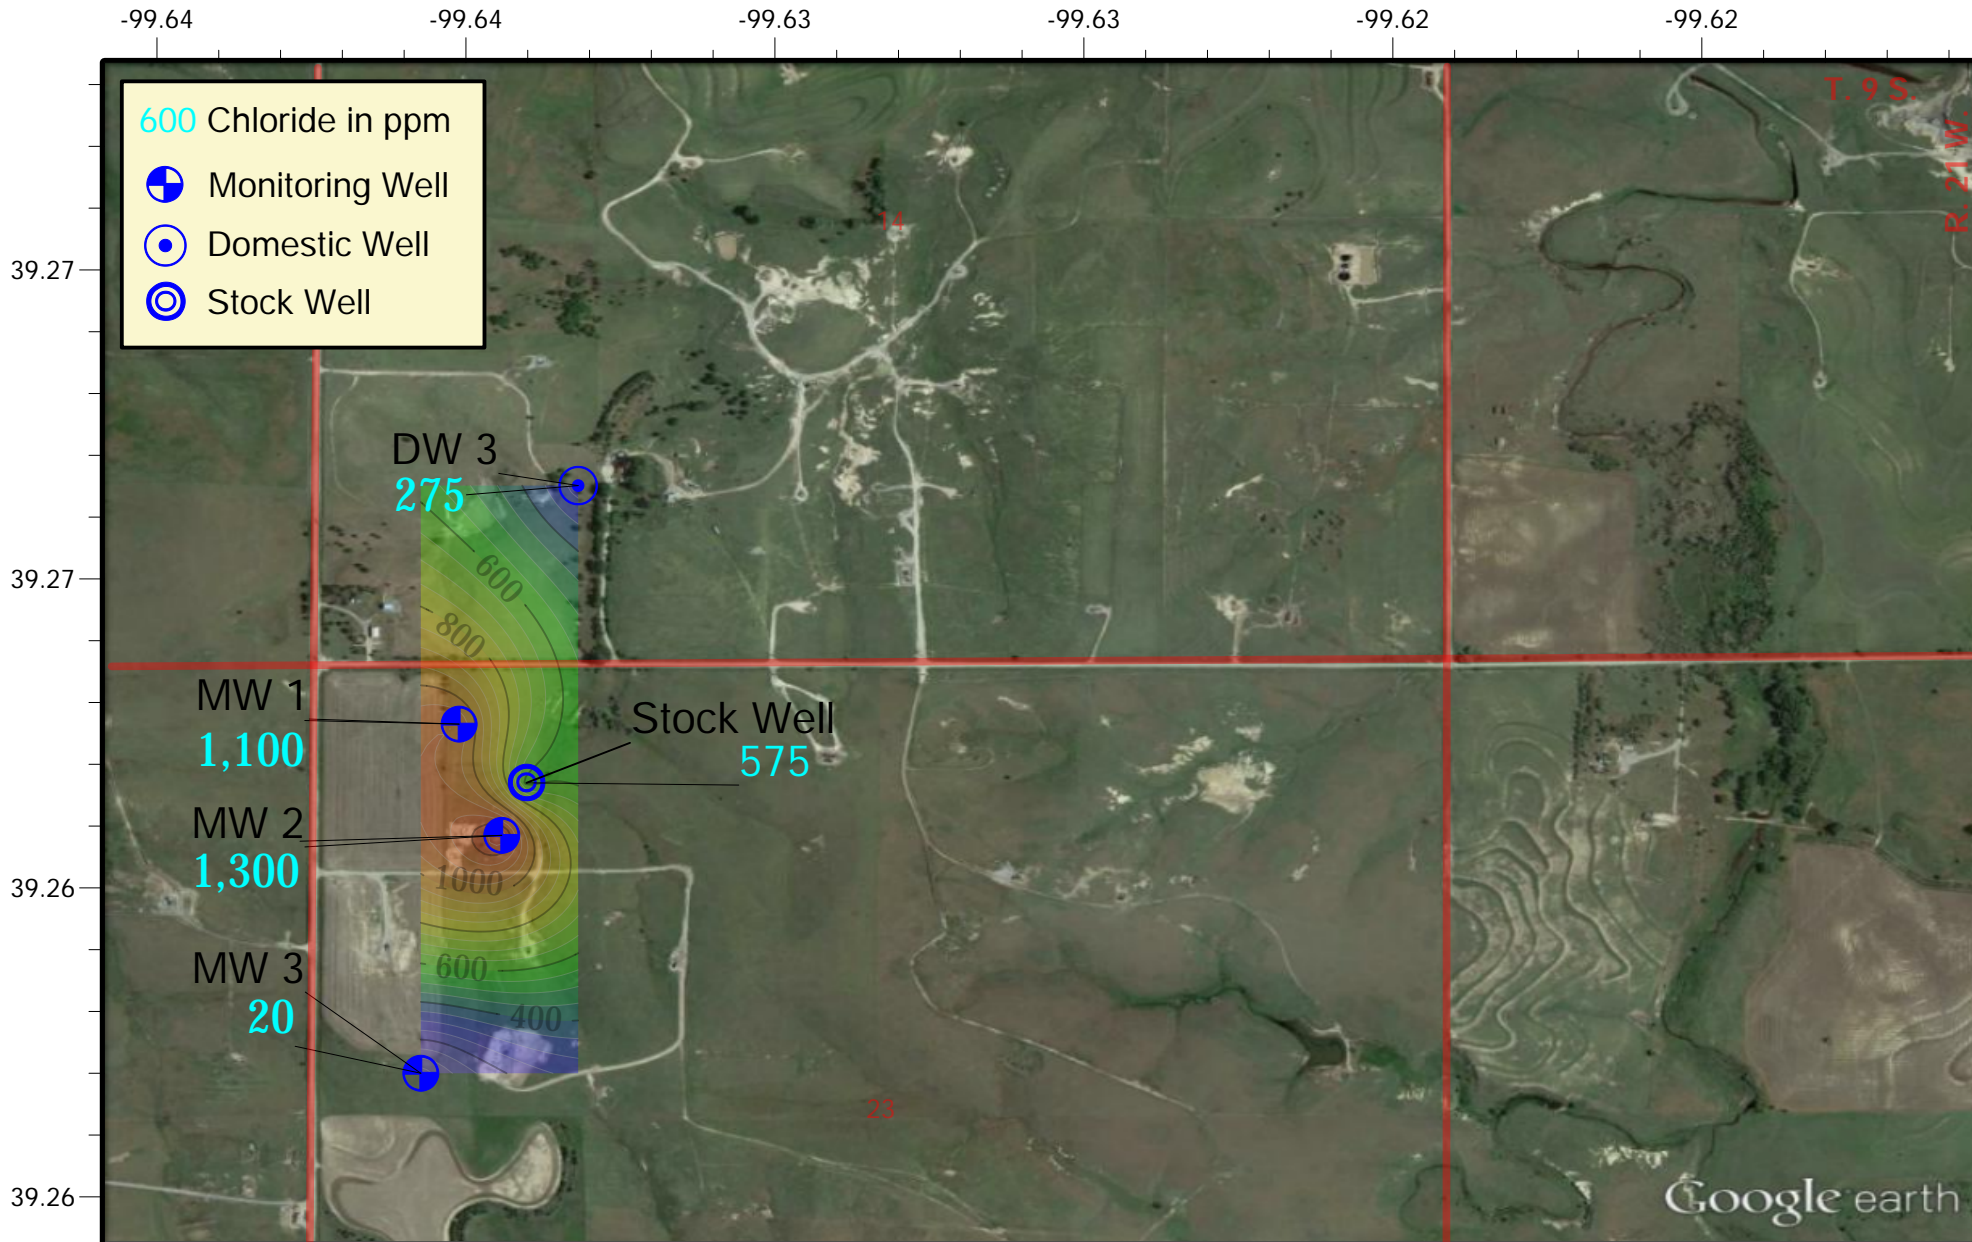
Balthazor Groundwater Monitoring Site

Status of Project: When the new stock/domestic well was drilled in 2011, the chloride level was 2,300 ppm. In 2022, the concentration was 375 ppm. It is currently 575 ppm. A line failure necessitated that the property owner switch to a third well, west of the home. This well is 275 ppm. The three monitoring wells on the location have remained relatively stable with a subtle overall decrease in contamination. The contamination levels in 2021 were found to be 1,000 ppm in MW #1, 1,200 ppm in MW #2, and 10 ppm in MW #3. In 2024, they are 1,100 ppm, 1,300 ppm, and 20 ppm, respectively.

Control No.	Staff Hours/Expenditures	Fund Expenditures	
		FY 2024/25	Total
970023-00	10 Hrs. / \$344.44		
Current Contaminate Level: 20 ppm to 1,300 ppm Cl⁻			
Status:			
<input type="checkbox"/> 1. Site Assessment	<input type="checkbox"/> 2. Short Term Monitoring	<input type="checkbox"/> 3. Investigation	
<input checked="" type="checkbox"/> 4. Long Term Monitoring	<input type="checkbox"/> 5. Remediation Plan	<input type="checkbox"/> 6. Installation	
<input type="checkbox"/> 7. Remediation	<input type="checkbox"/> 8. Post Rem. Monitoring	<input type="checkbox"/> 9. Resolved

Recommendations for Future Work: The source of the contamination is likely an old brine pit in the NW/4 of Section 23, Township 9 South, Range 21 West, and the feasibility of decreasing the contamination level through remediation will be considered but needs to be weighed against the site parameters. The contamination level will continue to be monitored.

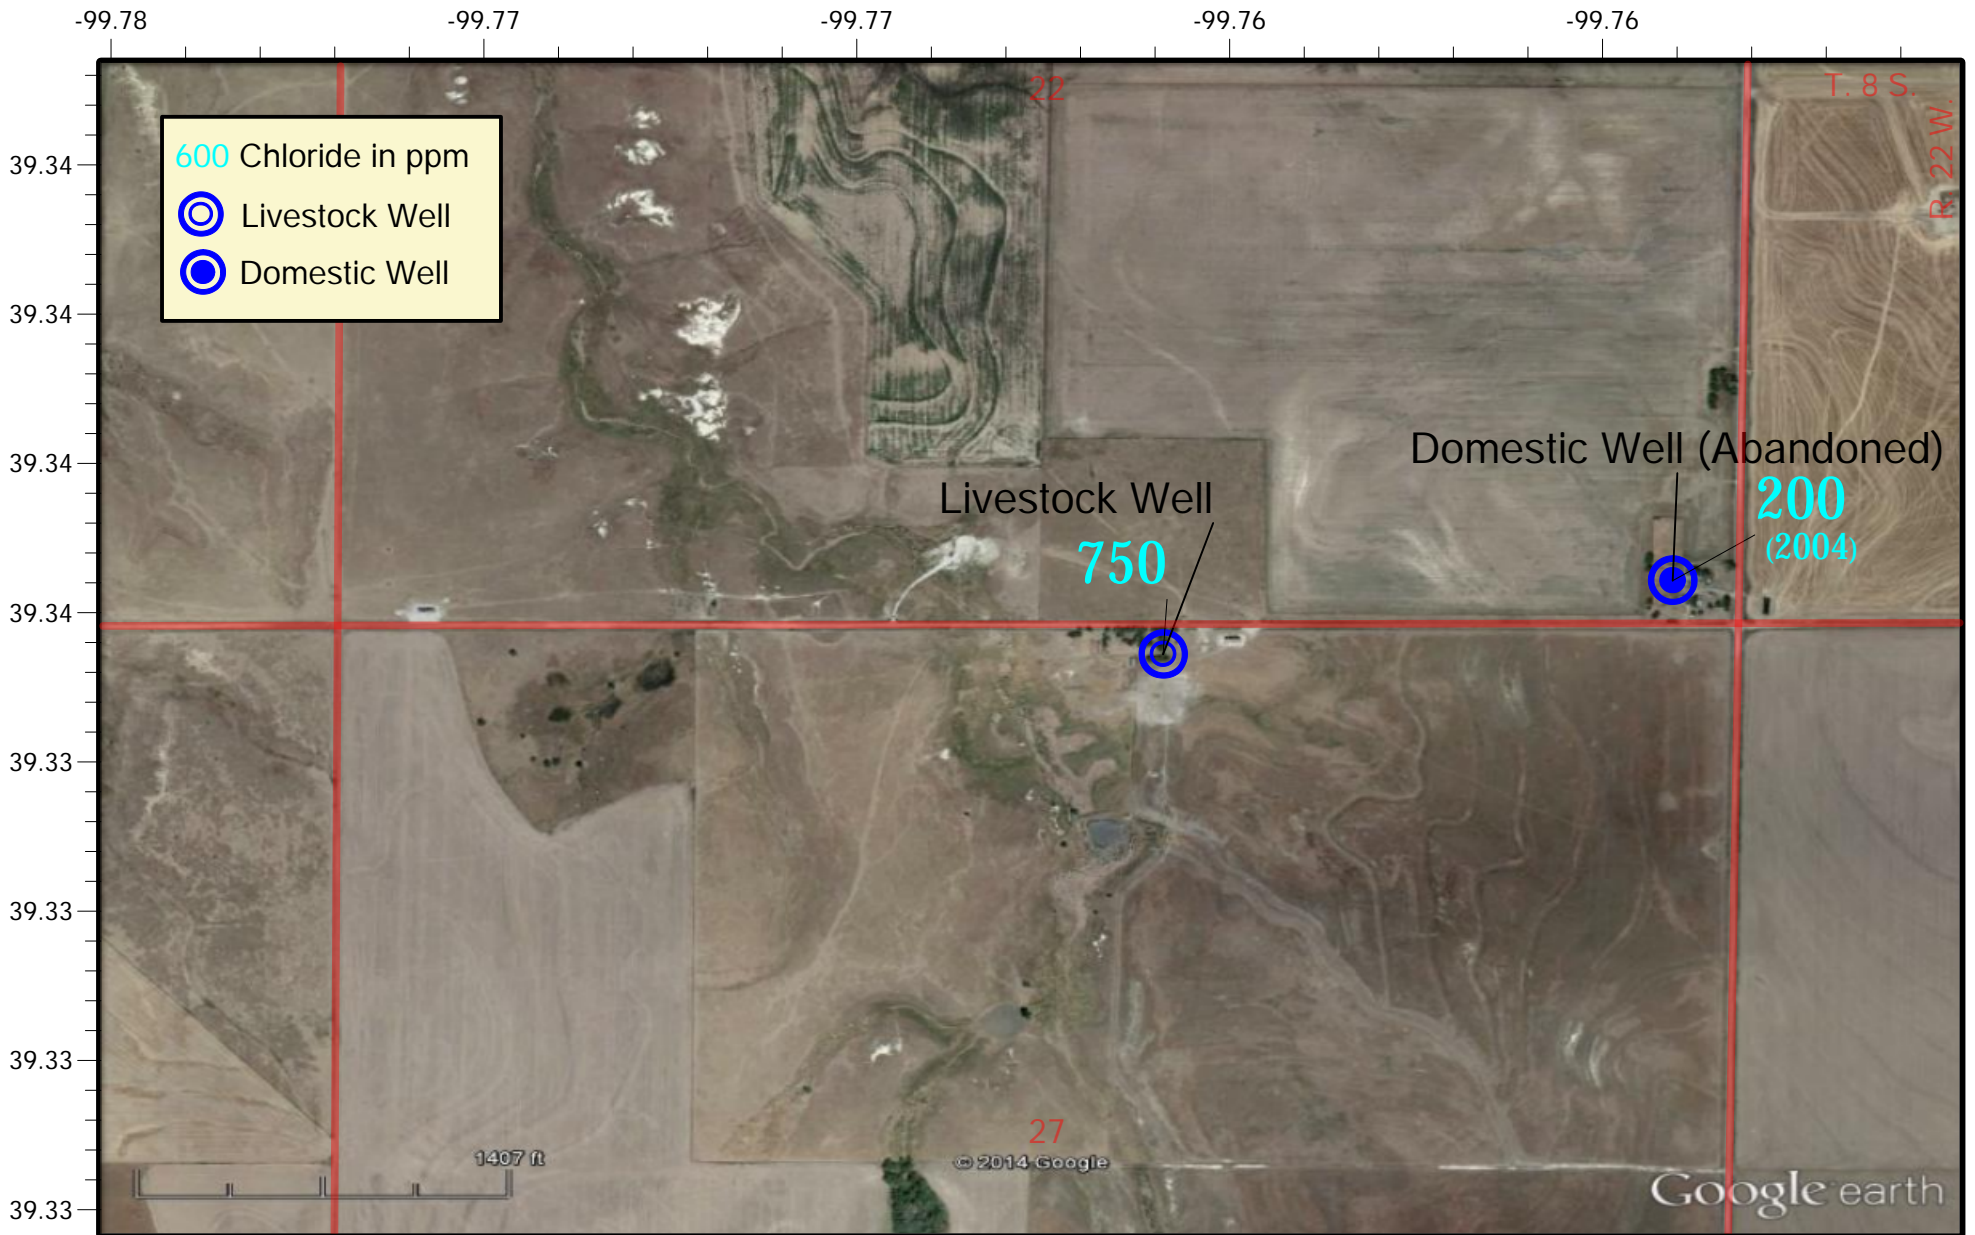
Leon Fink Groundwater Monitoring Site

Status of Project: The domestic well has been abandoned due to a water level that is inadequate for use by the owner, and the house has been demolished. The last sample taken from this source in 2004 contained a chloride concentration of 200 ppm. Samples from the stock well continue to be tested, and the well is presently being utilized for livestock, which will contribute to a reduction in chloride concentrations if the source has been eliminated. An overall downward trend has been observed over the history of the site, and the current contamination concentration is at 750 ppm.

Control No.	Staff Hours/Expenditures	Fund Expenditures	
		FY 2024/25	Total
970007-00	4 Hrs. / \$145.48		
Current Contaminate Level: 750 ppm Cl⁻			
Status:			
<input type="checkbox"/> 1. Site Assessment	<input checked="" type="checkbox"/> 2. Short Term Monitoring	<input type="checkbox"/> 3. Investigation	
<input type="checkbox"/> 4. Long Term Monitoring	<input type="checkbox"/> 5. Remediation Plan	<input type="checkbox"/> 6. Installation	
<input type="checkbox"/> 7. Remediation	<input type="checkbox"/> 8. Post Rem. Monitoring	<input type="checkbox"/> 9. Resolved

Recommendations for Future Work: This site should be monitored short-term to ascertain if the lowered chloride concentration will be maintained.
