2025

**OIL AND GAS
REMEDIATION SITE STATUS**

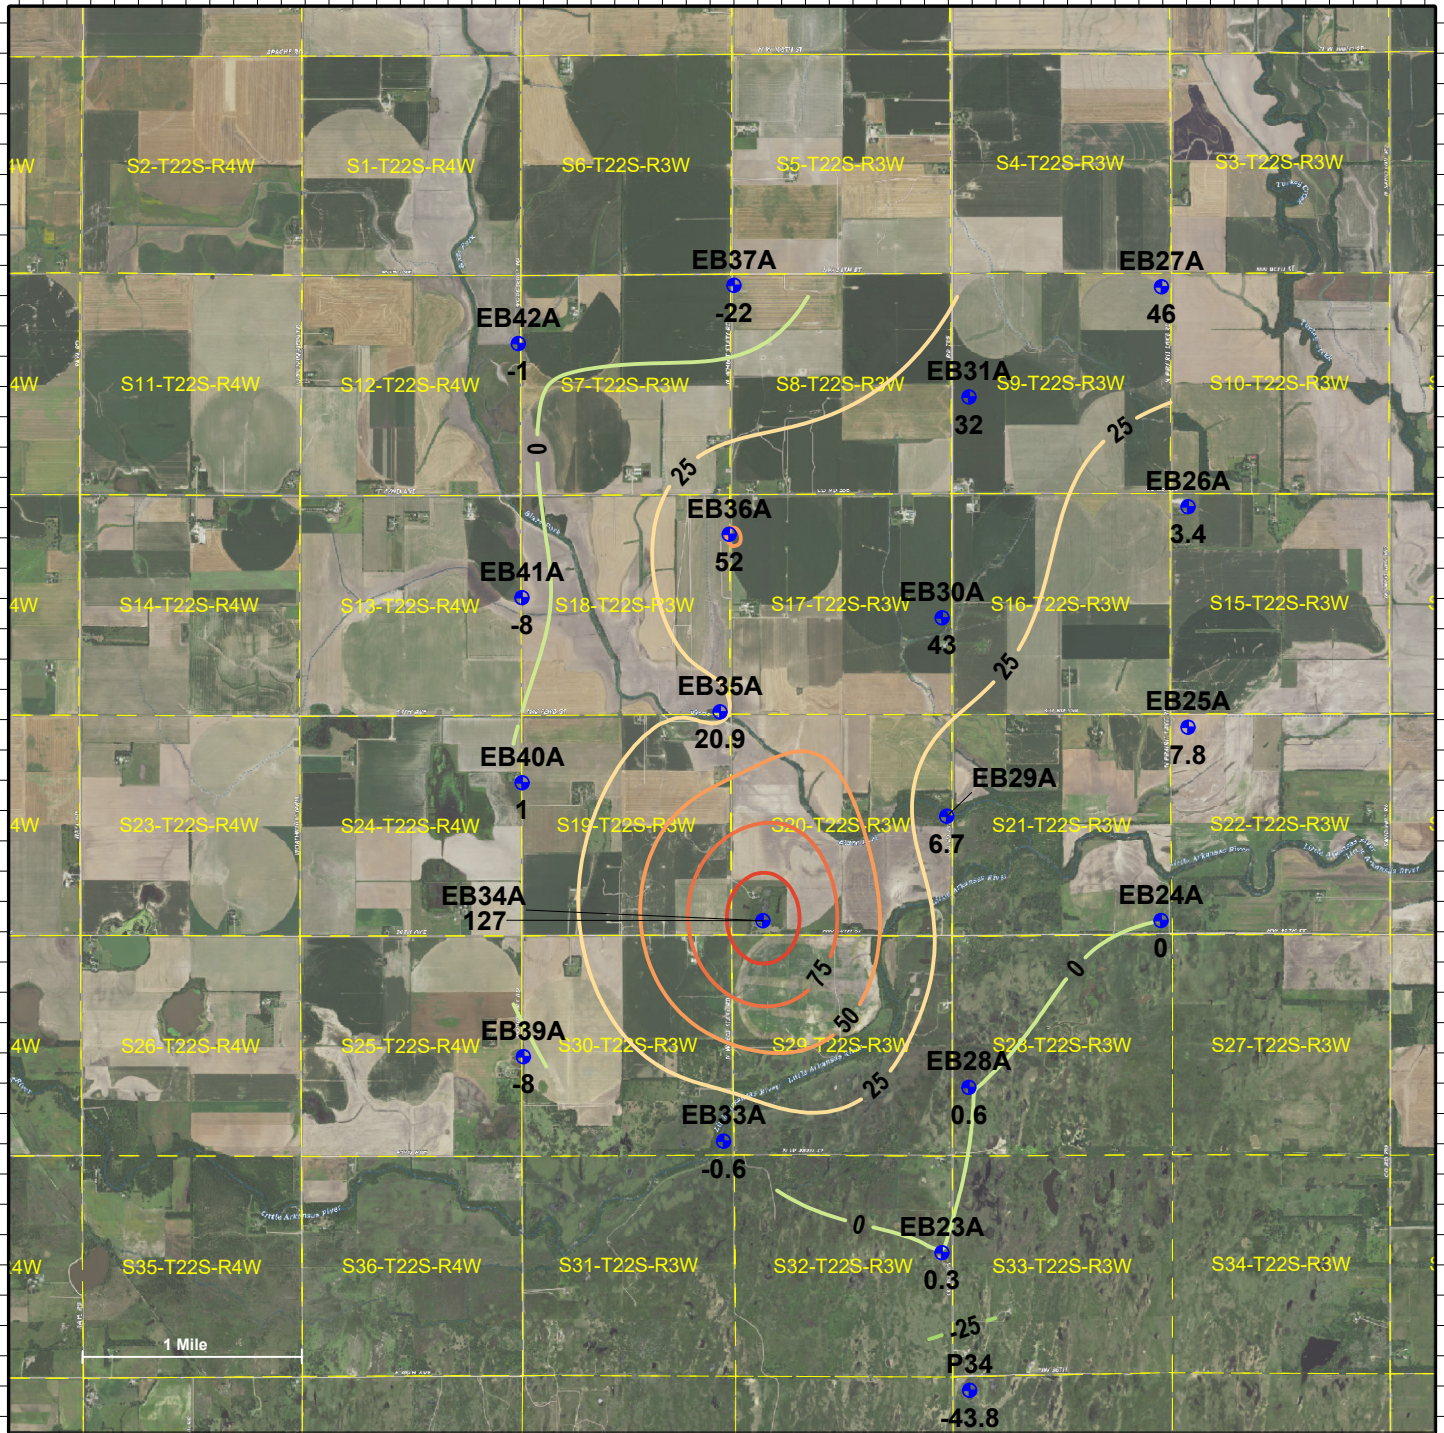
**Hollow-Nikkel Brine Contamination Site
KCC Control #970009-00**

A Zone wells had modest chloride increases through the site's middle and northeastern edge. EB-34A, historically the highest chloride well, rose the most by 127 mg/L from 2023. Local drought conditions have probably influenced this rise. B Zone wells had similar changes, but solely down the middle three wells, EB-34B, EB-35B, and EB-36B. All monitoring well increases were moderate and not over 100 mg/L since 2023. These wells historically are within the heart of the plume. Outside of these wells, the levels remained stable, with slight decreases found except for EB-25B, which showed a slight increase of 6.2 mg/L.

C Zone wells were found to be different, with the middle historical plume monitoring wells decreasing by as much as 250 mg/L. However, increases in the north and east were noted, with increases at EB-37C and EB-27C of 134 and 160 mg/L, respectively. The north and northeast edges of the site should be monitored for future increases as they are along the outskirts of the monitoring well matrix and, thus, will no longer be delineating wells with continued increases.

Recommendations for Future Work: KCC should continue to collect data from GMD #2 annually for monitoring purposes. The highest chlorides appear centered on EB-34 in all vertical zones. This has always been the case with the Hollow-Nikkel site. Adding new monitoring wells near EB-34, the heart of the plume, could help define the highest chlorides for successful remedial action. With the city of McPherson currently planning on installing a long-term public water supply source just south of the area, additional monitoring wells to the south may be necessary to supplement the monitoring wells installed by the city. In addition, monitoring wells added north of the current site could further investigate the source of higher chlorides seen over the last five years in the northern wells.

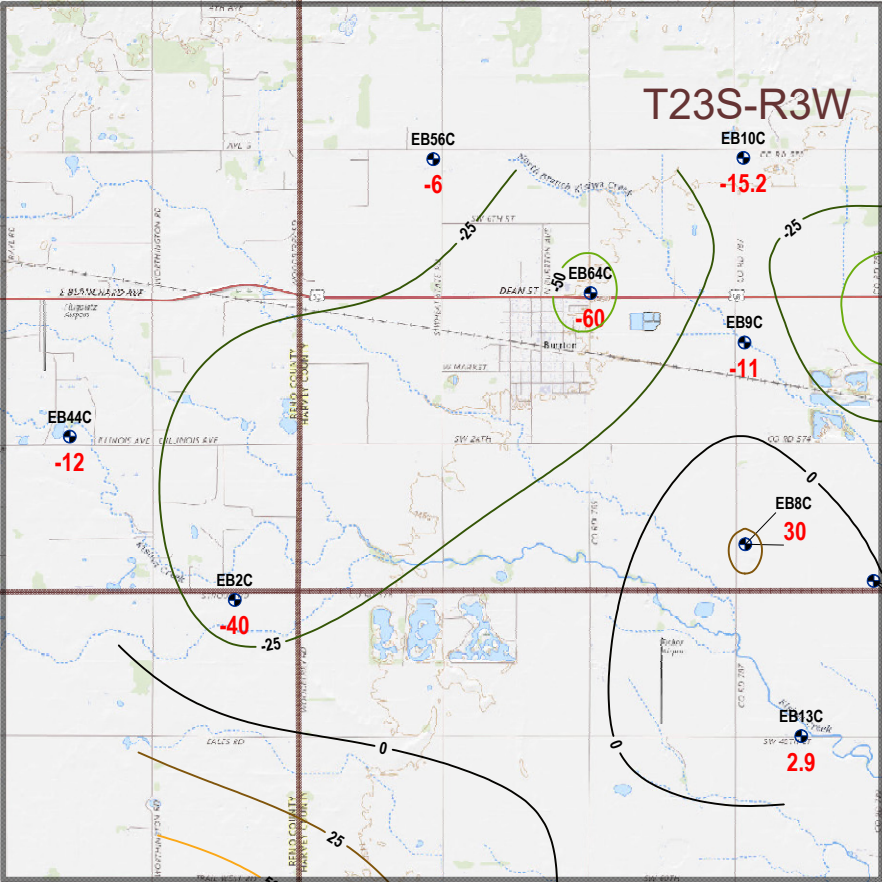
**Burton IGUCA Brine Contamination Field
C Zone Chloride Change from 2023 to 2024
Reno and Harvey Counties, Kansas**

KCC Project Code #970003-00 - KCC District #2 Field office - Map drawn on 10/17/2024 by D. Bollenback

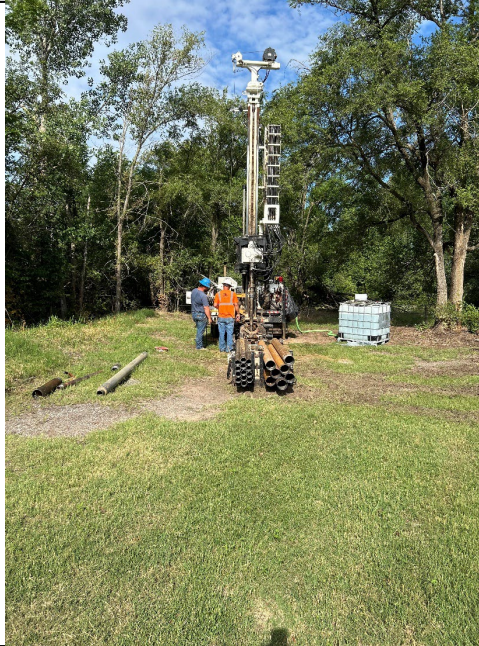
Description:
Drilling MW-324B
with the Sonic Rig

KCC installed five new monitoring wells utilizing a drilling technique called sonic drilling. KCC hired ppB/EWI to perform the work under direct supervision by KCC geologists. The new wells are located in the NW of the IGUCA area in the sand hills and centered around a homestead that filed a complaint of brine water impaction in 2023. KCC has sampled the wells and has determined that the A zone in the local area is impacted, but brine was not found in the AA and B zones. KCC is working with the landowners to design a plan to drill a new well in alternate zones. Cores from drilling suggest that well design and construction will be vital to obtaining usable water for the landowners.

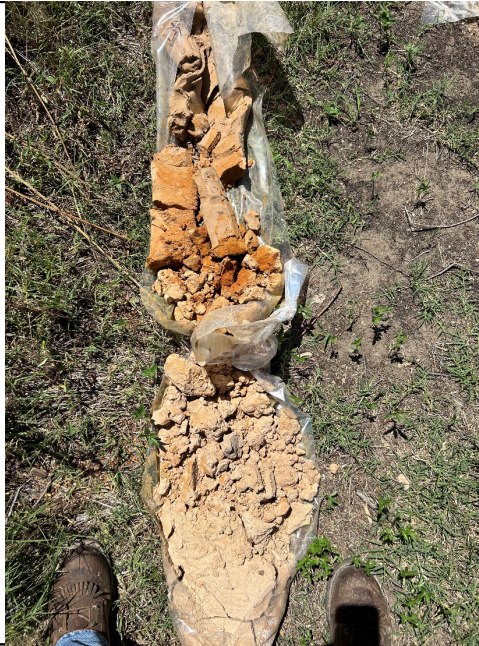
Photo No.: 2

Description:
AA sands at the
MW-324 AA well

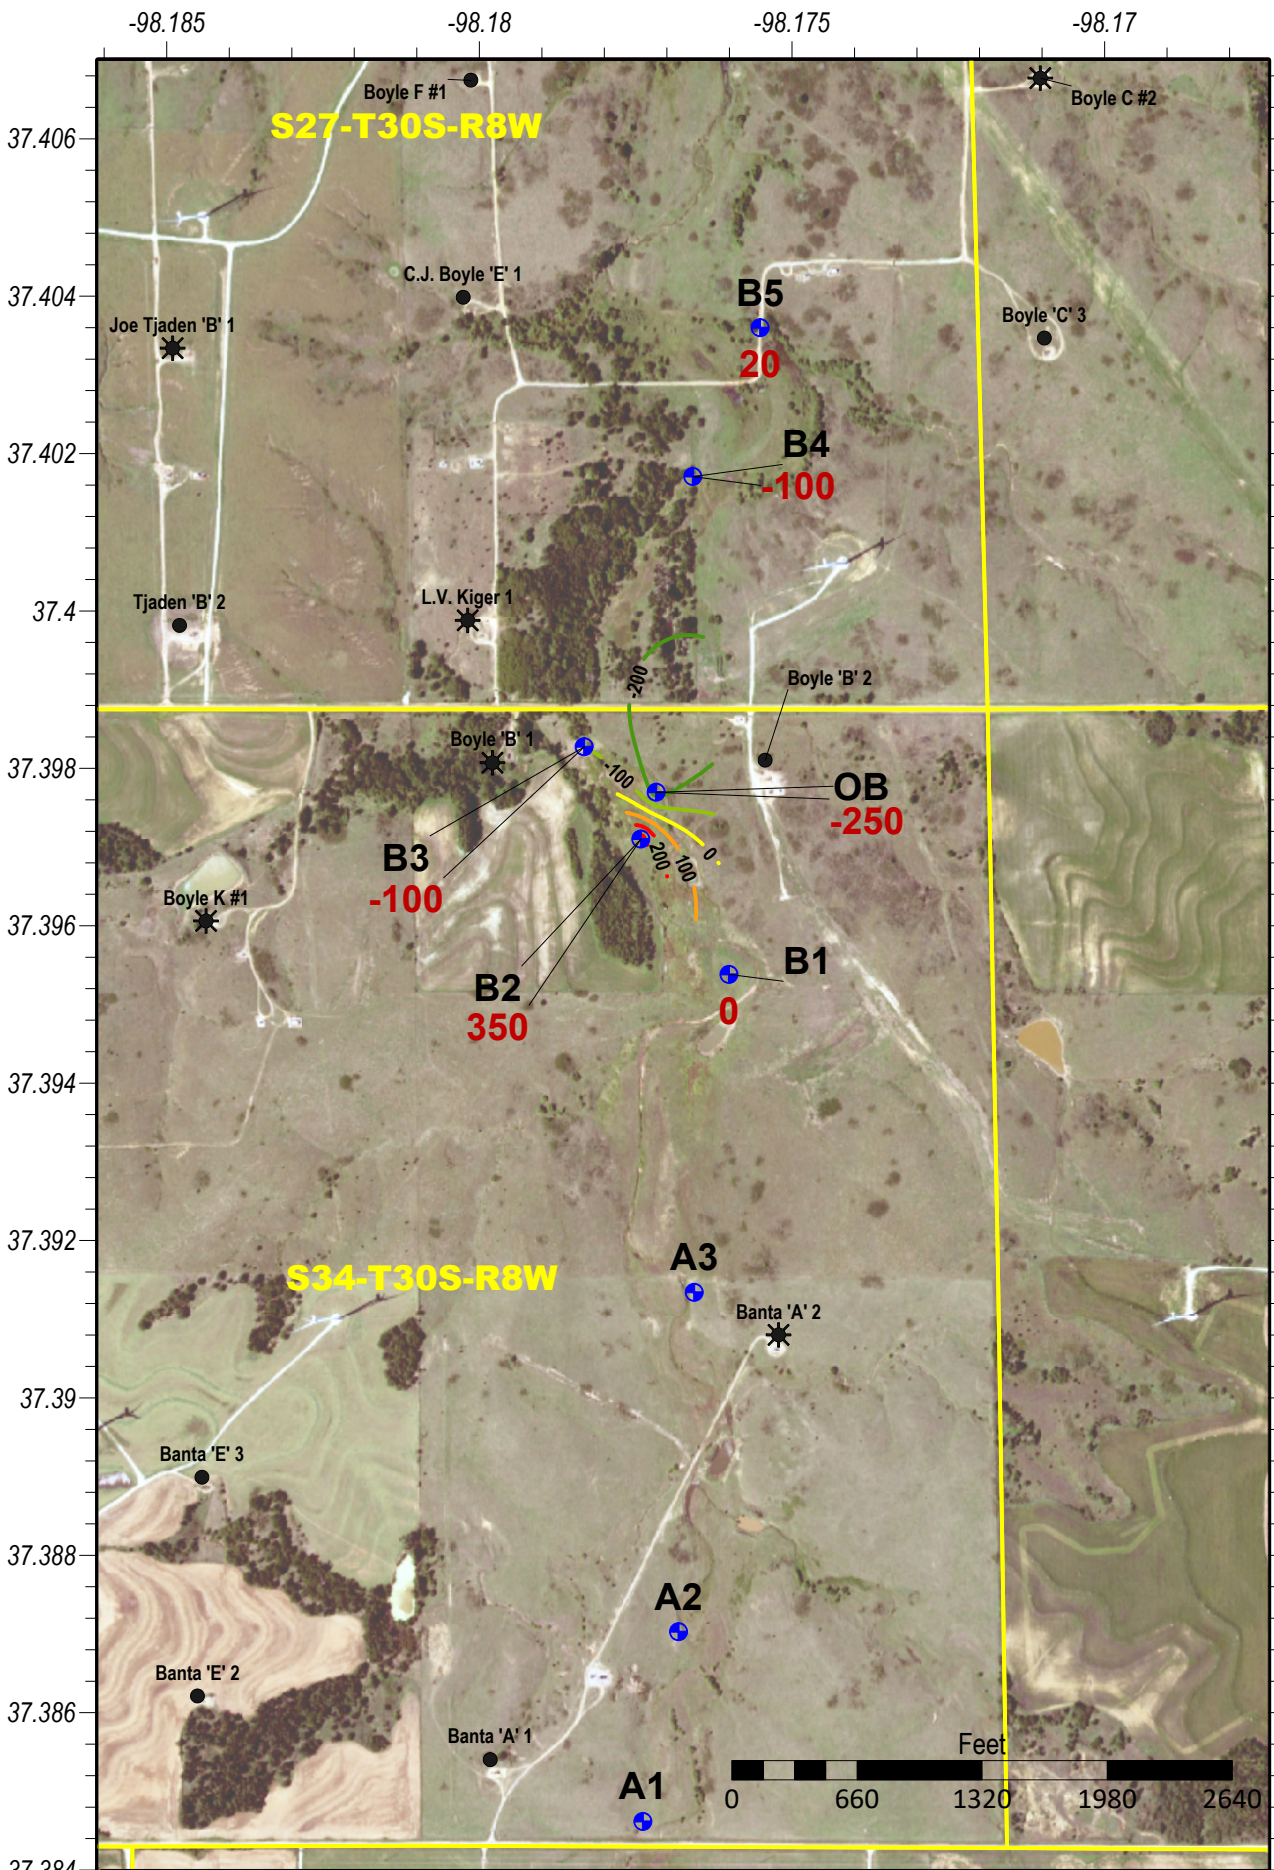
South Spivey Brine Monitoring Site - #970096-00
 Sections 27 & 34 of Township 30 South and Range 8 West, Kingman County, Kansas
Chloride Change from 2023 to 2024
 KCC District #2 Field Office - Site wells sampled on 8/20/2024 - Map Drawn on 9/25/2024 by D.Bollenback

Status of Project: The southernmost B wells continued to drop in chlorides over the last year. Heavy rains in early 2019, 2020, and 2021 may have pushed these chlorides north. The area is currently in extreme drought conditions and has drastically lowered the local perched water table, including this year, which is even lower than in 2023. Static water levels dropped an average of 1.7' since last year's sampling. KCC sampled the wells via a submersible pump on July 20th, 2024. Chlorides in 2024 dropped in all wells except B2. With falling water levels, chlorides may have settled at B2. The pond south of the B wells was not sampled this year, as there was very little fluid, and it contained rampant blue-green algae. For the first time in recent years, all wells were below 1000 mg/L chlorides. The OB monitoring well was the only well above the target limit of 750 mg/L.

Recommendations for Future Work: KCC recommends that the closure of the South Spivey Site begin over the next year. One well, OB, remains over the target level of 750 mg/L of chlorides, but no monitoring wells exceed 1,000 mg/L. KCC will assemble a plugging plan for the monitoring wells and return the site to pre-remedial conditions.

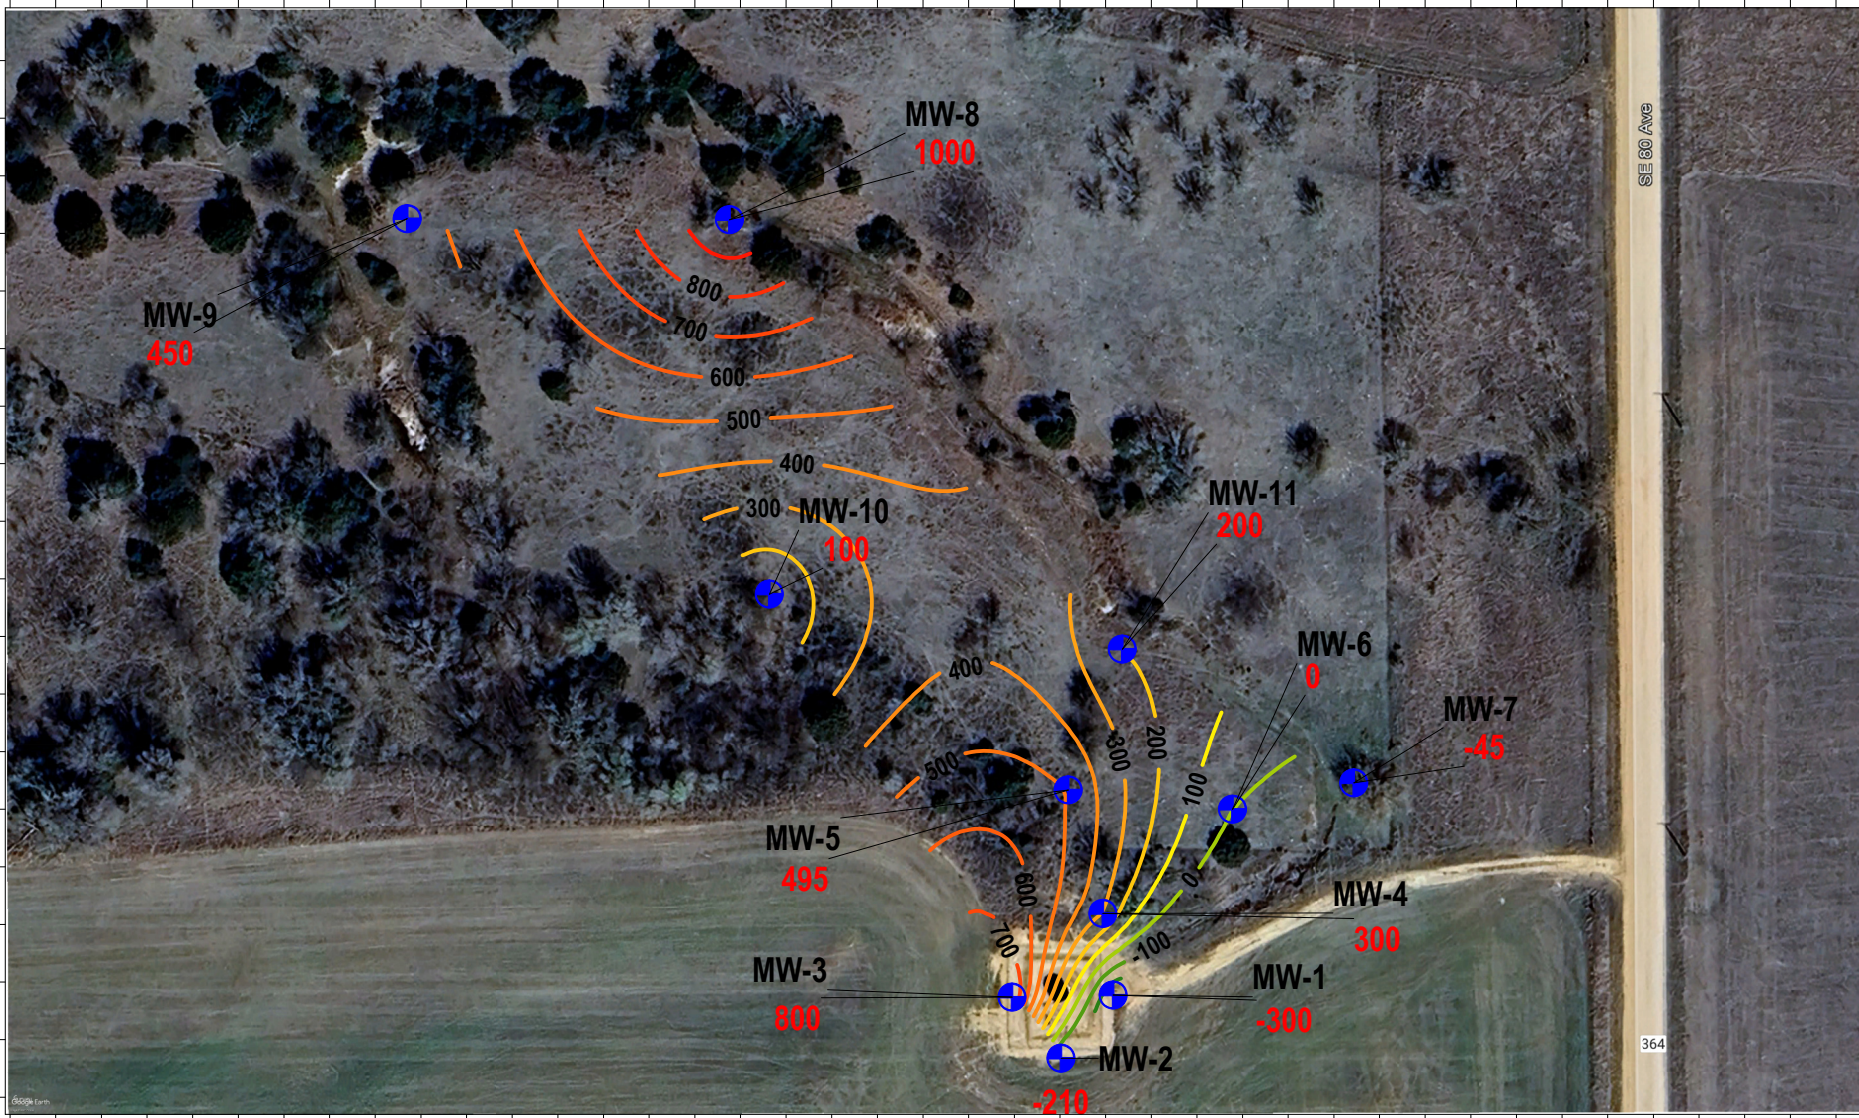
Trostle Brine Contamination Monitoring Site
 Section 33 of Township 28 South and Range 6 West, Kingman County, Kansas
Chloride Change from 2023-2024
 KCC District #2 Field Office - Control #980038-001
 Wells Sampled on 9/26/2024 - Map Drawn on 10/10/2024 by D Bollenback

Site Description: Historically, the Trostle salt-water disposal well battery has been the most affected. Seven monitoring wells below the Trostle salt-water disposal well also have elevated chlorides. The most likely cause was something related to the salt-water tank, such as discharges or line leaks. A PRP remediated the plume via an interceptor trench. However, the PRP abandoned the system after the holding tanks failed, and the site moved into the monitoring phase of the investigation. There has only been one reported spill at the SWDW since 2005. Local hydrology is a perched aquifer system. Precipitation that infiltrated the Pleistocene Alluvium moves downward until it contacts the impermeable red Ninnescah shale. Groundwater then flows down a gradient on top of the shale. The general movement of fluids in the perched water table flows to the northwest.

Laboratory results showed higher chloride levels down gradient of the tank battery, mainly MW-8, which increased by 1000 mg/L from 2023. MW-3 along the west side of the battery also showed an increase of 800 mg/L. Slight chloride drops along the southern and eastern edges were noted. 2022, 2023, and 2024 were extremely dry in the region. The static water levels in the wells dropped, averaging 0.28' lower across the site from last year. Most wells had less than 3 feet of groundwater, and some wells had less than 1 foot of water. Water levels were lower than any sampling event in the last ten years.

Recommendations for Future Work: Due to the limited amount of water resources affected and the recent data, KCC recommends continuing to sample the Trostle annually. KCC does not recommend expanding the monitoring well matrix, currently. A small, low-volume recovery system is an option, but KCC is uncertain about how beneficial a system would be due to the aquifer's low deliverability. Higher precipitation rates may help flush out the local system, though KCC expects to see higher chlorides down gradient if that occurs.

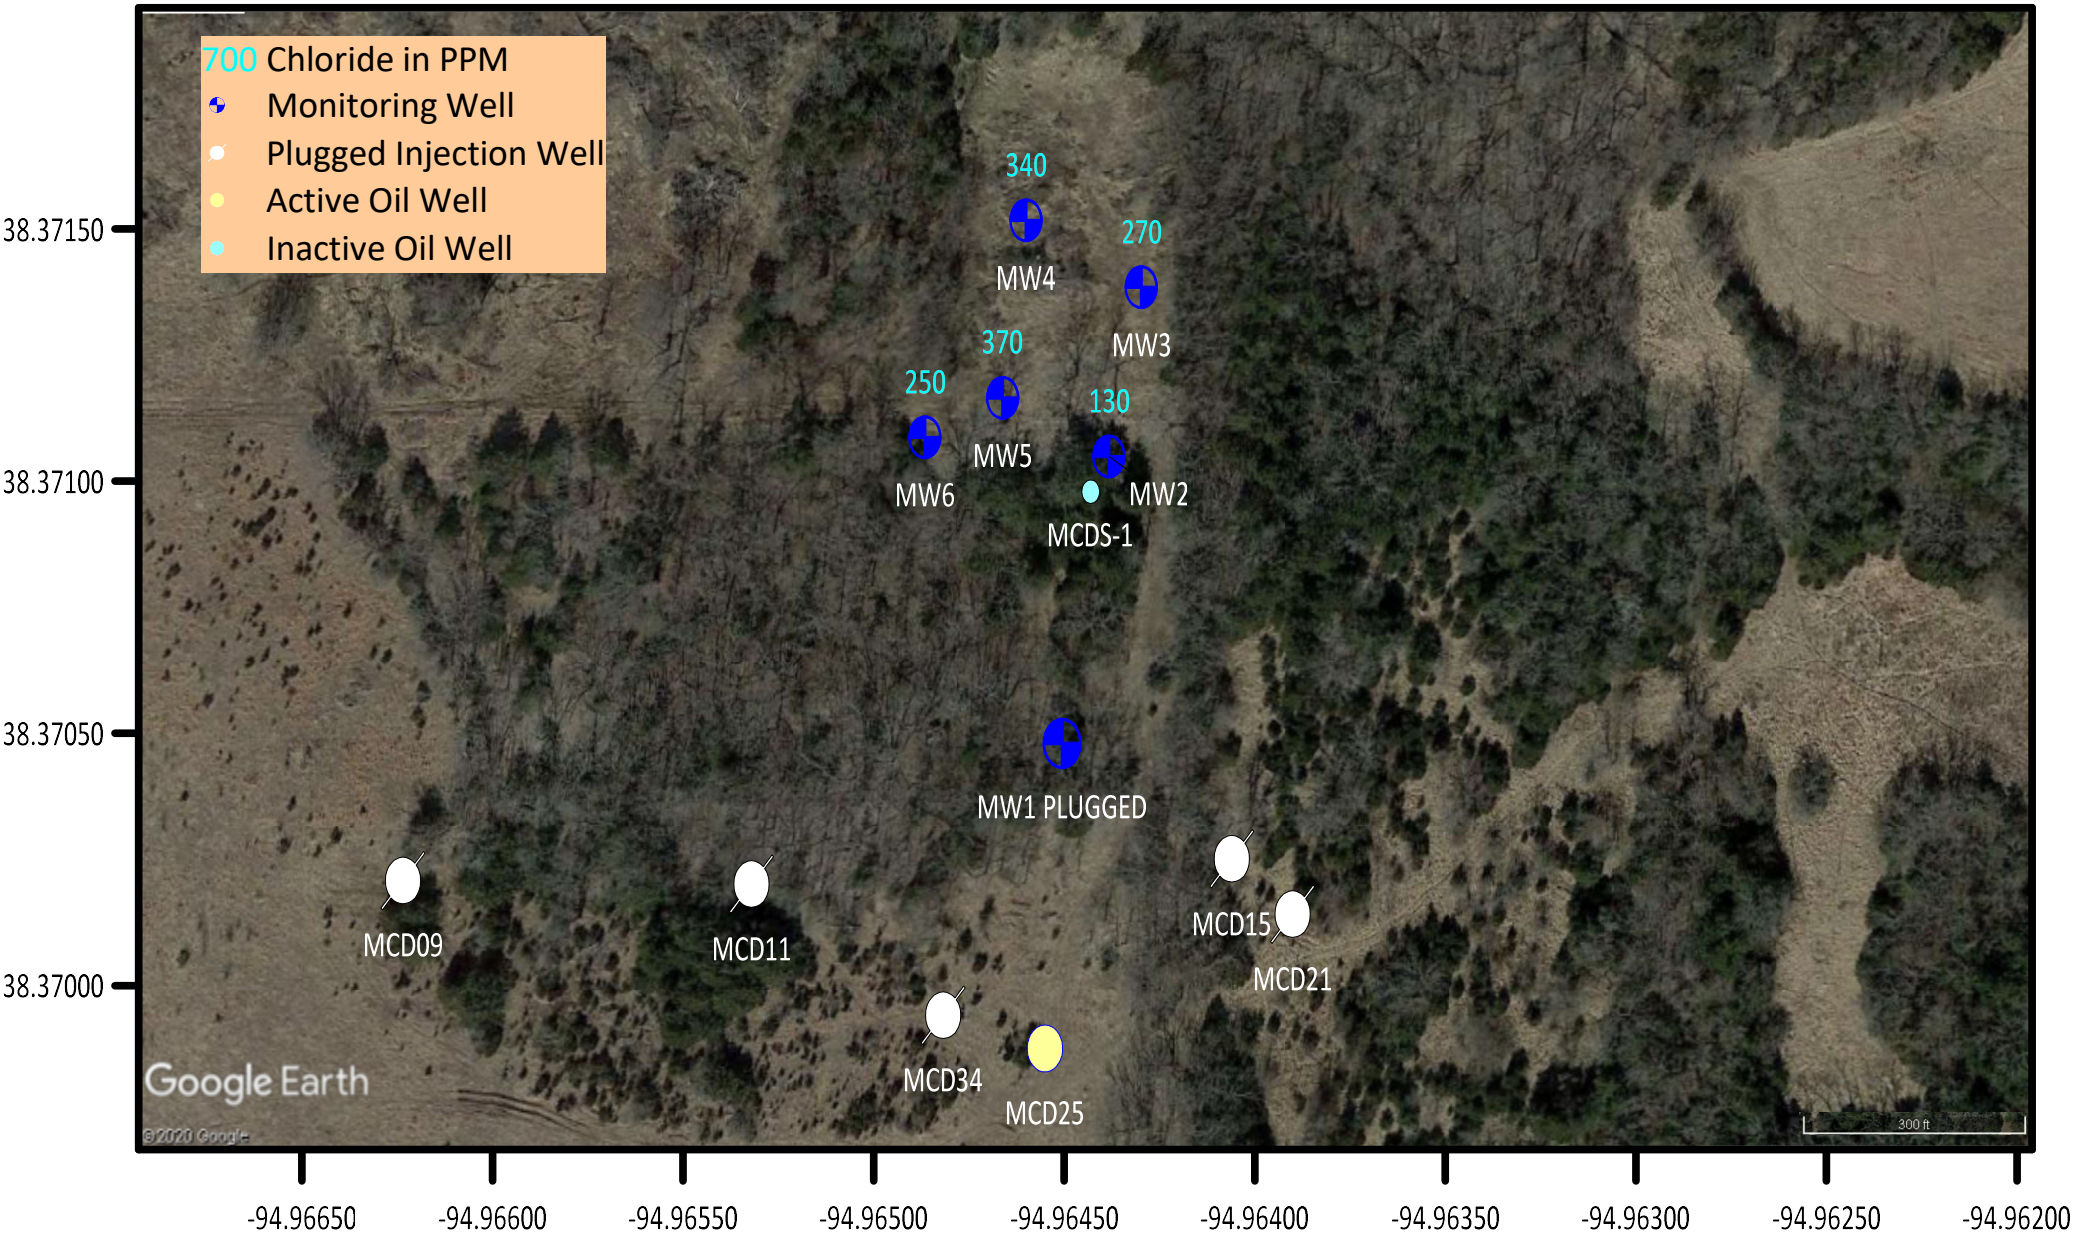
McDonald East Remediation Site
 NW27-T19S-R22E Linn County, Kansas
 2024 Groundwater Chloride Levels - District #3 Sampled 7/24/2024
 Map Drawn on 8/10/2024 by L. Short
 Project 970070-00

Control No.	Staff Hours/Expenditures	Fund Expenditures	
		FY 2024/25	Total
970070-00	15 Hrs. / \$492.30		
Current Contaminate Level: 130 ppm Cl- to 370 ppm Cl-			
Status:			
<input type="checkbox"/> 1. Site Assessment	<input type="checkbox"/> 2. Short Term Monitoring	<input type="checkbox"/> 3. Investigation	
<input type="checkbox"/> 4. Long Term Monitoring	<input type="checkbox"/> 5. Remediation Plan	<input type="checkbox"/> 6. Installation	
<input type="checkbox"/> 7. Remediation	<input checked="" type="checkbox"/> 8. Post Rem. Monitoring	<input type="checkbox"/> 9. Resolved

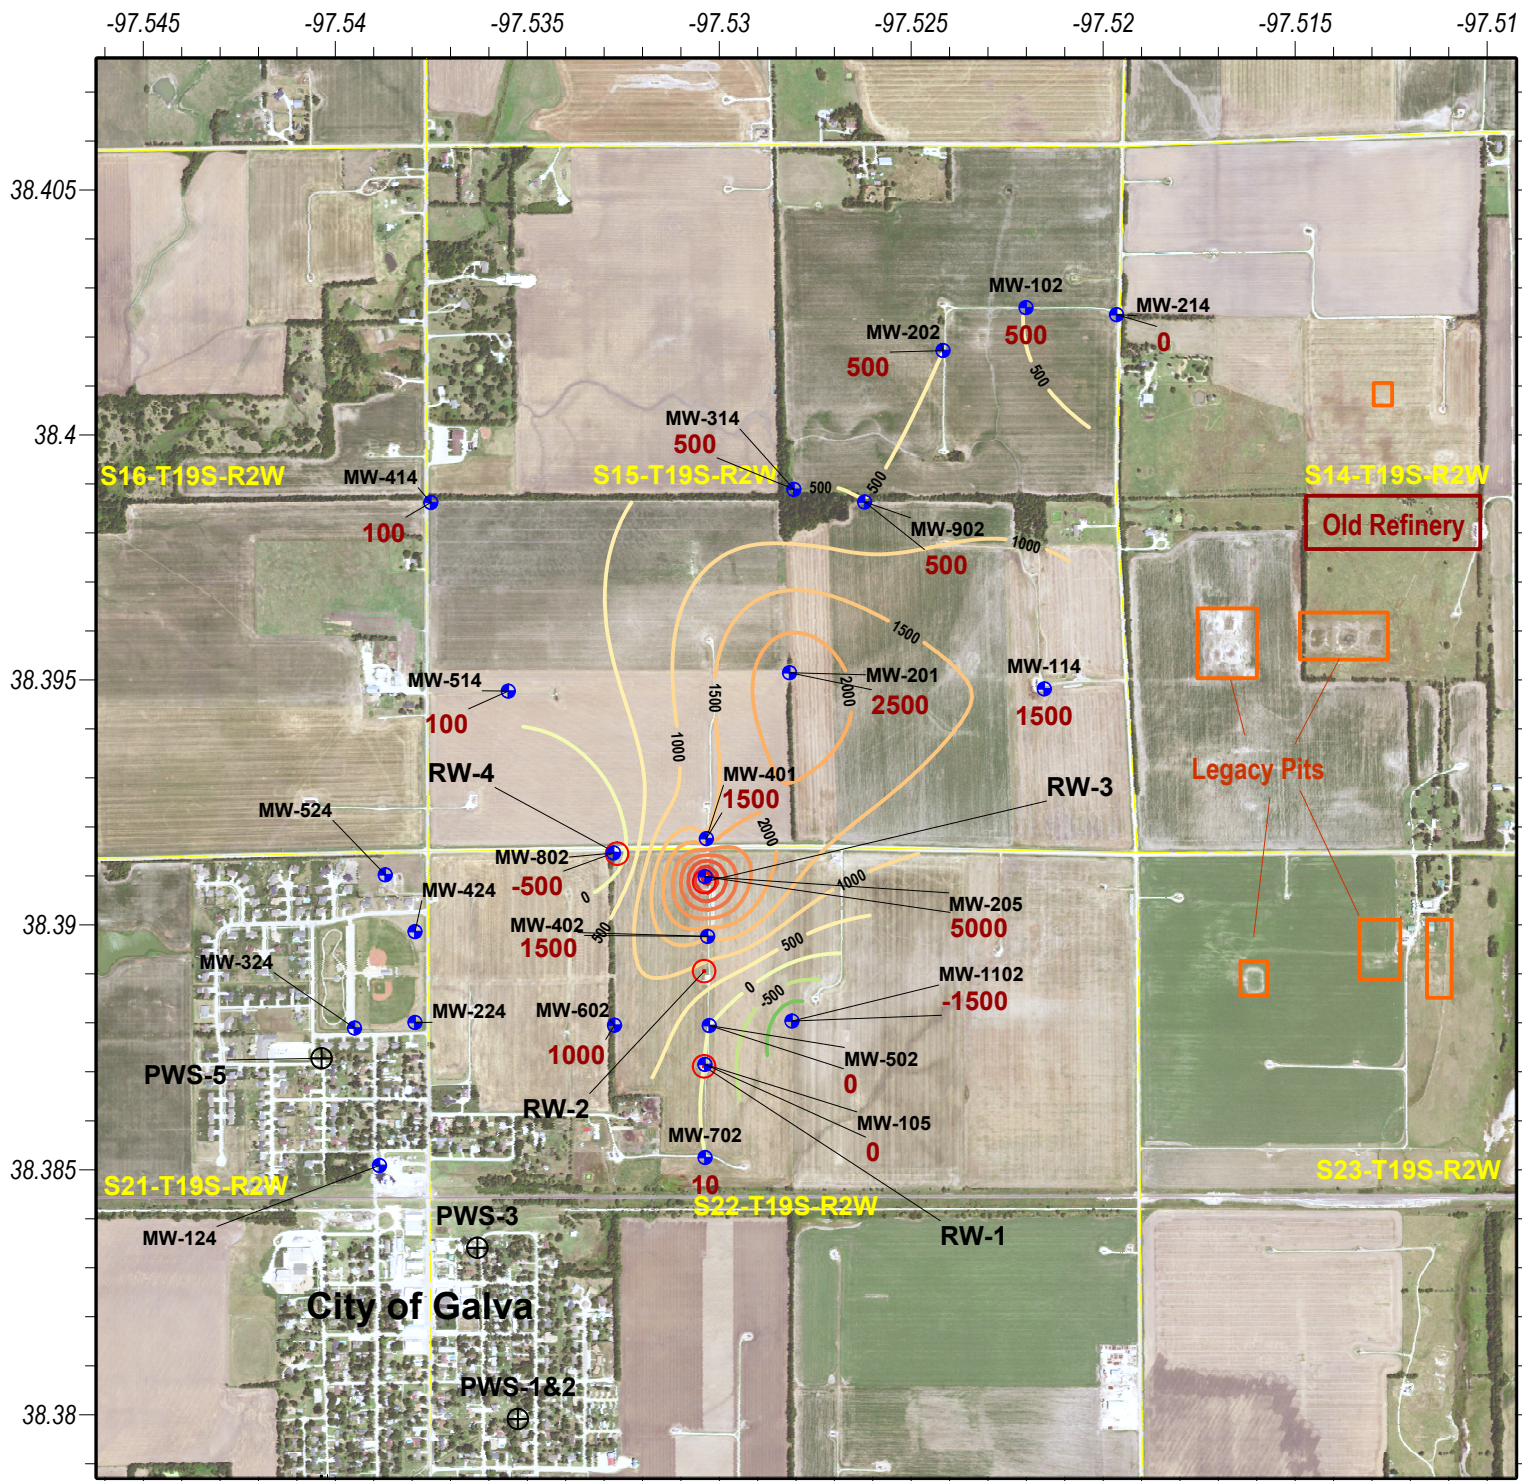
Galva City Brine Remediation Site
 Sections 15, 16, 21, and 22 of T19S and R2W, McPherson County, Kansas
Chloride Change from 2023 to 2024
 KCC Control #980033-01 - KCC District #2 Field Office
 Wells sampled mid-July, 2024 - Map Drawn on 10/16/2024 by D.Bollenback

Control No.	Staff Hours/Expenditures	Fund Expenditures	
		FY 2024/25	Total
980033-001	316 Hrs. / \$11,090.32	\$171,095.82	\$527,537.05
Current Contaminate Level: 30 mg/L (MW 702) to 32,000 mg/L (MW 401) chlorides for 2024			
Status:			
<input type="checkbox"/> 1. Site Assessment	<input type="checkbox"/> 2. Short Term Monitoring	<input checked="" type="checkbox"/> 3. Investigation	
<input checked="" type="checkbox"/> 4. Long Term Monitoring	<input type="checkbox"/> 5. Remediation Plan	<input type="checkbox"/> 6. Installation	
<input checked="" type="checkbox"/> 7. Remediation	<input type="checkbox"/> 8. Post Rem. Monitoring	<input type="checkbox"/> 9. Resolved

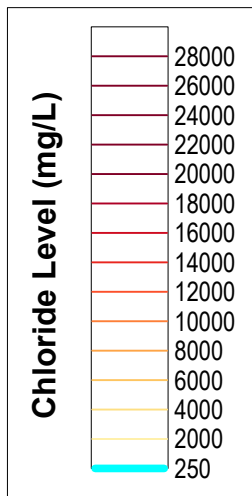
Galva City Brine Remediation Site
 Sections 15, 16, 21, and 22 of T19S and R2W, McPherson County, Kansas
2024 Chloride Levels
 KCC Control #980033-01 - KCC District #2 Field Office
 Wells sampled mid-July, 2024 - Map Drawn on 10/16/2024 by D.Bollenback

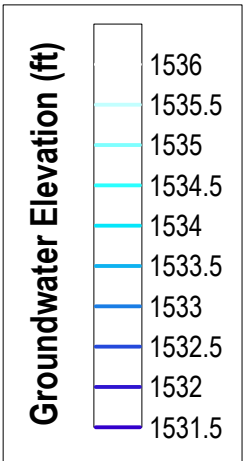
Galva City Brine Remediation Site
 Sections 15, 16, 21, and 22 of T19S and R2W, McPherson County, Kansas
Groundwater Elevations
 KCC Control #980033-01 - KCC District #2 Field Office
 Wells Gauged mid-July, 2024 - Map Drawn on 10/16/2024 by D.Bollenback

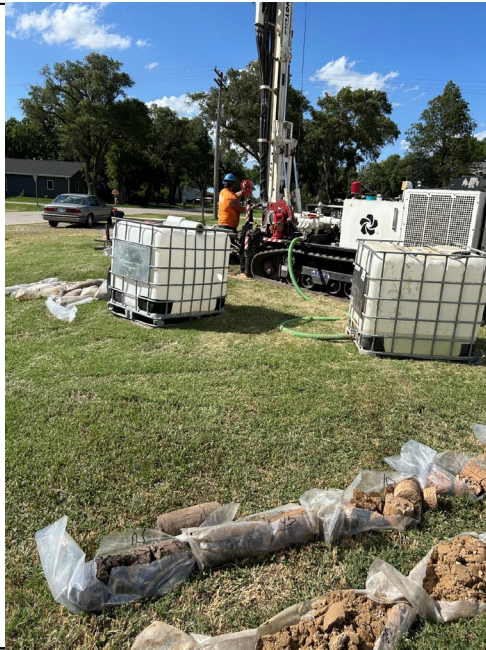
Description:
Drilling MW-124,

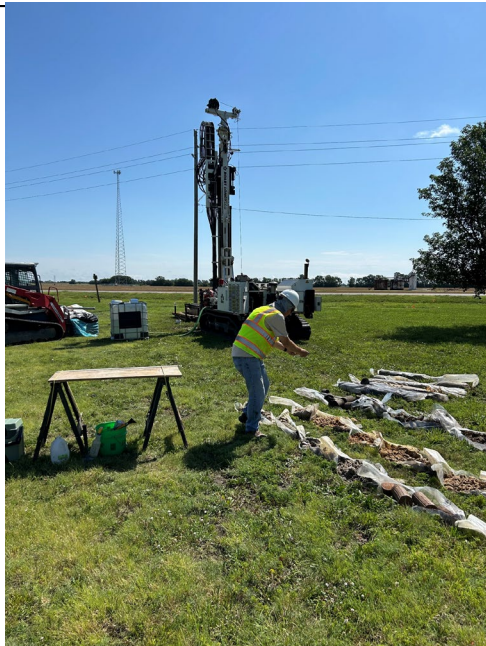
Photo No.:2

Description:
Post drilling MW-224, KCC geologist studies Sediment cores

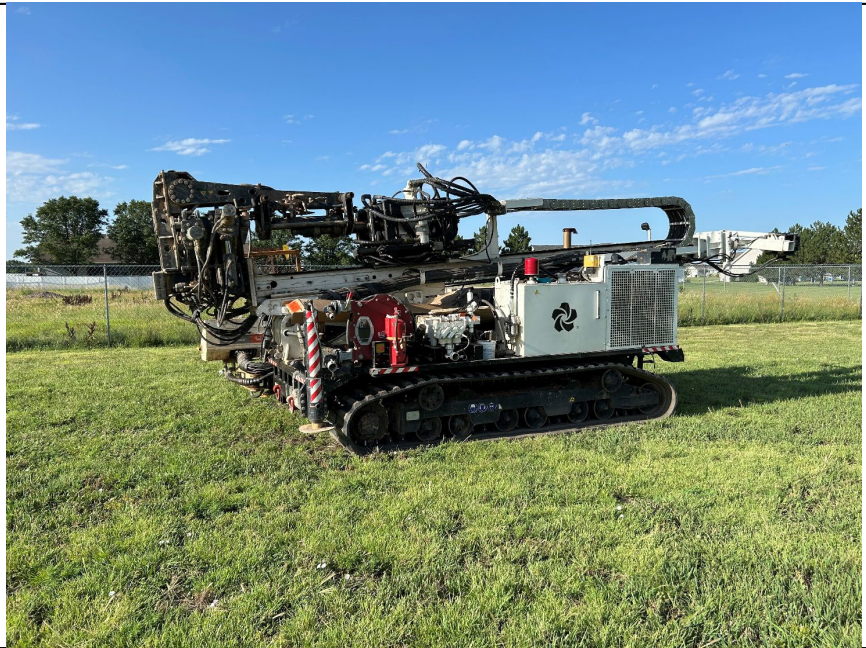
Description:
The Sonic Rig with
mast down for
moving locations

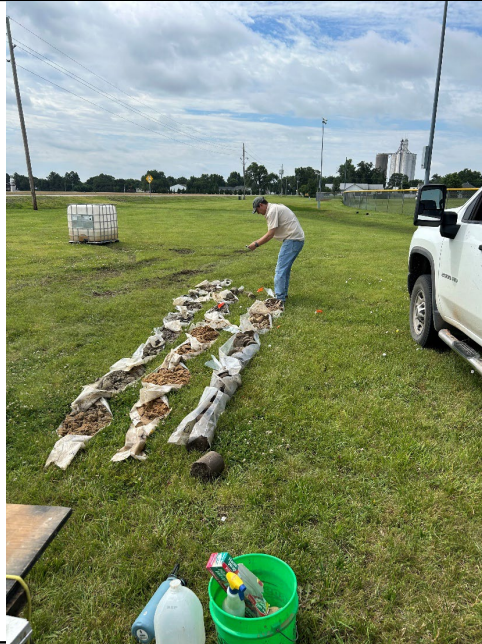
Photo No.:4

Description:
The sediment cores
laid out after drilling
for geologists to go
over.

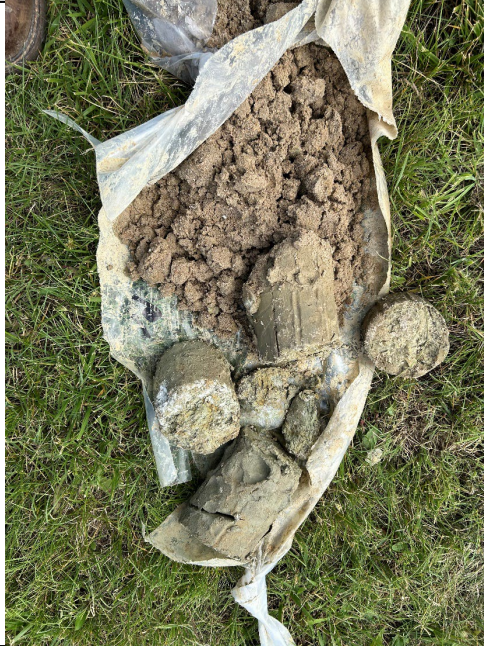
Description:
Core showing aquifer sand on top of Wellington Shale bedrock.

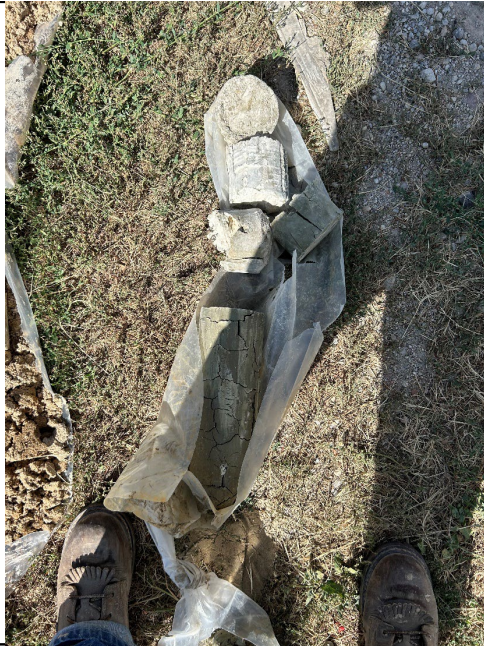
Photo No.:6

Description:
Core of Wellington Shale at MW-124

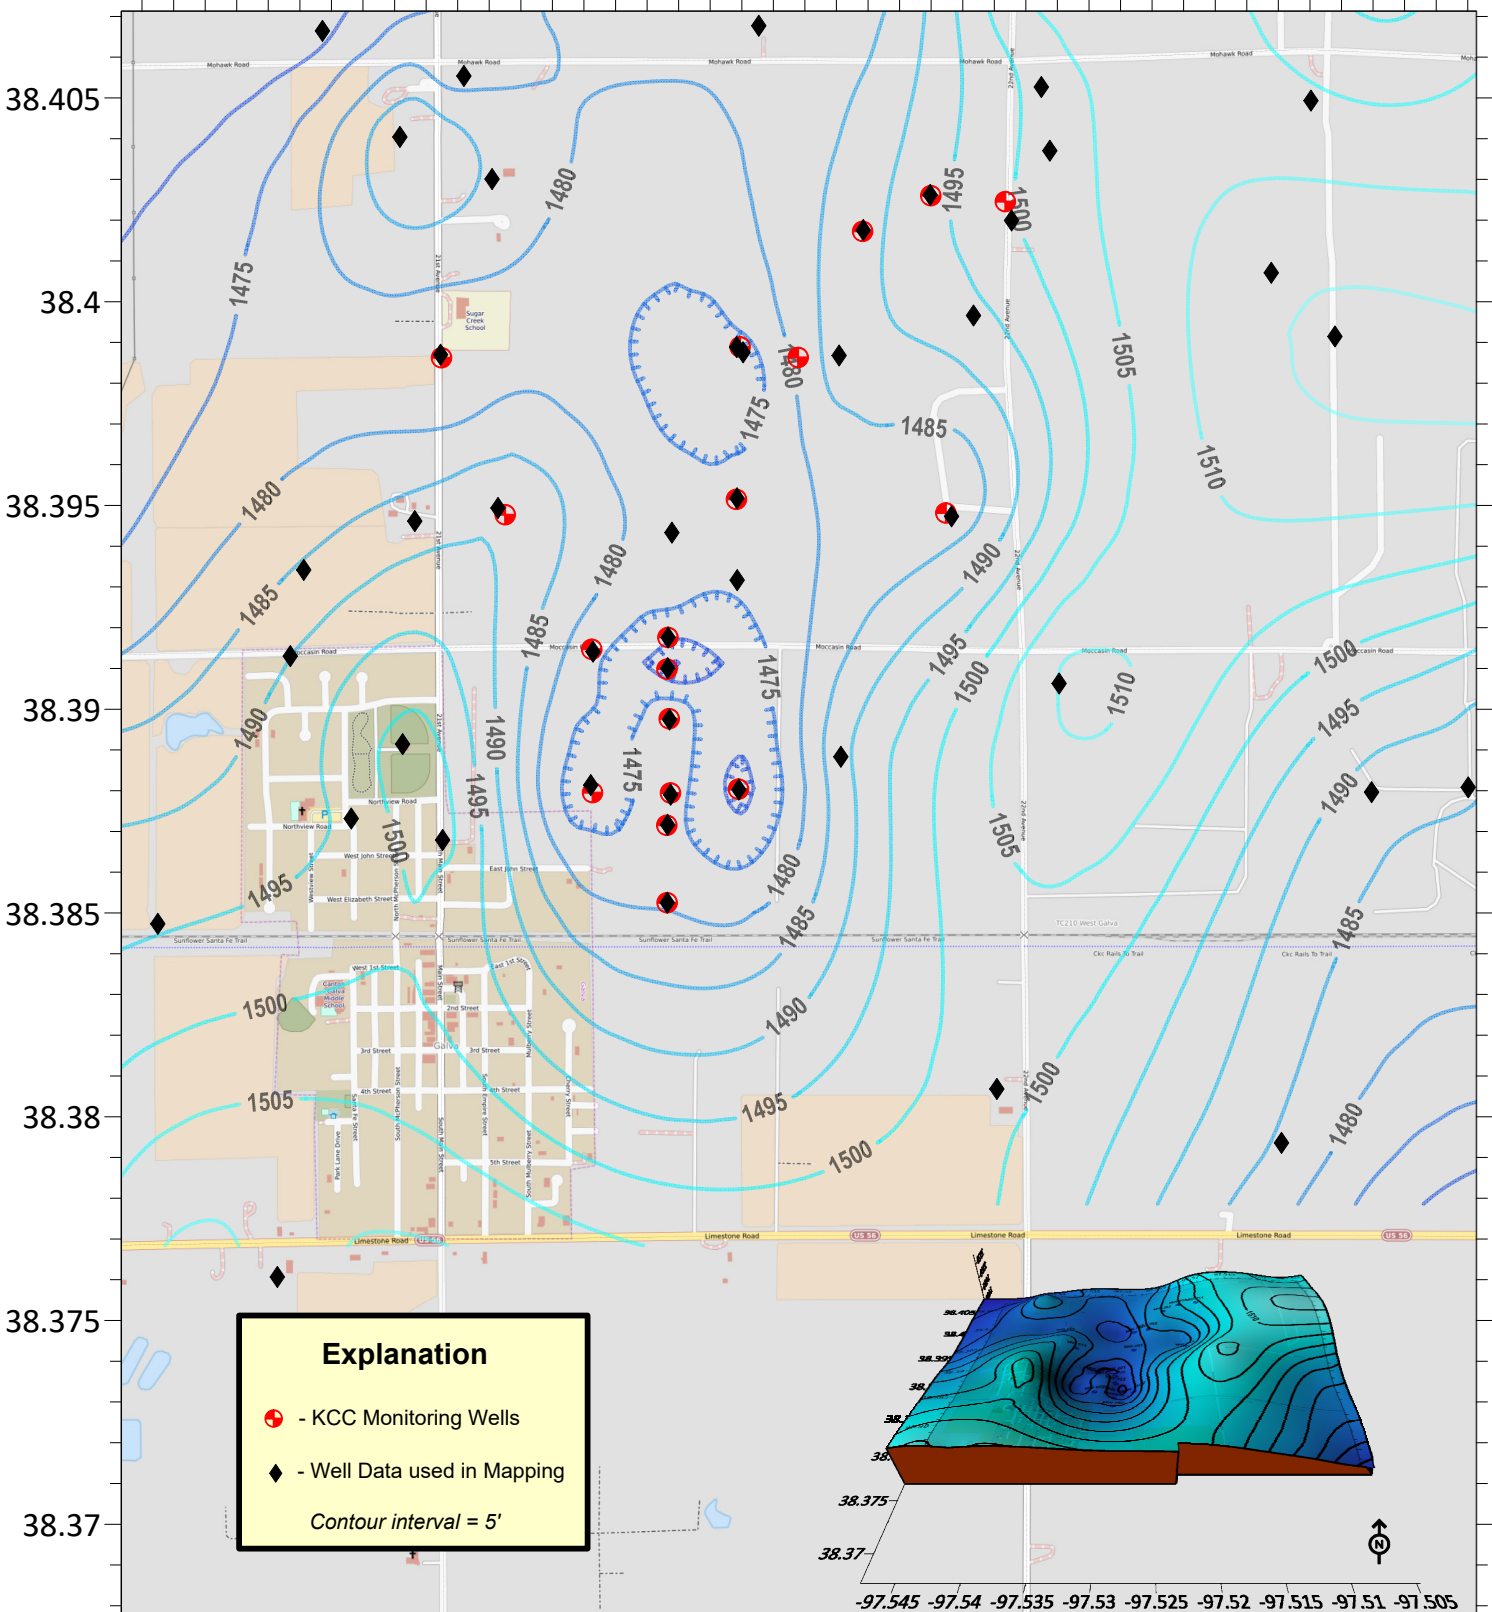
Galva City Brine Remediation Site
Wellington Bedrock Elevation Map
 Multiple Sections in Township 19 South & Range 2 West, McPherson County
 KCC District #2 Field Office - #980033-01 - Map Drawn on 10/18/2021 by D. Bollenback

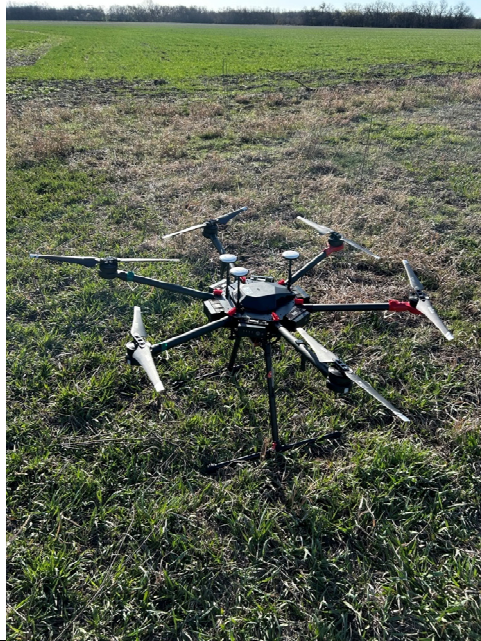
Description:
The KGS Drone used to perform the magnetic survey

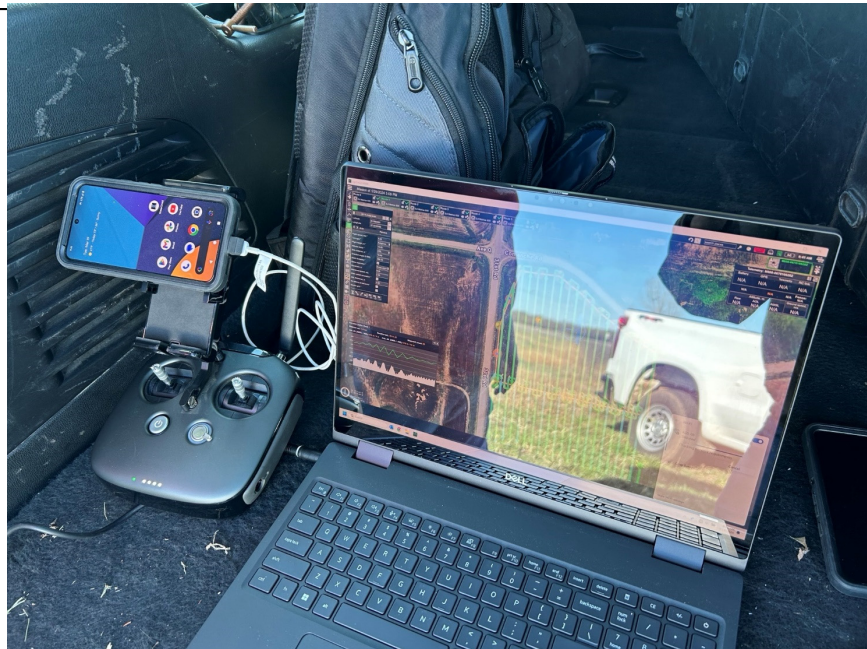
Photo No.:2

Description:
Computer and controller for the drone.

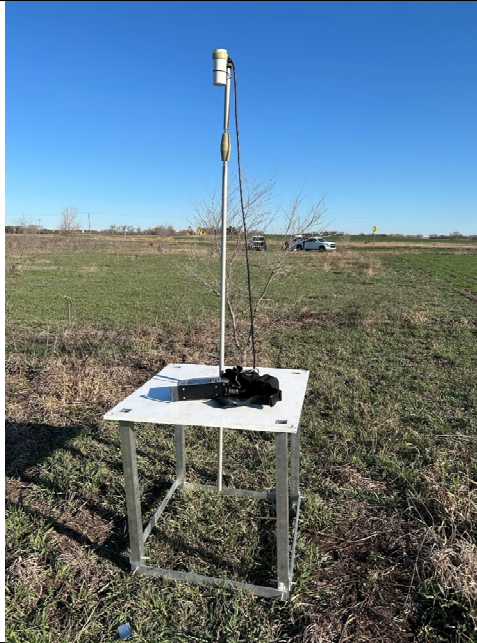
Description:
Base Station for the
drone.

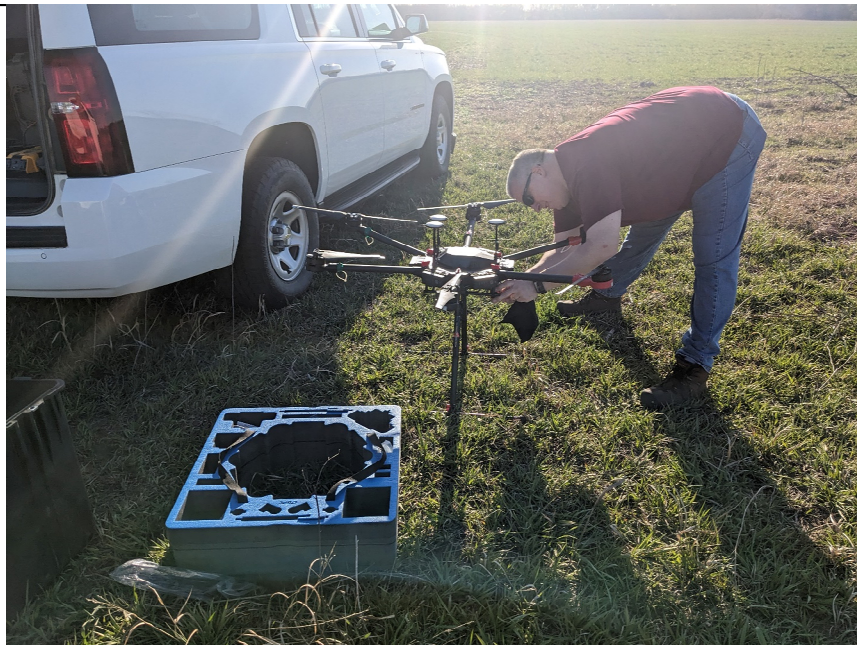
Photo No.:4

Description:
KGS Engineer
performing pre-flight
checks on drone.
