2025

**OIL AND GAS
REMEDIATION SITE STATUS**

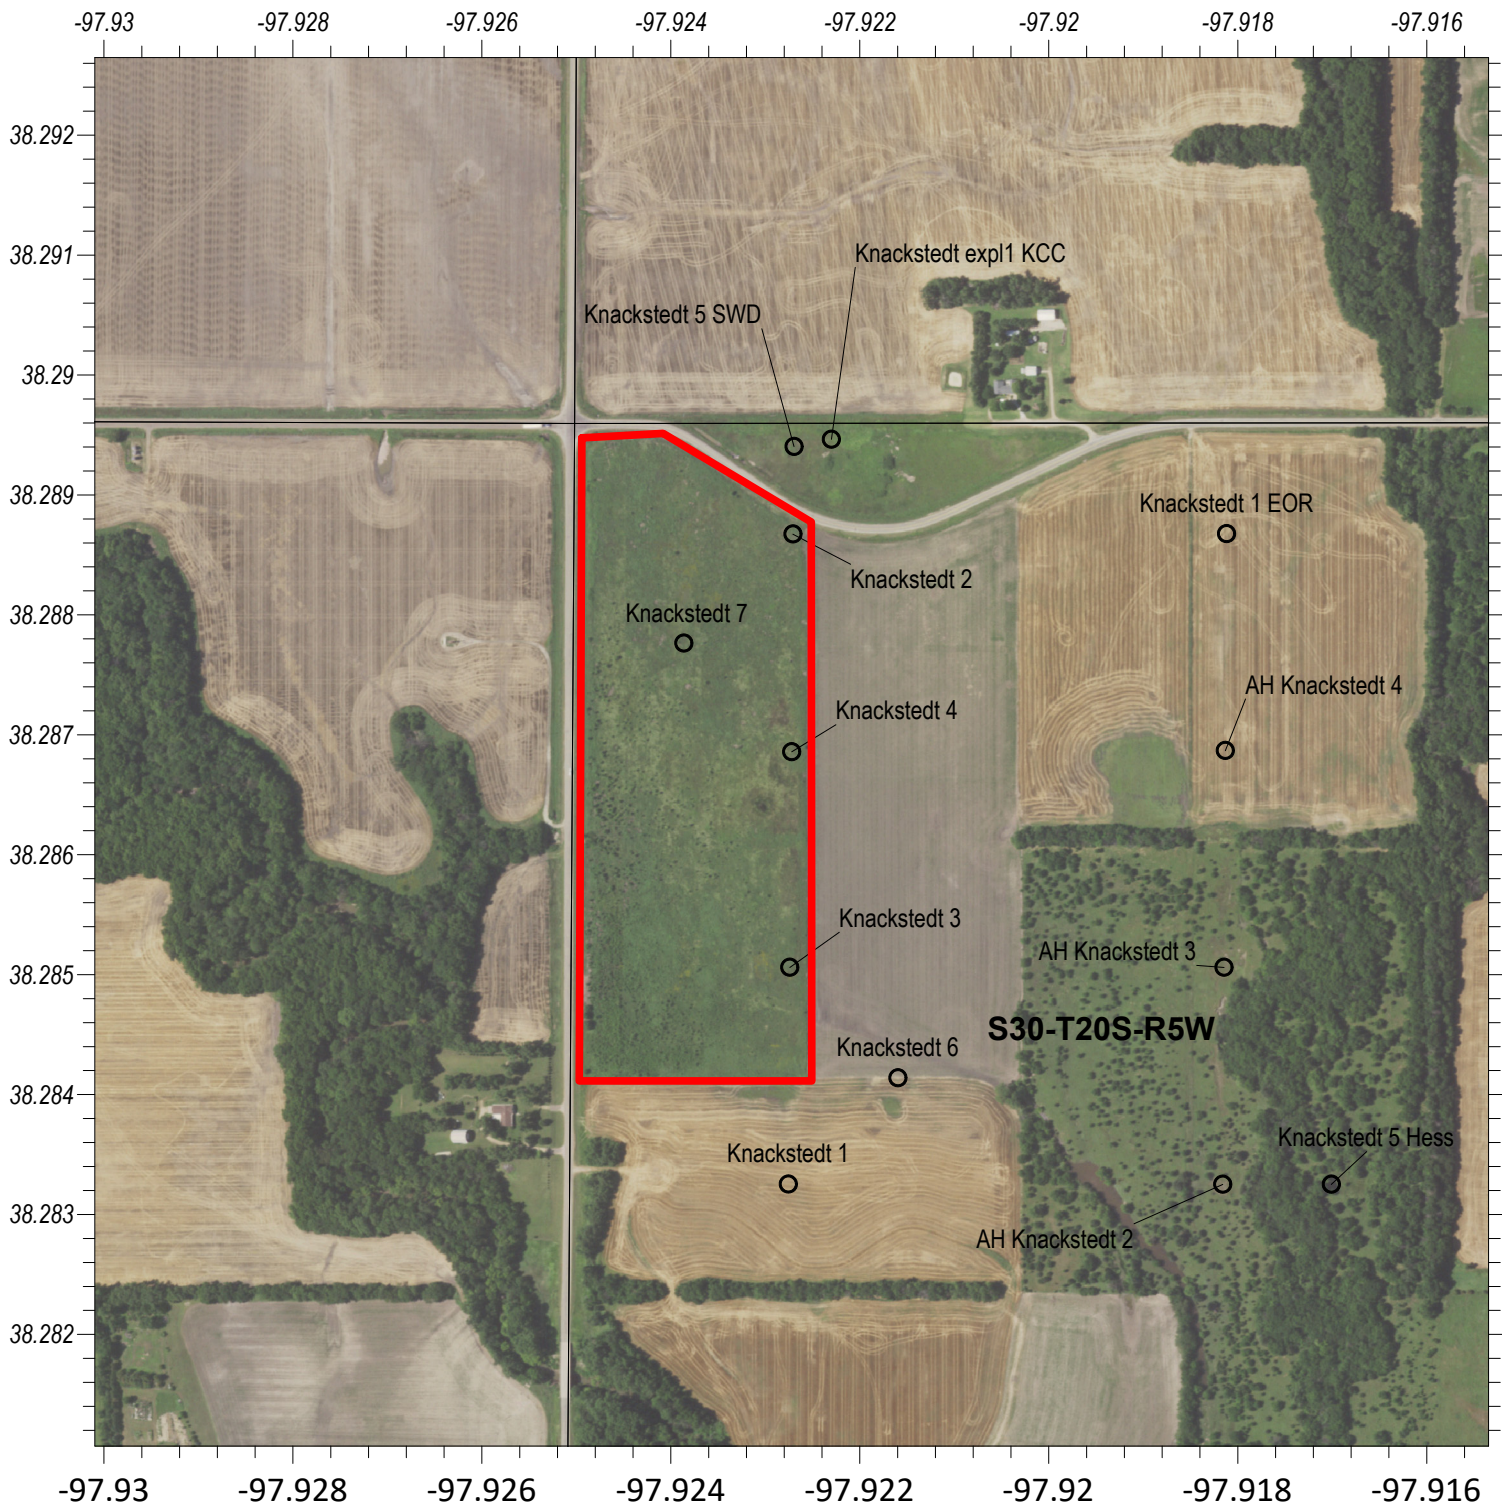
Kansas Corporation Commission
 Section 30 of T20S and R5W, McPherson County, Kansas
KCC Field Verified Oil and Gas Wells
 KCC District #2 Field Office - Map Drawn on 10/16/2024

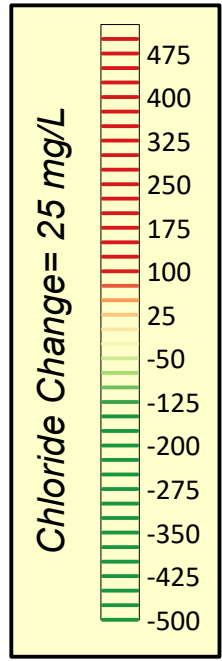
Seltzer-Bitikofer Brine Contamination Site
 Sections 1 and 2 of Township 20 South and Range 1 West, McPherson County, Kansas
Chloride Level Change from 2023-2024
 KCC Project Code #970093-00 - KCC District #2 Field Office - Wells Sampled on 10/1/2024 - Map Drawn on 10/18/2024 by D. Bollenback

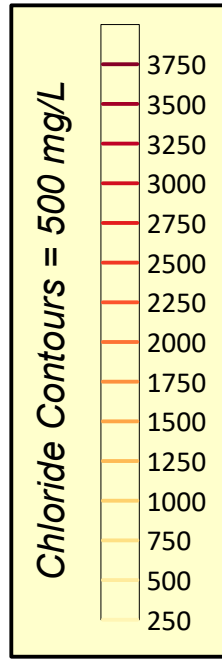
Seltzer-Bitikofer Brine Contamination Site
 Sections 1 and 2 of Township 20 South and Range 1 West, McPherson County, Kansas
2024 Chloride Levels
 KCC Project Code #970093-00 - KCC District #2 Field Office - Wells Sampled on 10/1/2024 - Map Drawn on 10/18/2024 by D.Bollenback

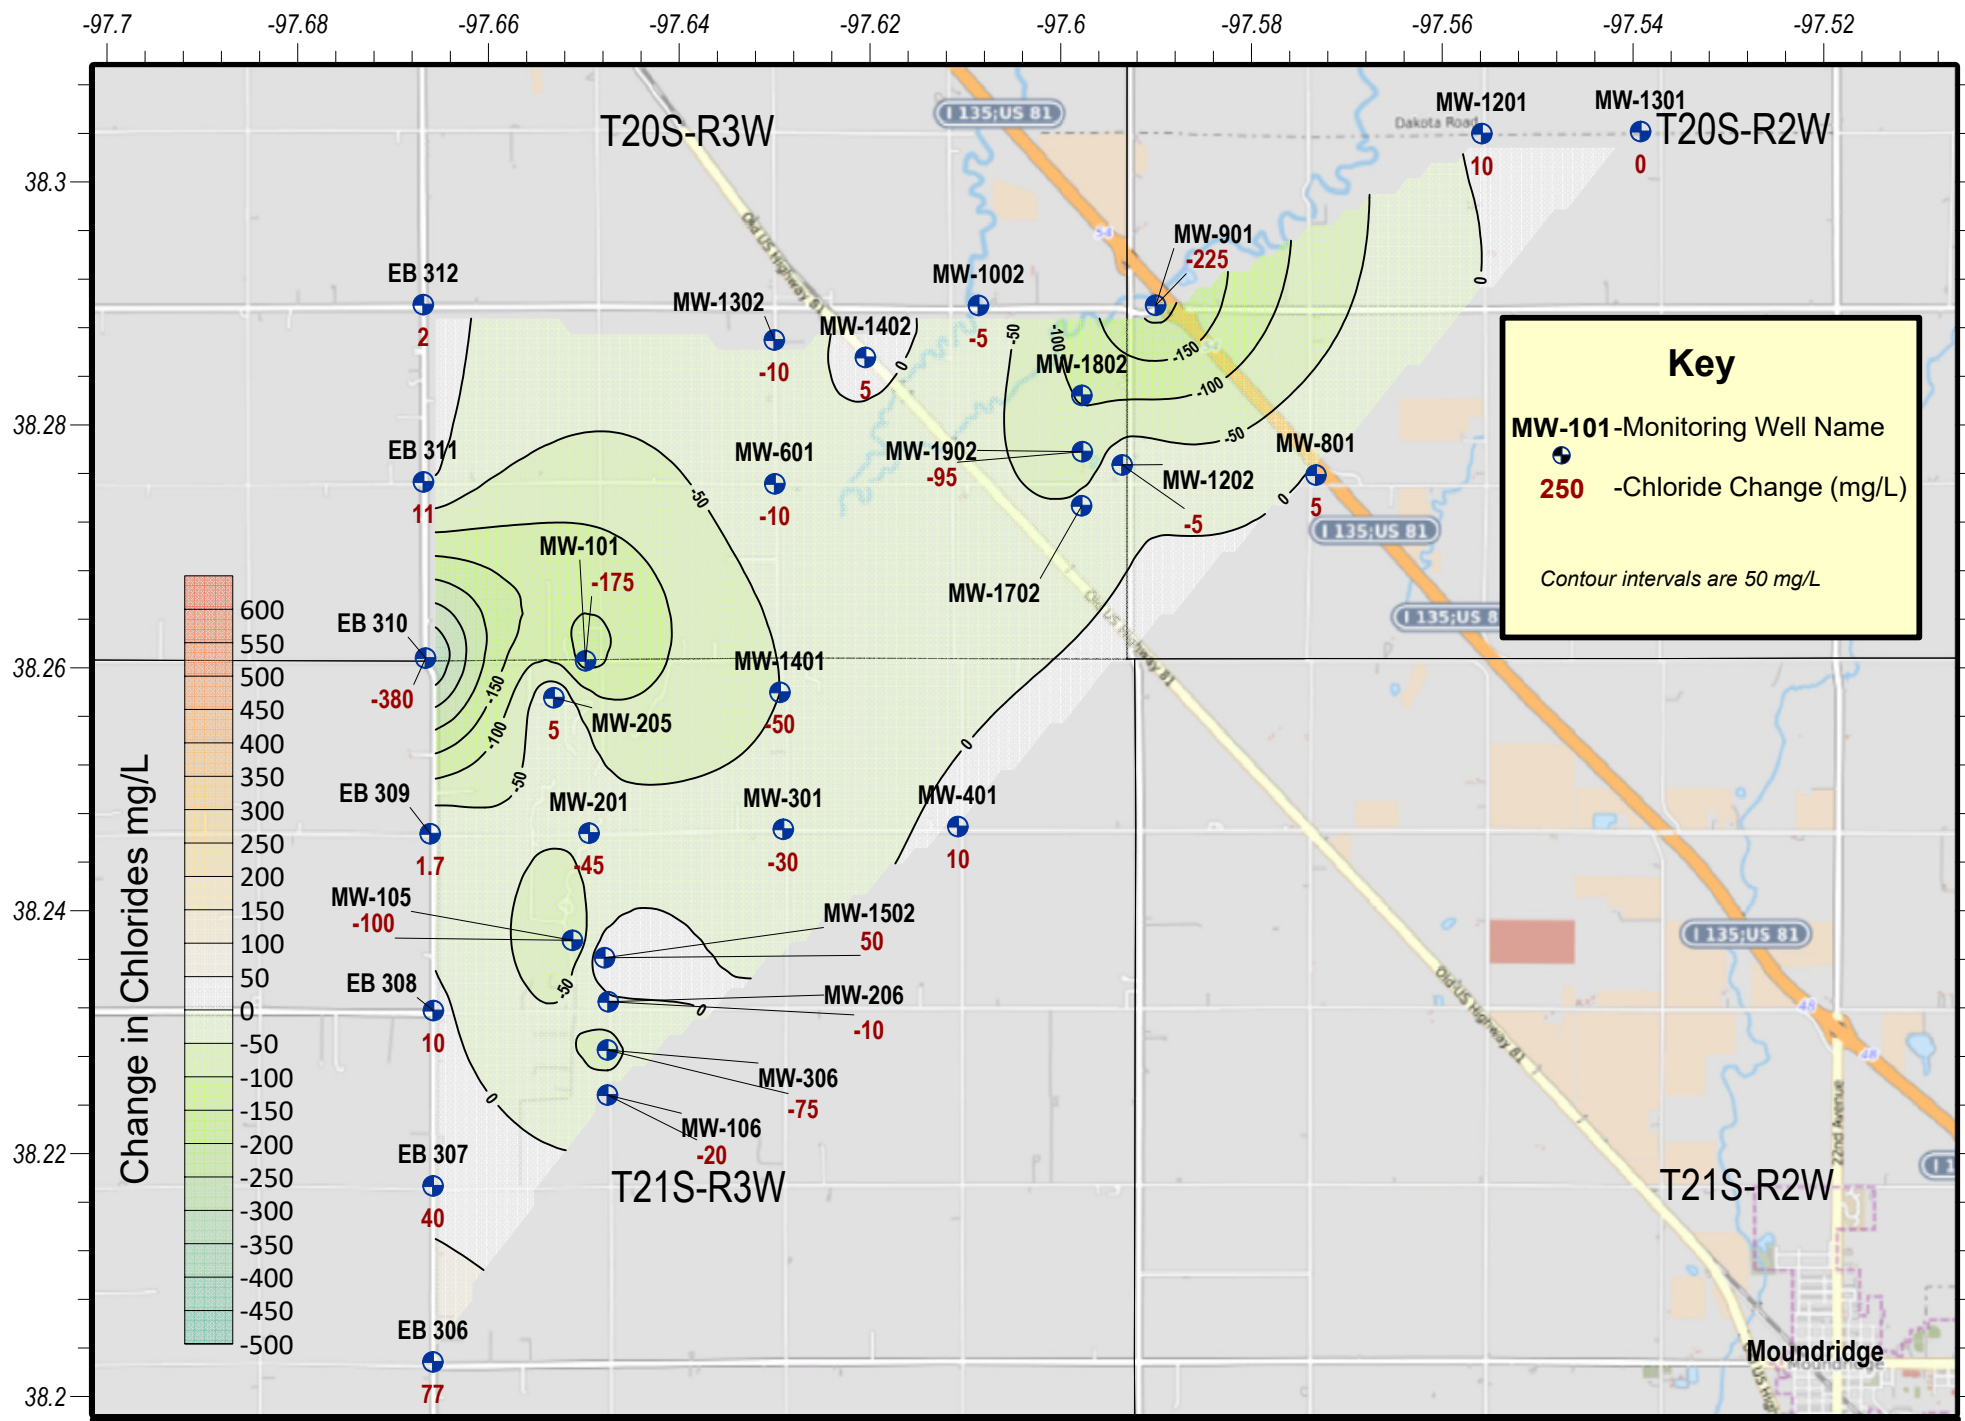
Voshell Contamination Site
 Multiple Section of Townships 20 & 21 South and Range 2 & 3 West, McPherson County, Kansas
Change from 2023 to 2024 Chloride Level Map
 District #2 - Control Number #20030059-001 - Sampled on 10/3/2024 to 10/4/2024 - Drawn on 10/15/2024 by D. Bollenback

Control No.	Staff Hours/Expenditures	Fund Expenditures	
		FY 2024/25	Total
20030059-001	28 Hrs. / \$941.32	\$637.00	\$22,649.73
Current Contaminate Level: MW 1502 – 3,550 mg/L.			
Status:			
<input type="checkbox"/> 1. Site Assessment	<input type="checkbox"/> 2. Short Term Monitoring	<input checked="" type="checkbox"/> 3. Investigation	
<input checked="" type="checkbox"/> 4. Long-Term Monitoring	<input type="checkbox"/> 5. Remediation Plan	<input type="checkbox"/> 6. Installation	
<input type="checkbox"/> 7. Remediation	<input type="checkbox"/> 8. Post Rem. Monitoring	<input type="checkbox"/> 9. Resolved

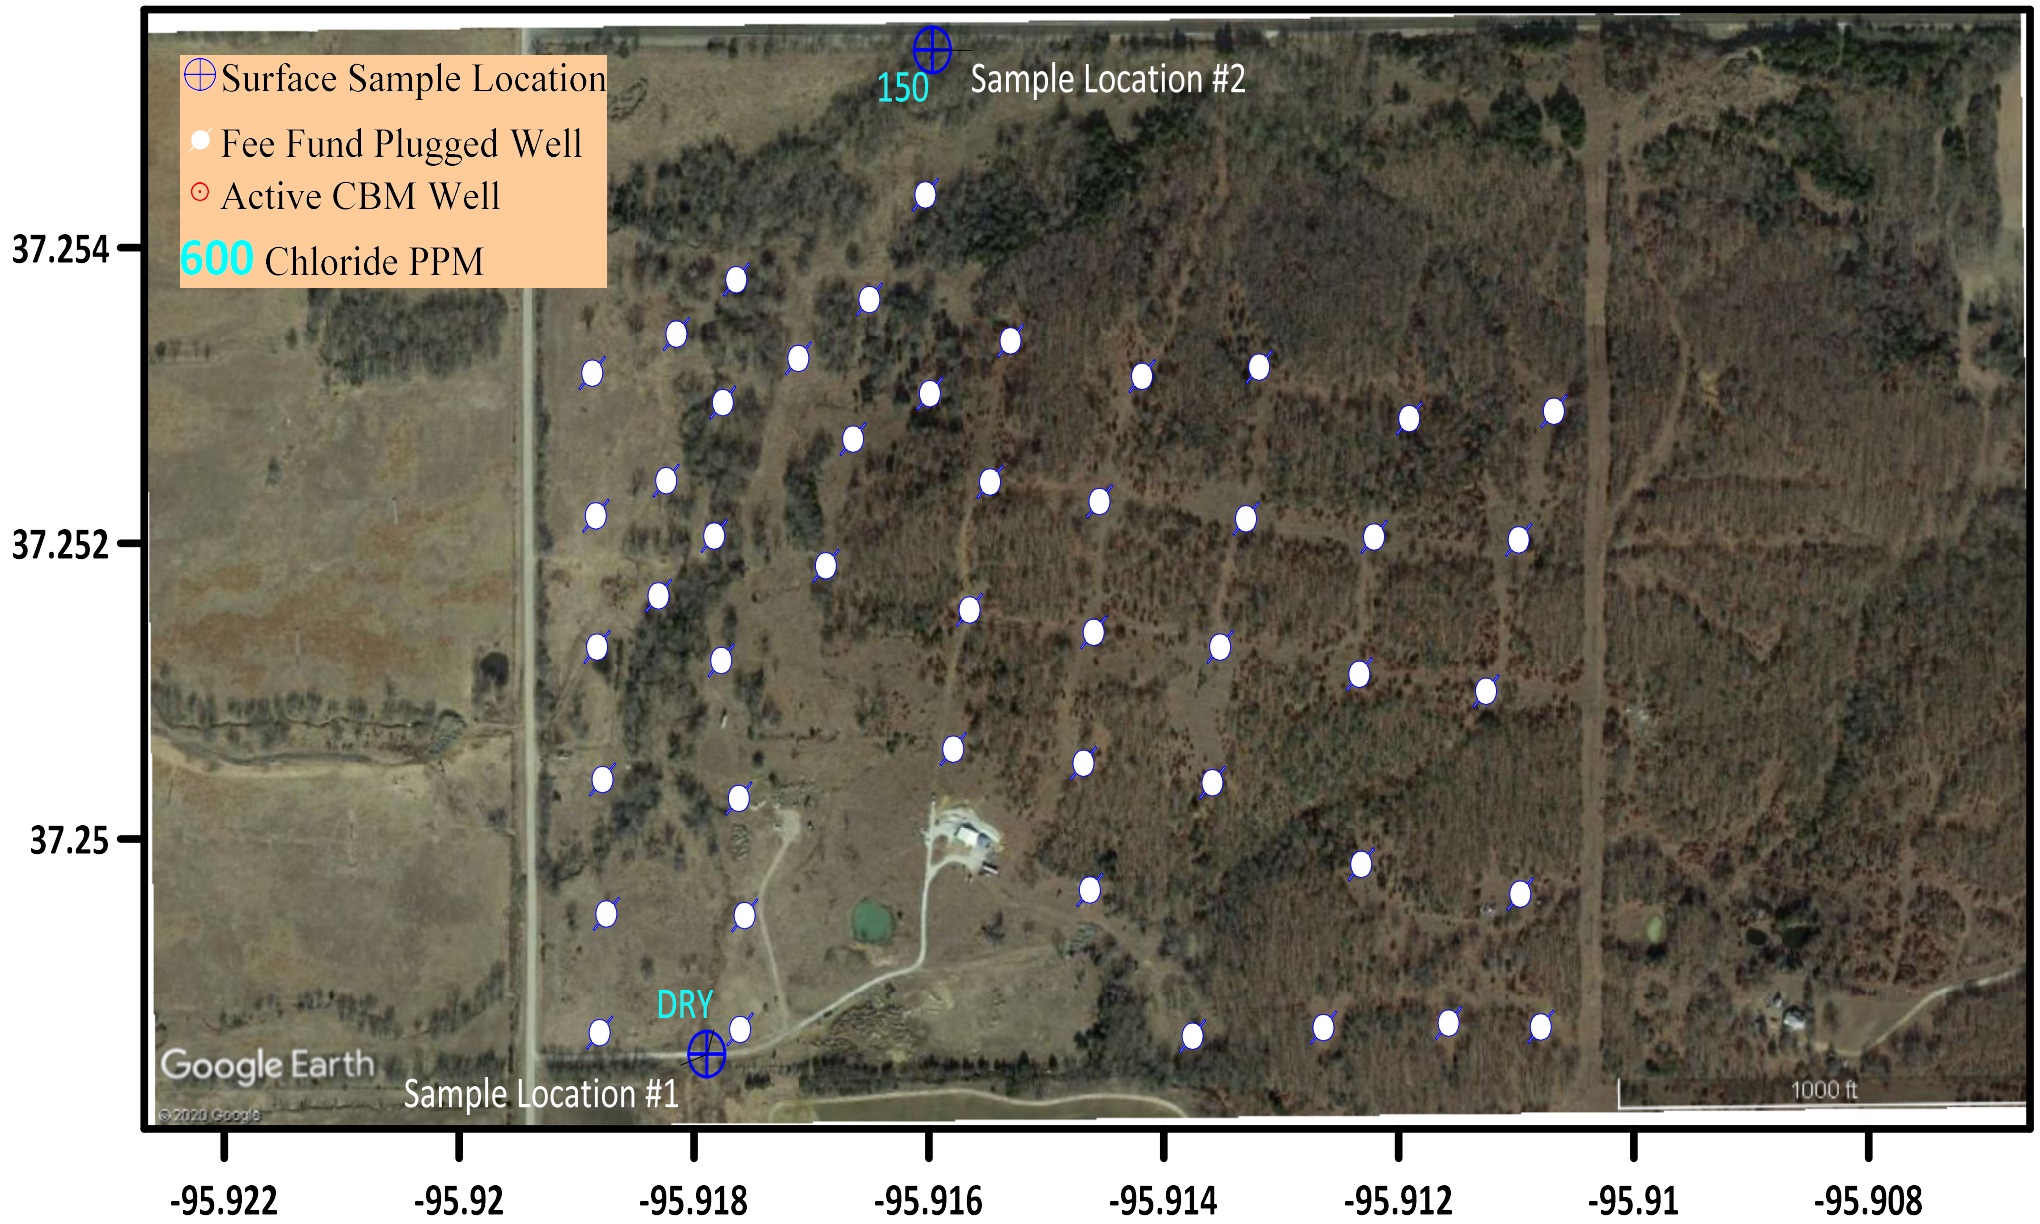
Fowler Remediation Site
 NE 19-T32S-R14E Montgomery County, Kansas
 2024 Surface Water Chloride Levels - District #3 Inspected 08/08/2024
 No Samples Collected, Dry Creek Conditions
 Map Drawn on 08/15/2024 by L. Short
 Project 970046-00

Control No.	Staff Hours/Expenditures	Fund Expenditures	
		FY 2024/25	Total
970046-00	7 Hrs. / \$240.82		
Current Contaminate Level: 150 ppm Cl-			
Status:			
<input type="checkbox"/> 1. Site Assessment	<input type="checkbox"/> 2. Short Term Monitoring	<input type="checkbox"/> 3. Investigation	
<input type="checkbox"/> 4. Long Term Monitoring	<input type="checkbox"/> 5. Remediation Plan	<input type="checkbox"/> 6. Installation	
<input type="checkbox"/> 7. Remediation	<input checked="" type="checkbox"/> 8. Post Rem. Monitoring	<input type="checkbox"/> 9. Resolved

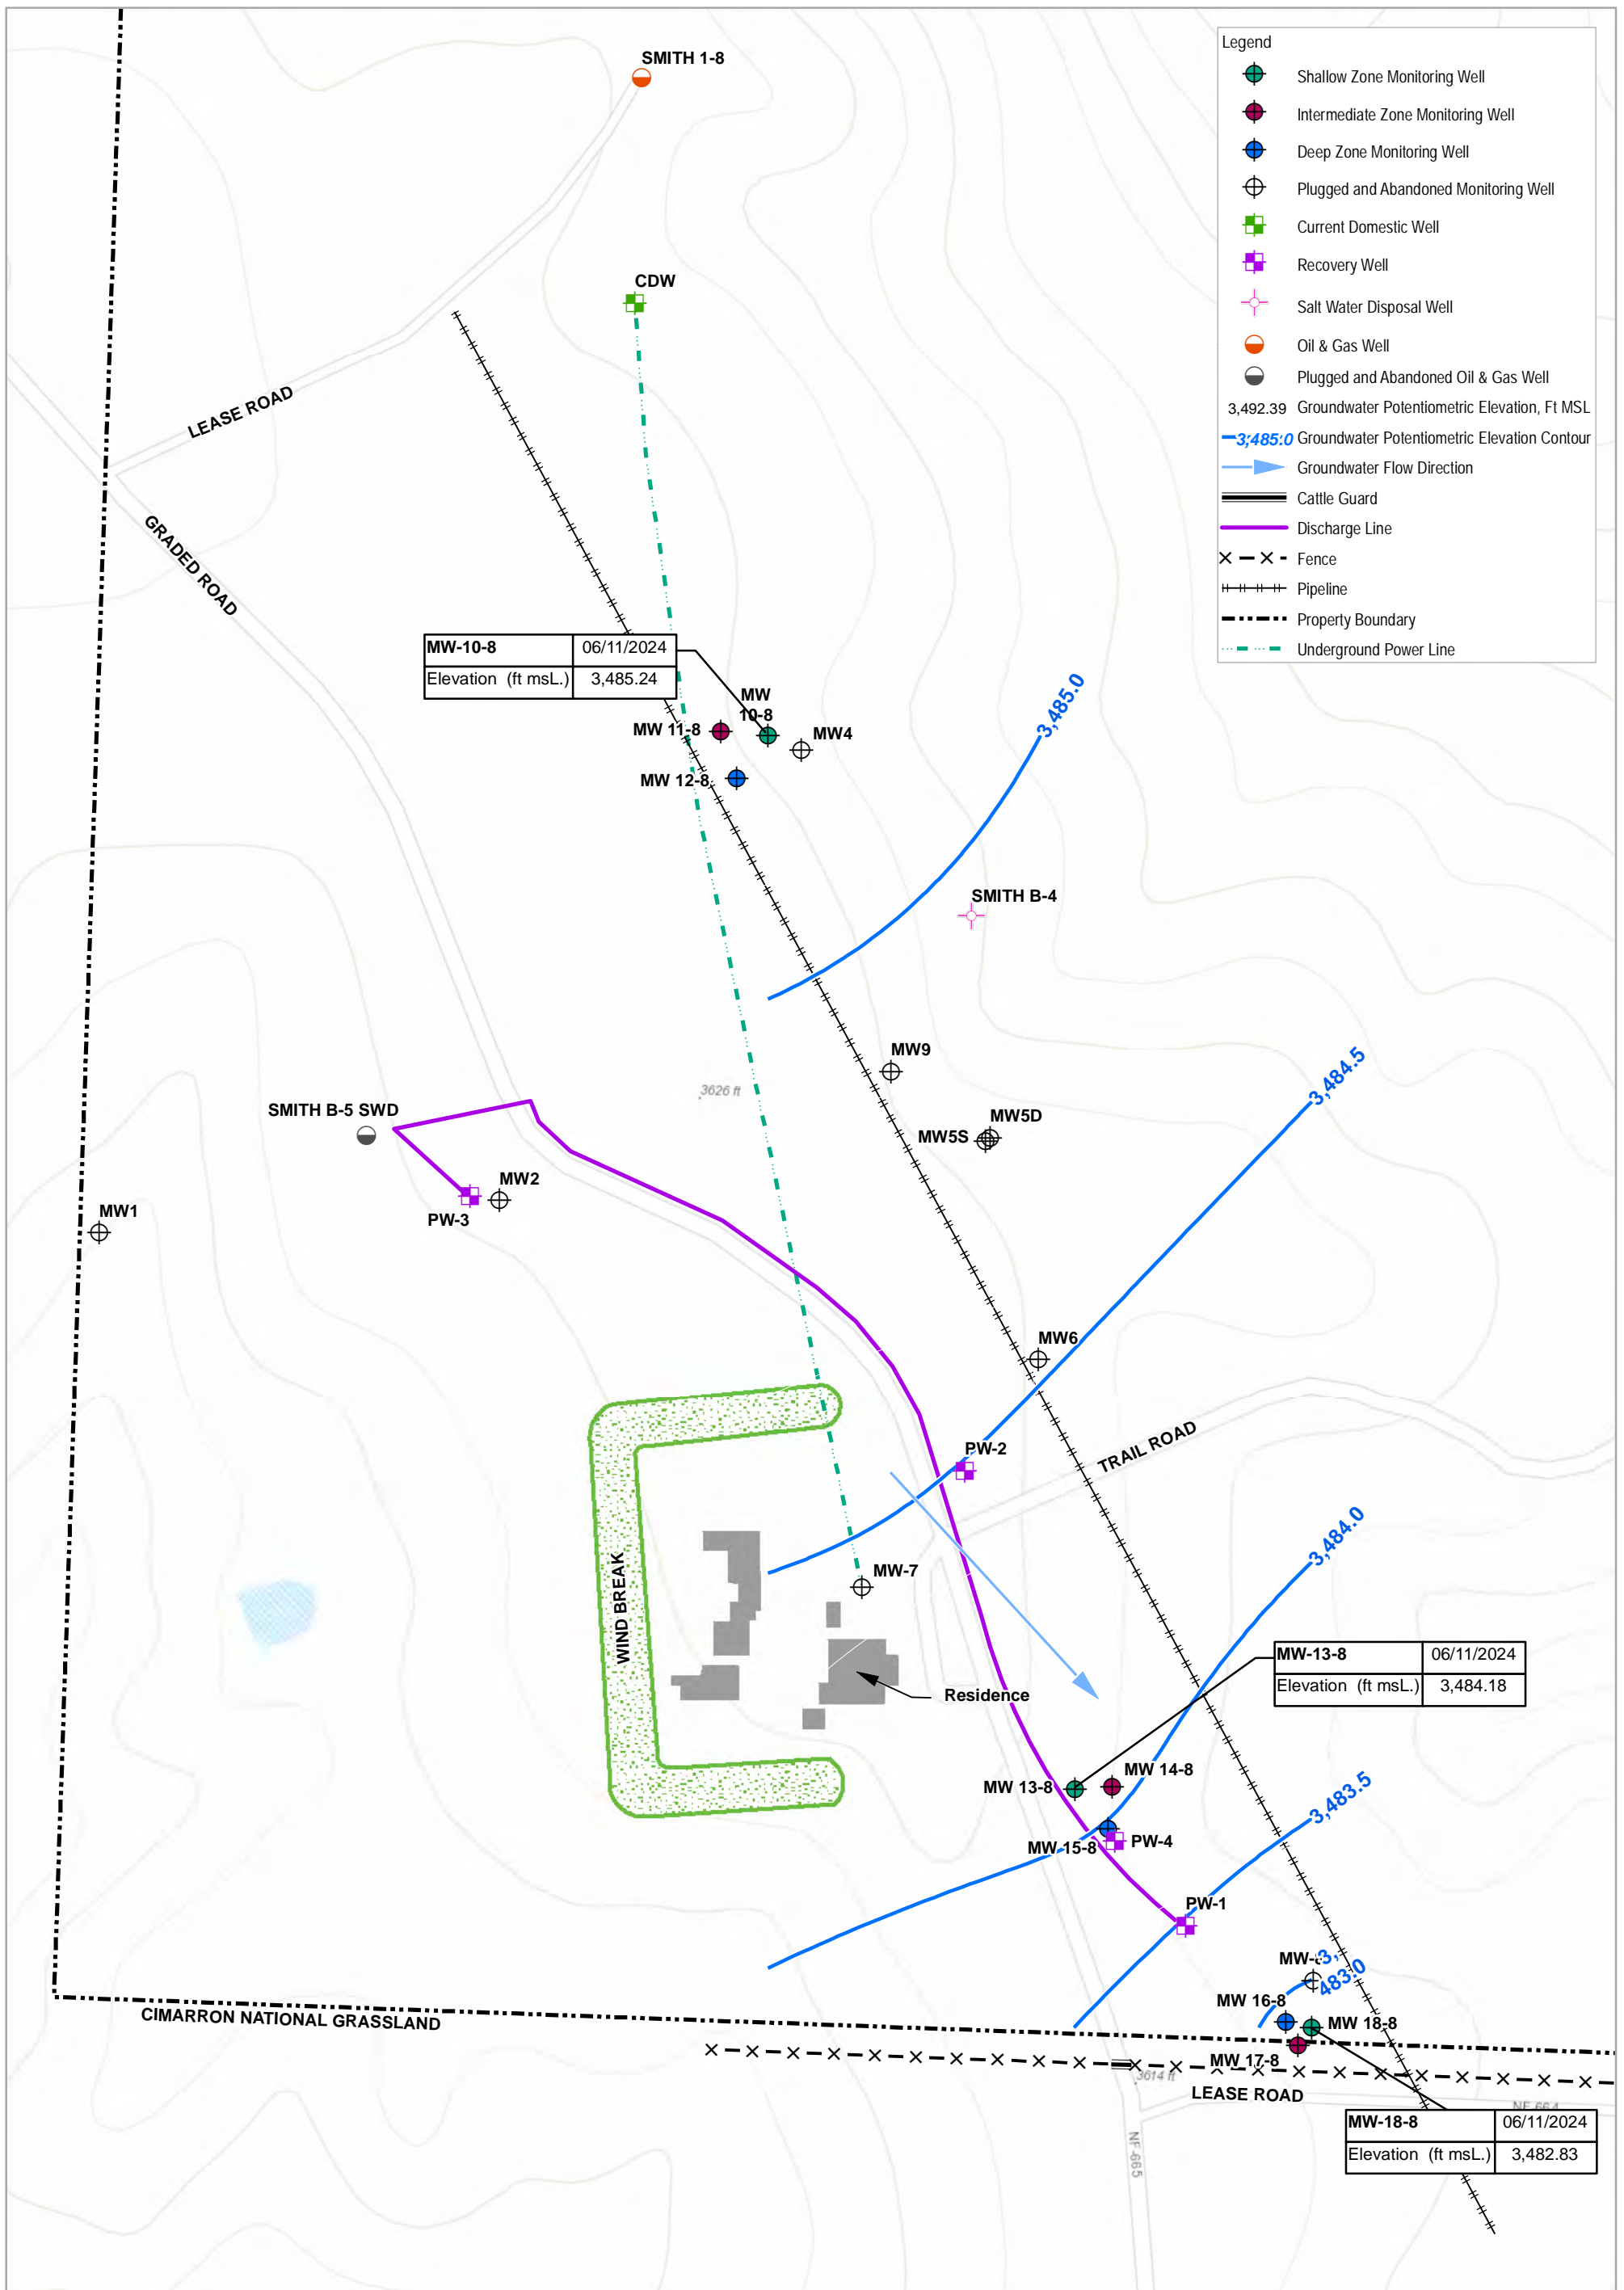
FIGURE 3

JUNE 2024 SHALLOW WELL
GROUNDWATER POTENTIOMETRIC MAP

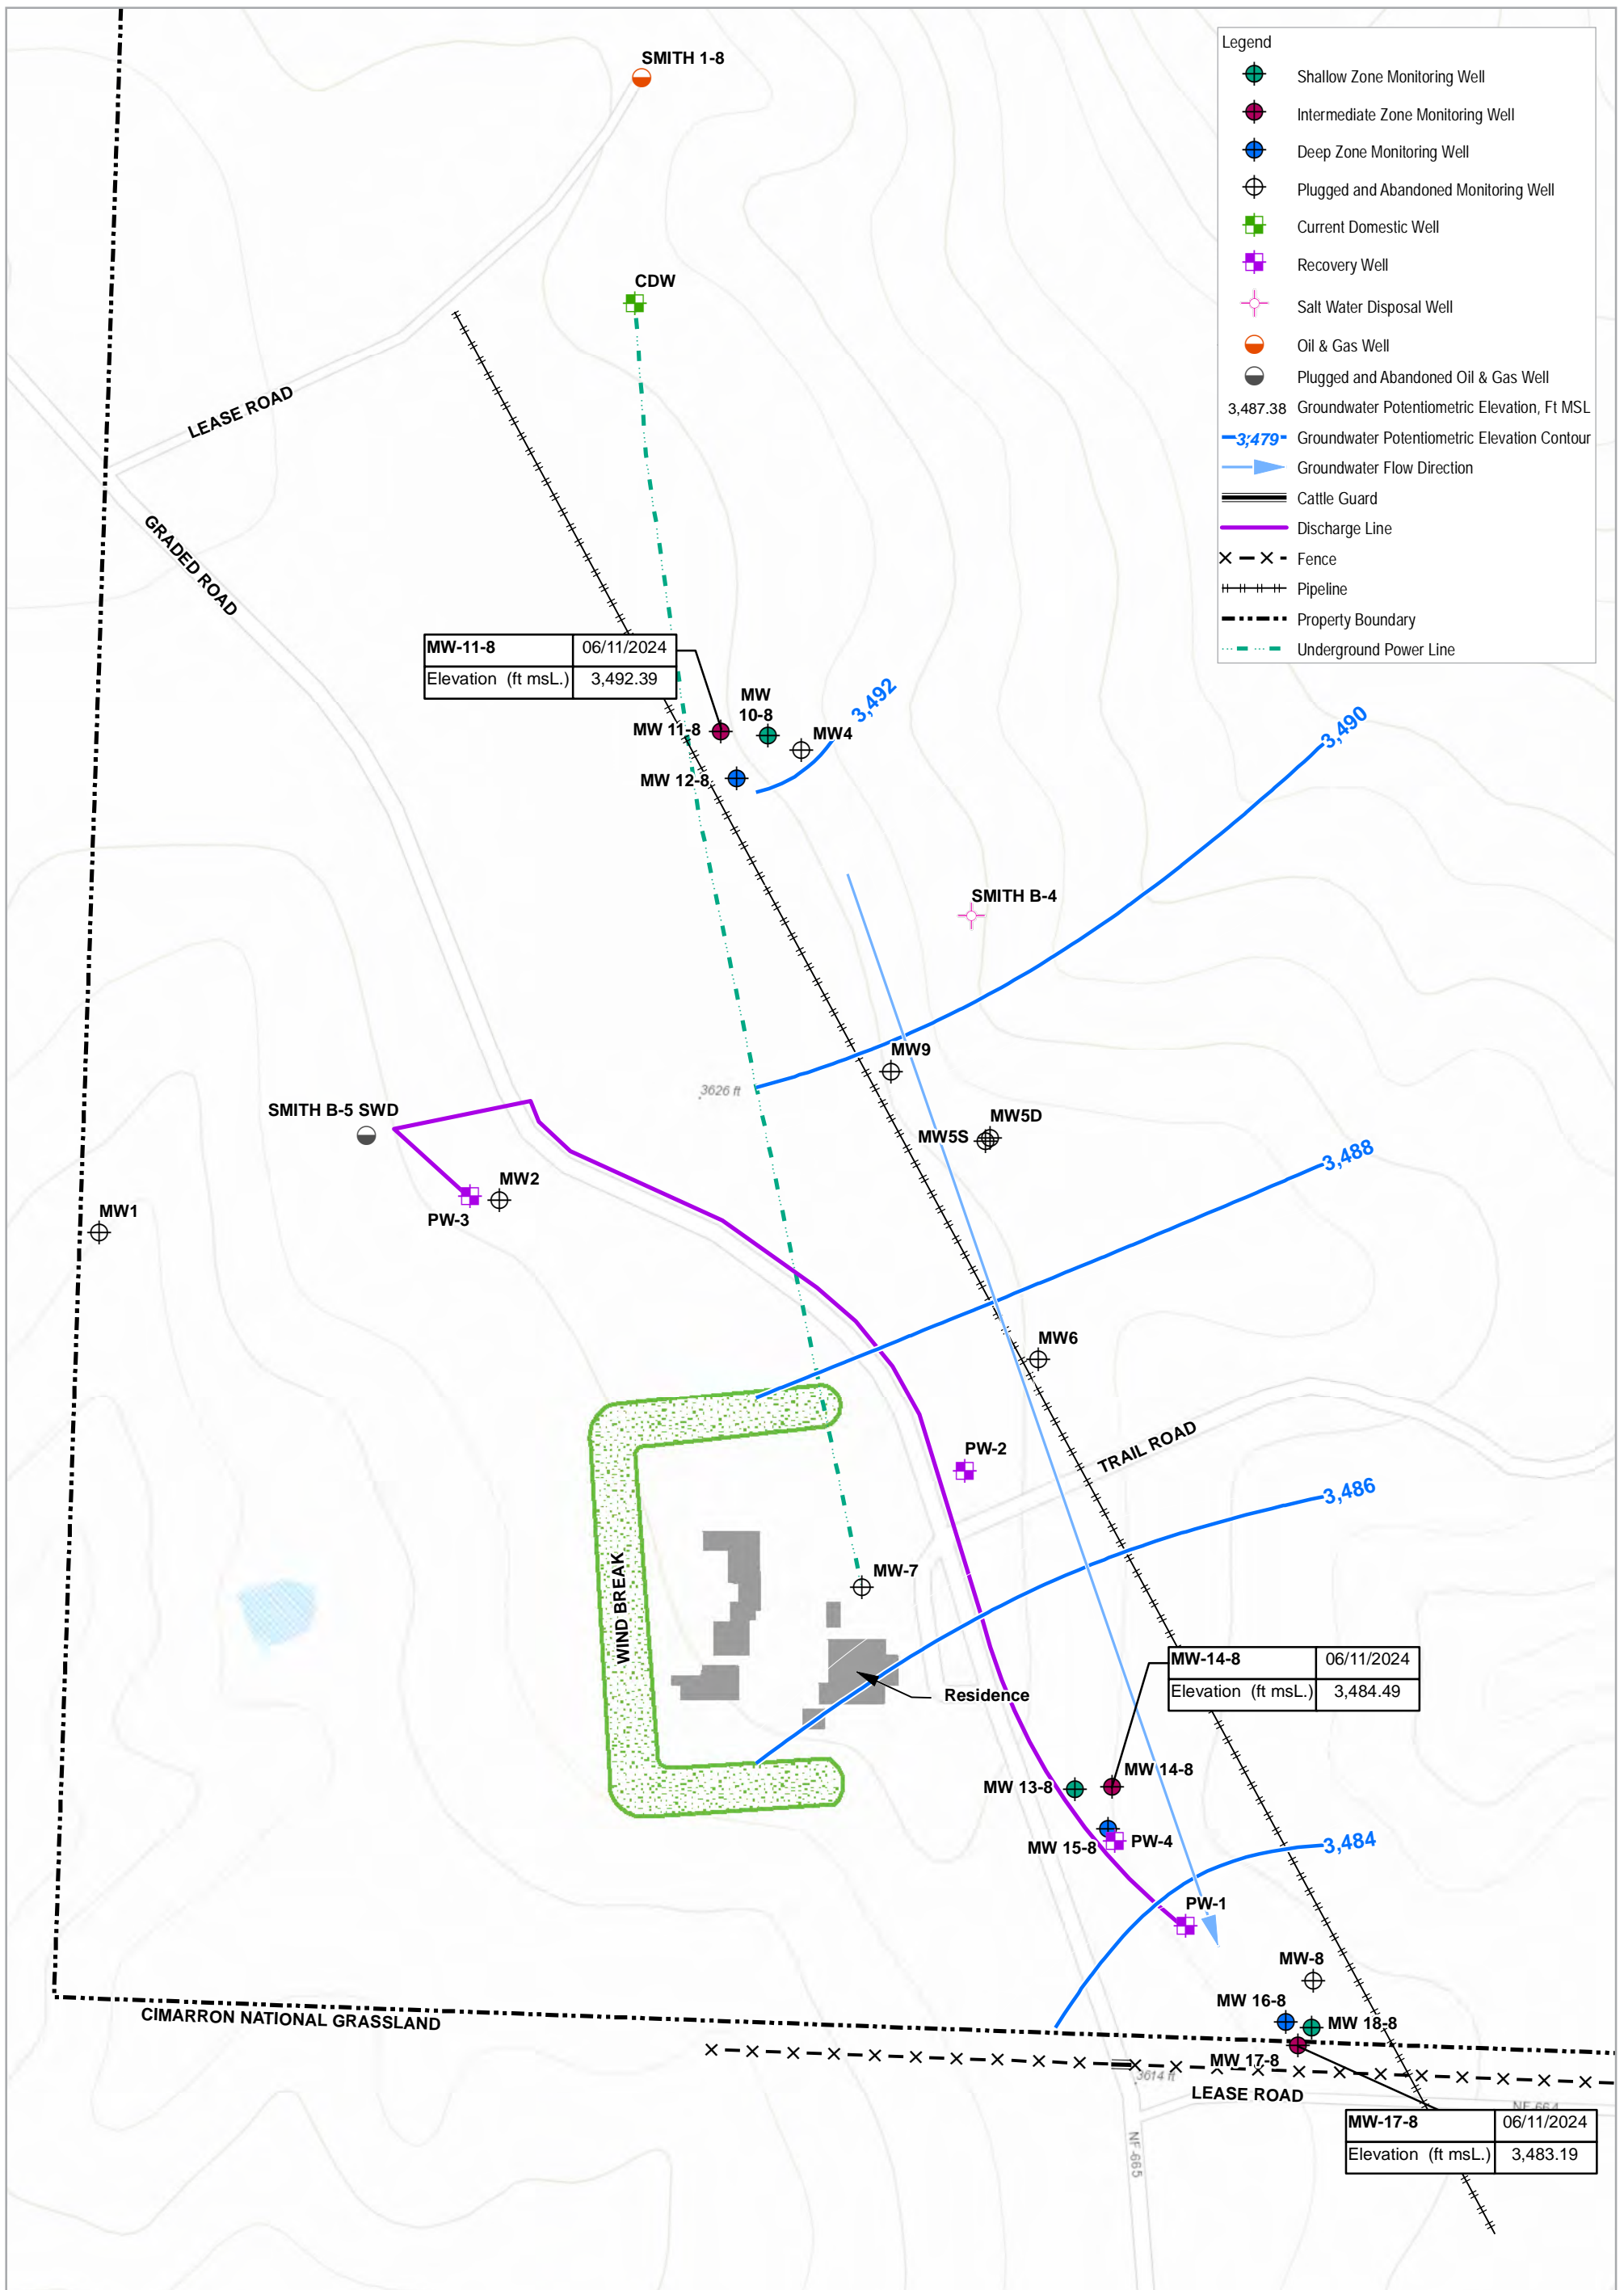
FIGURE 4

JUNE 2024 INTERMEDIATE WELL
GROUNDWATER POTENTIOMETRIC MAP

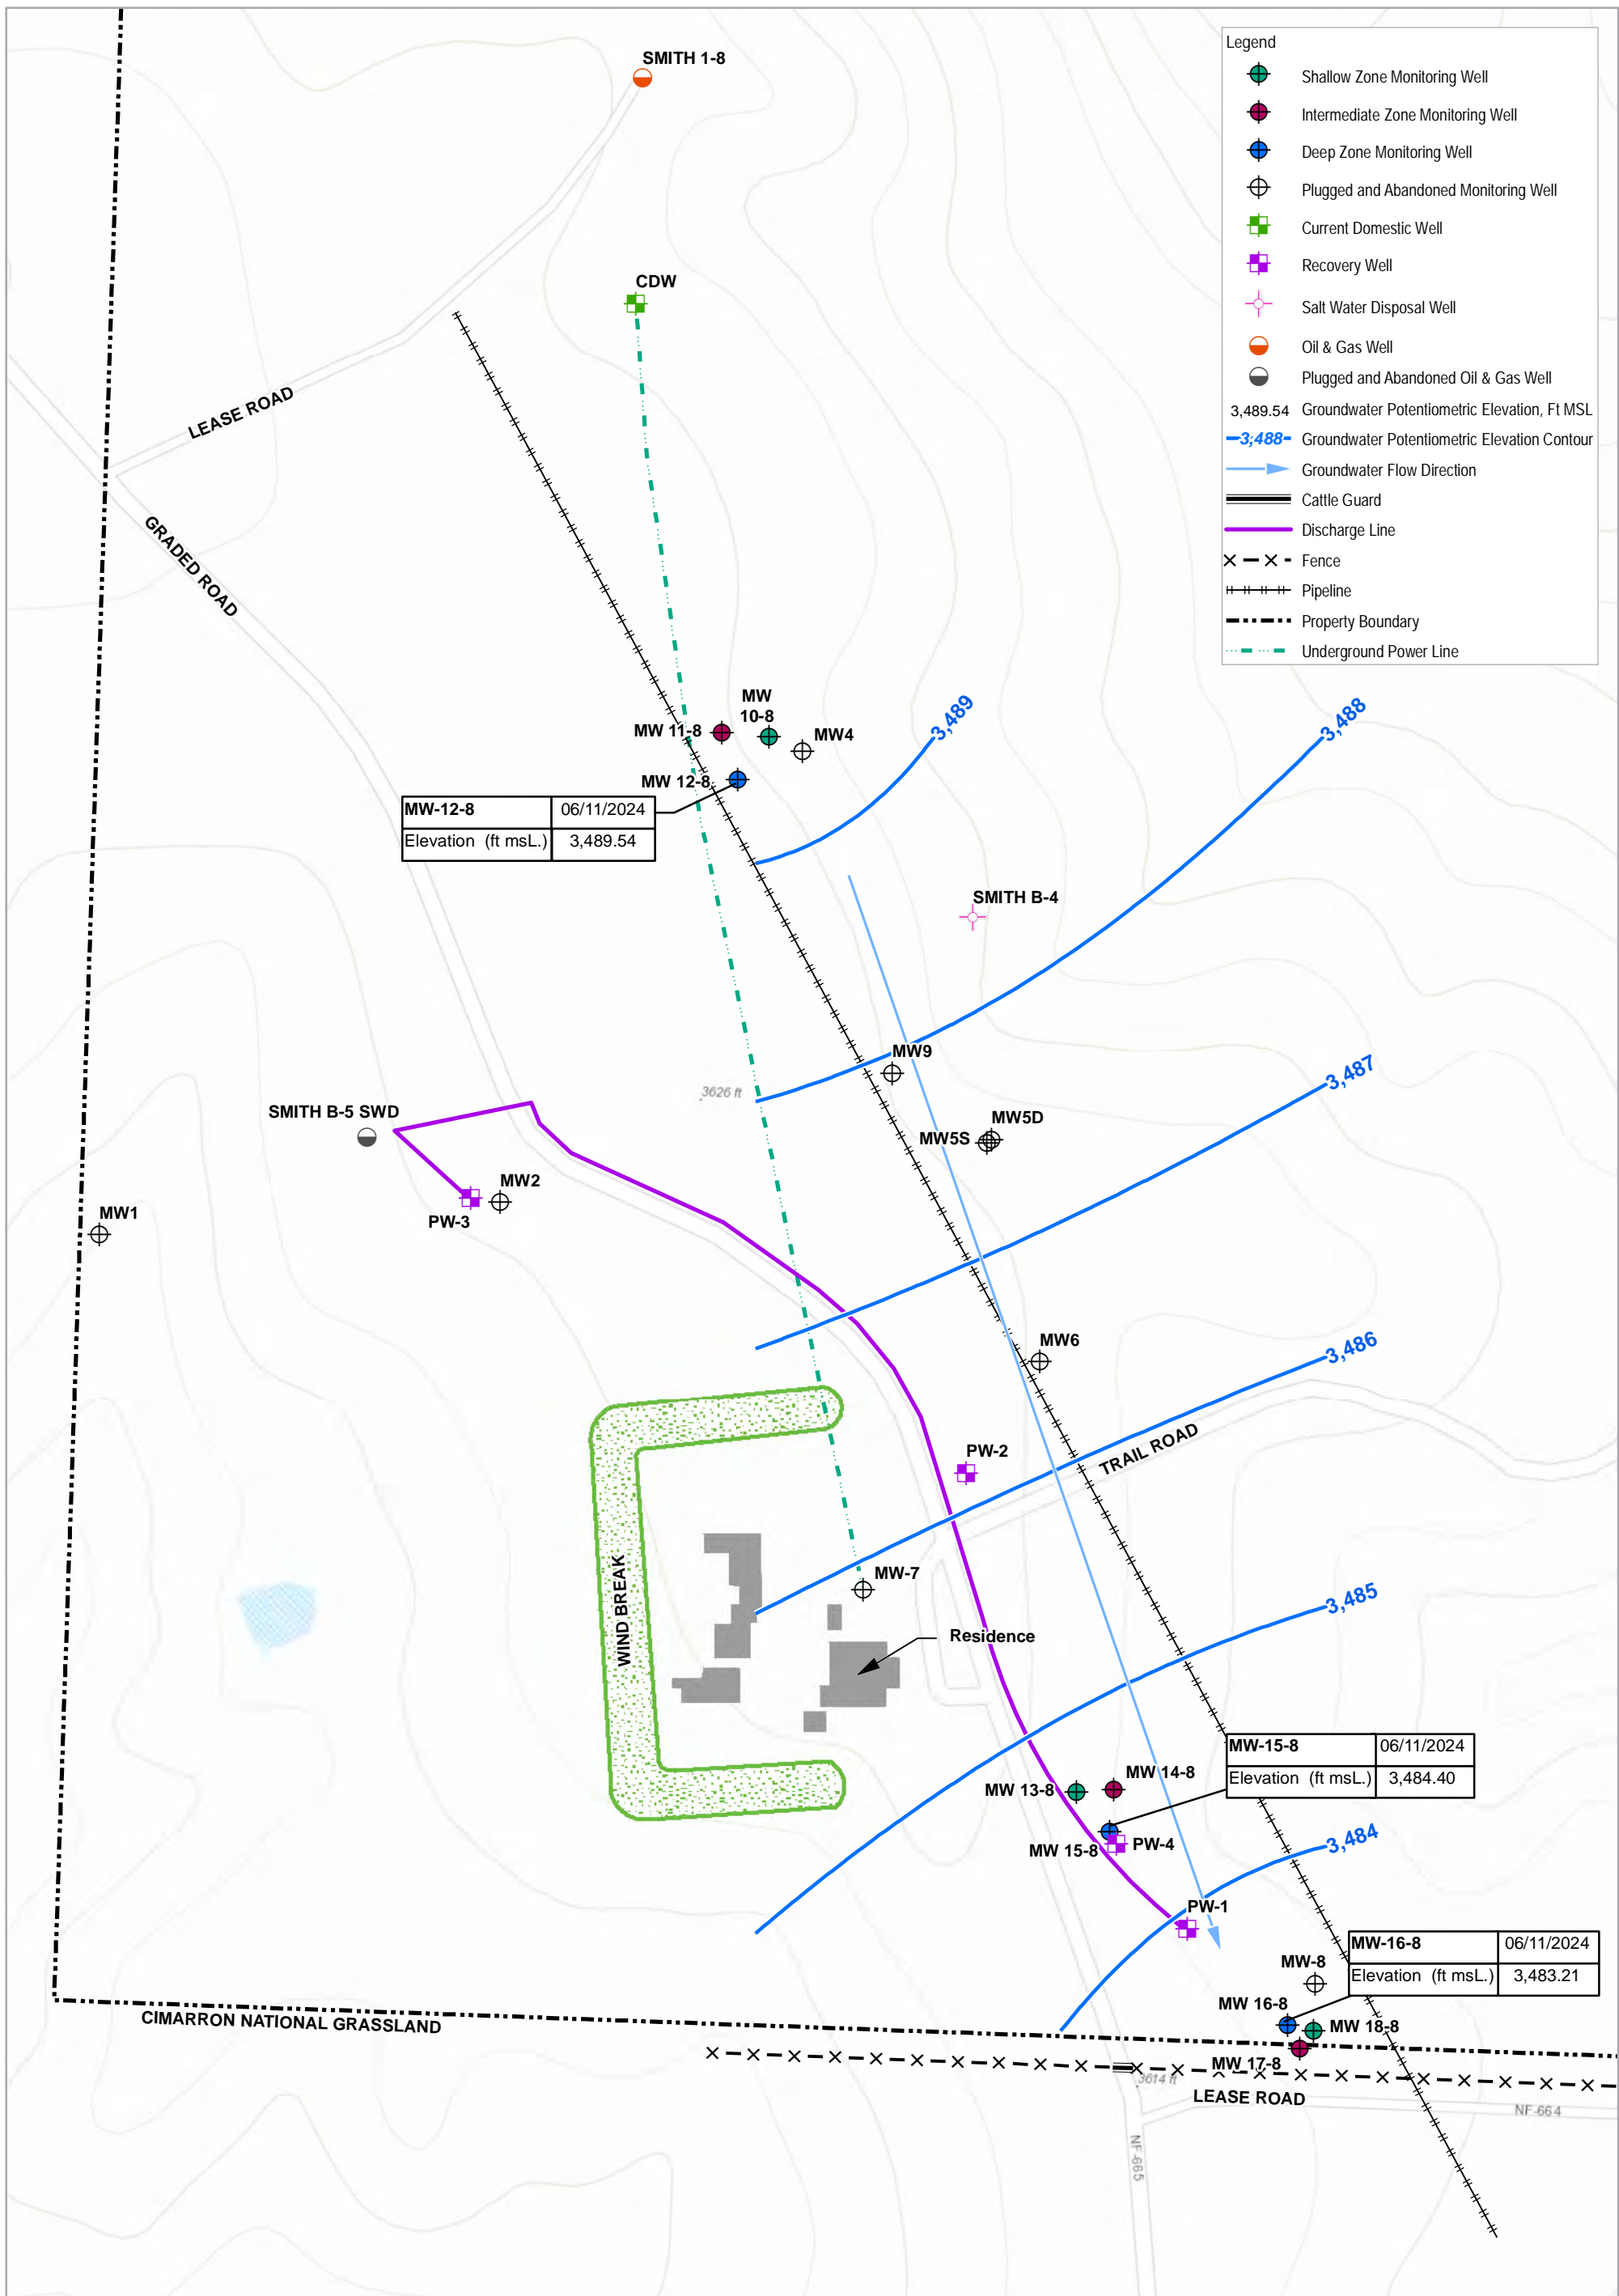
FIGURE 5

JUNE 2024 DEEP WELL
 POTENTIOMETRIC MAP
