2025

**OIL AND GAS
REMEDIATION SITE STATUS**

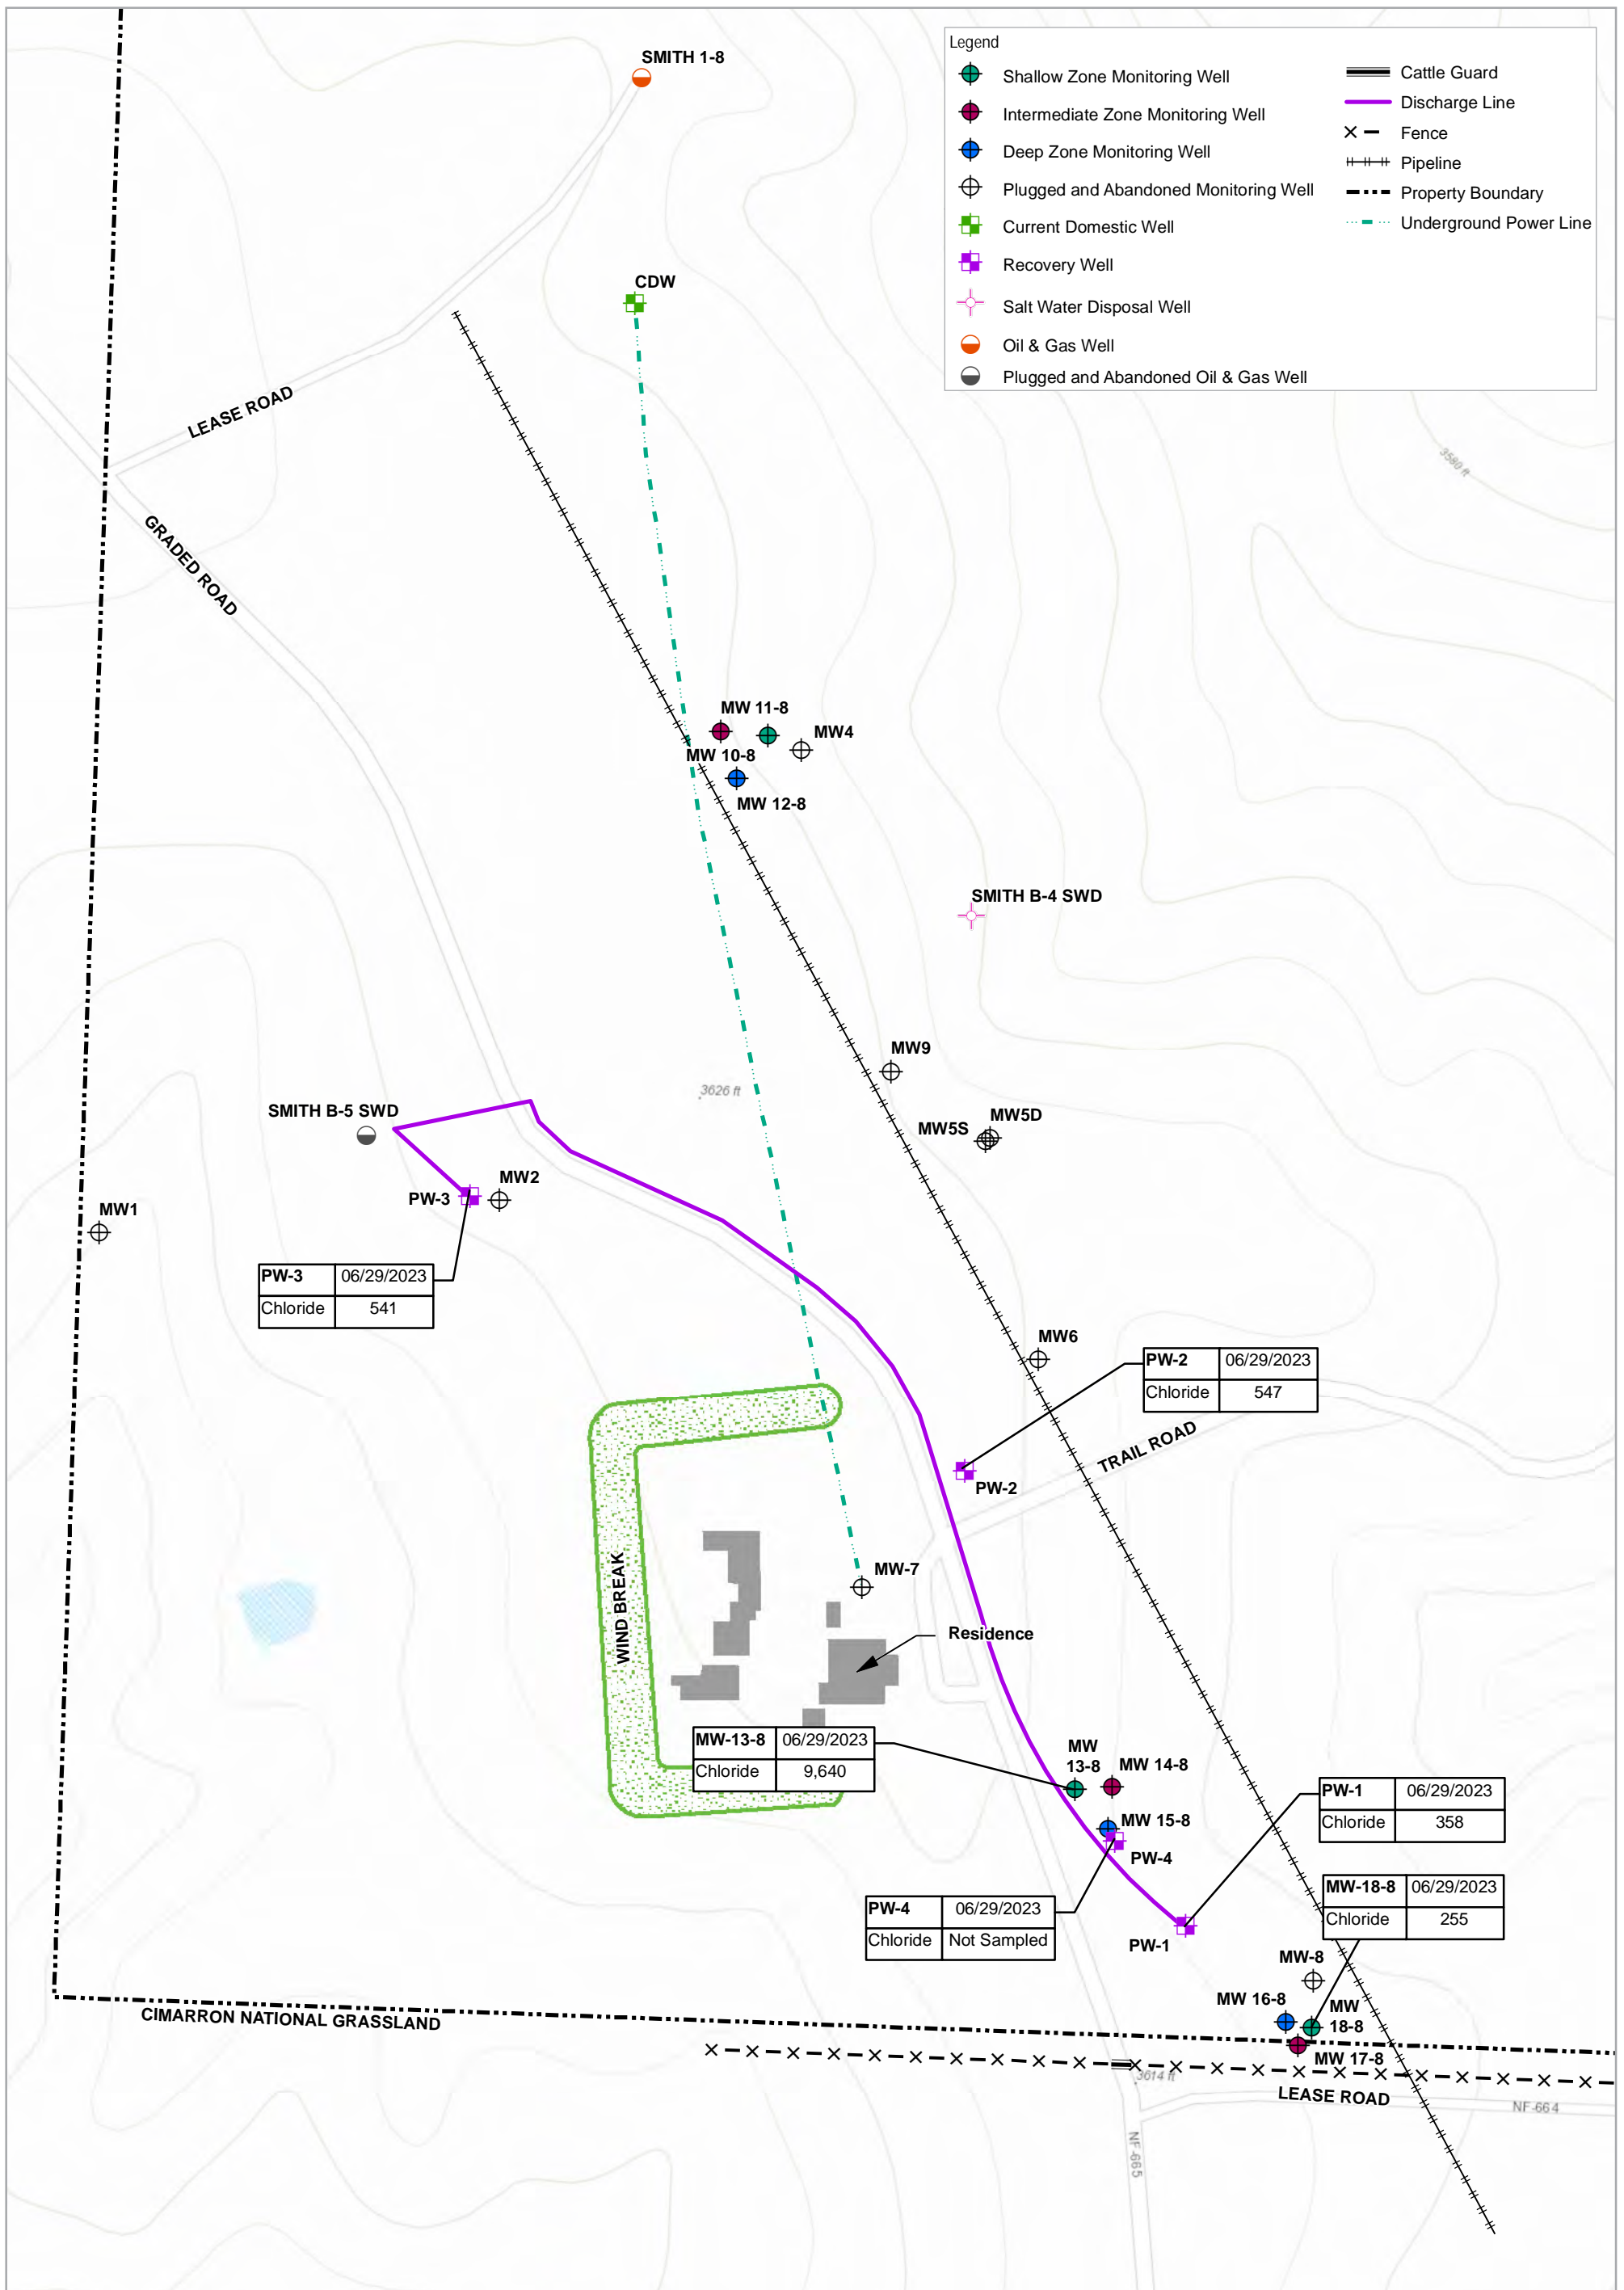
FIGURE 6

MERIT ENERGY COMPANY, LLC
SMITH-FINN
ELKHART, KANSAS
JUNE 2024 CHLORIDE
ISOCONCENTRATION MAP
FOR SHALLOW WELLS

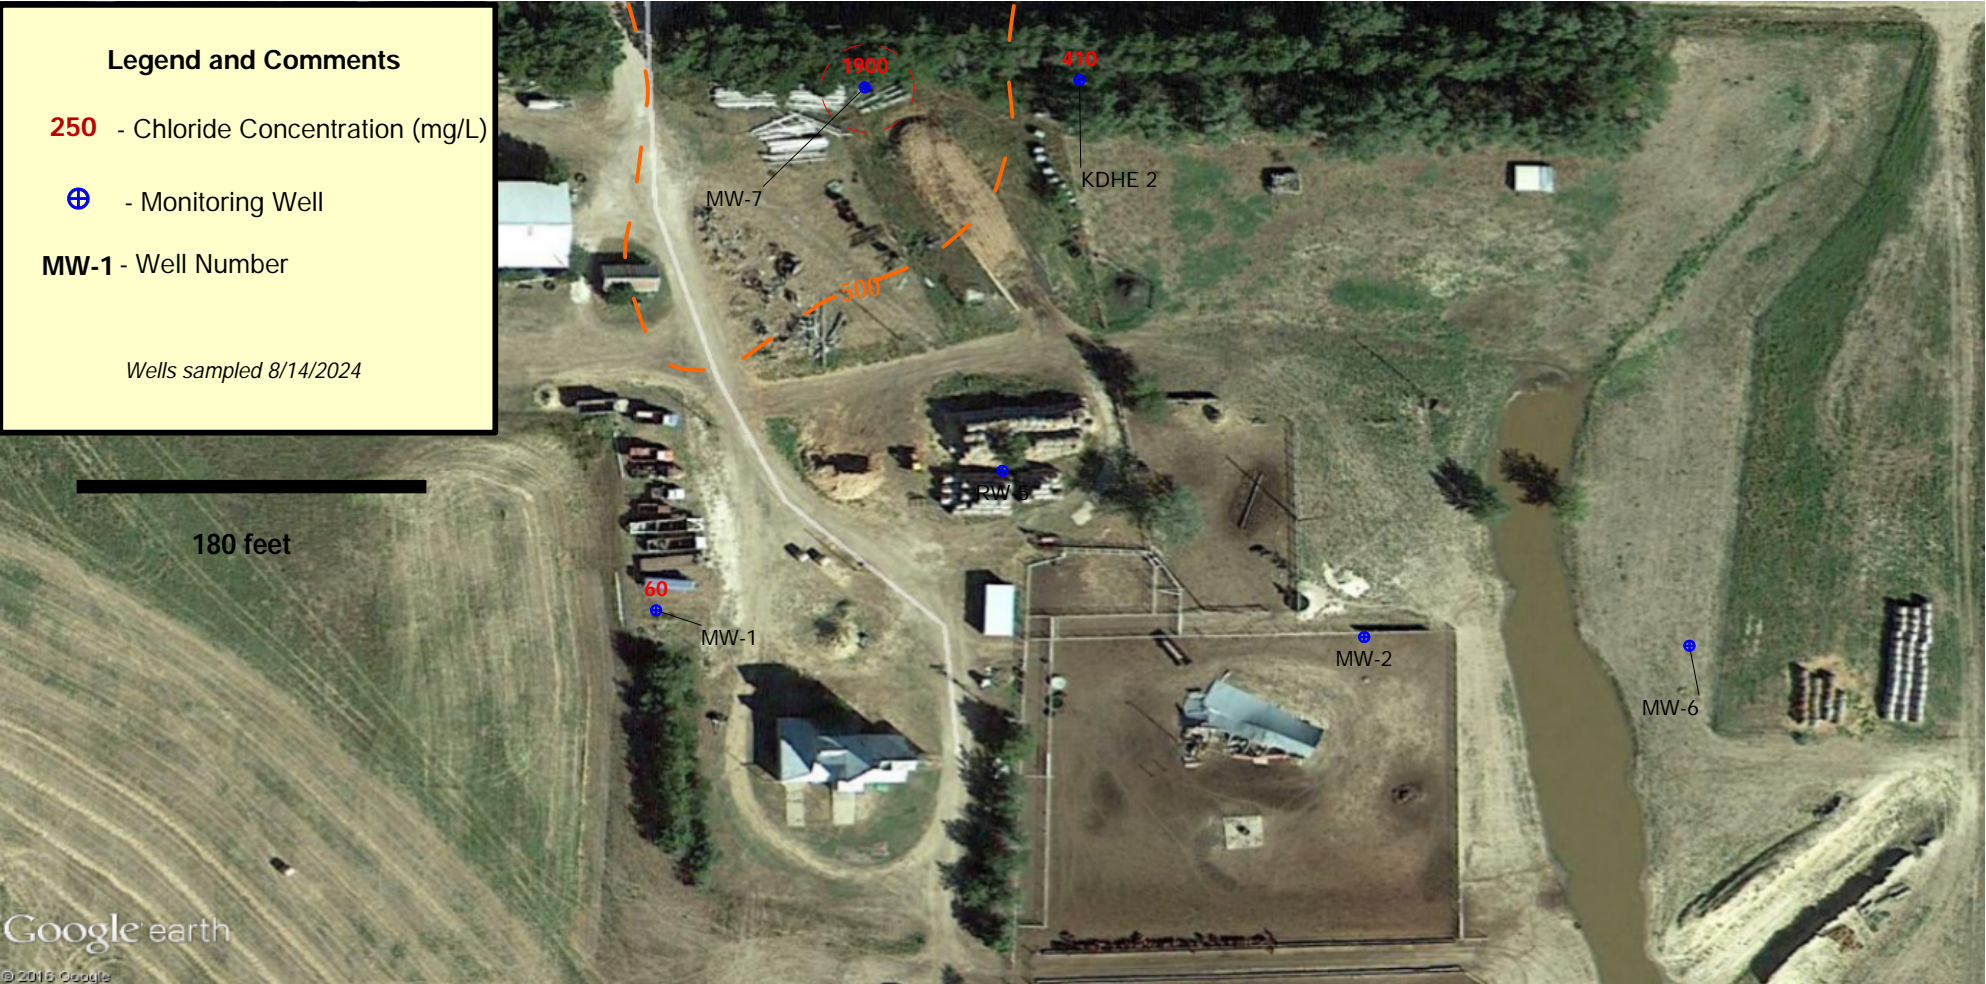
Enoch Thompson Site

Section 17-T21S-R20W
Pawnee County, Kansas

Recommendations for Future Work: Chlorides, overall, have been stable for several years. Since none of the wells that currently remain are above the usable water standards, it is recommended to begin plugging all of the wells at the site, starting with wells in the southwest quarter, and working back towards the fleeting plume. The feasibility of purchasing a new pump to drain the pond will be considered. The site should also continue to be surveyed on an annual basis to track the current rate of subsidence.

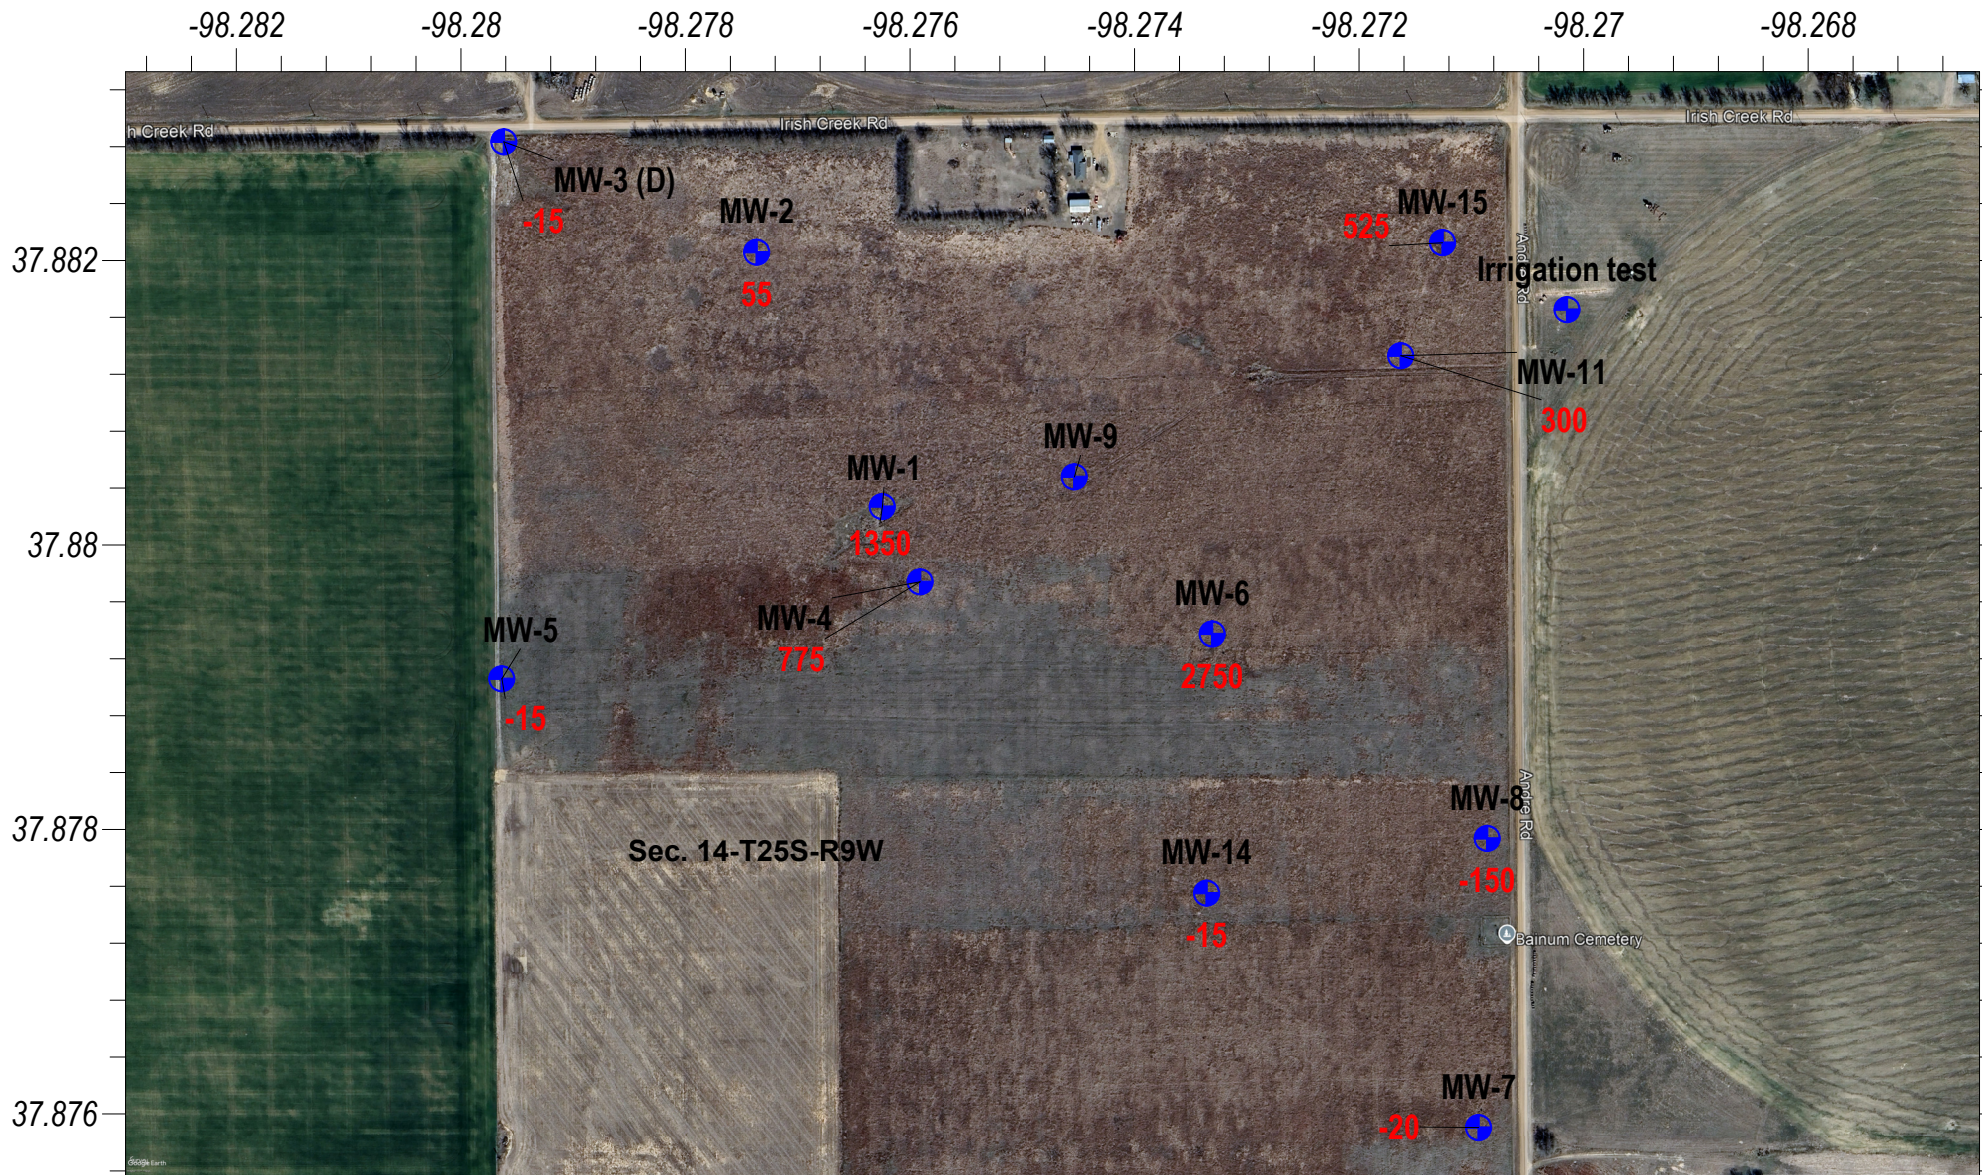
Arlington Contamination Site
 Section 14 of Township 25 South and Range 9 West, Reno County, Kansas
Chloride Change from 2023 to 2024
 KCC Project Code #20030016-001 - KCC District #2 Field Office
 Wells Sampled on 9/17/2024 - Map Drawn on 10/11/2024 by D Bollenback

Control No.	Staff Hours/Expenditures	Fund Expenditures	
		FY 2024/25	Total
20030016-001	21.5 Hrs. / \$797.39		
Current Contaminate Level: 10,000 mg/l in MW-6			
<input type="checkbox"/> 1. Site Assessment	<input type="checkbox"/> 2. Short Term Monitoring	<input type="checkbox"/> 3. Investigation	
<input checked="" type="checkbox"/> 4. Long Term Monitoring	<input type="checkbox"/> 5. Remediation Plan	<input type="checkbox"/> 6. Installation	
<input type="checkbox"/> 7. Remediation	<input type="checkbox"/> 8. Post Rem. Monitoring	<input type="checkbox"/> 9. Resolved

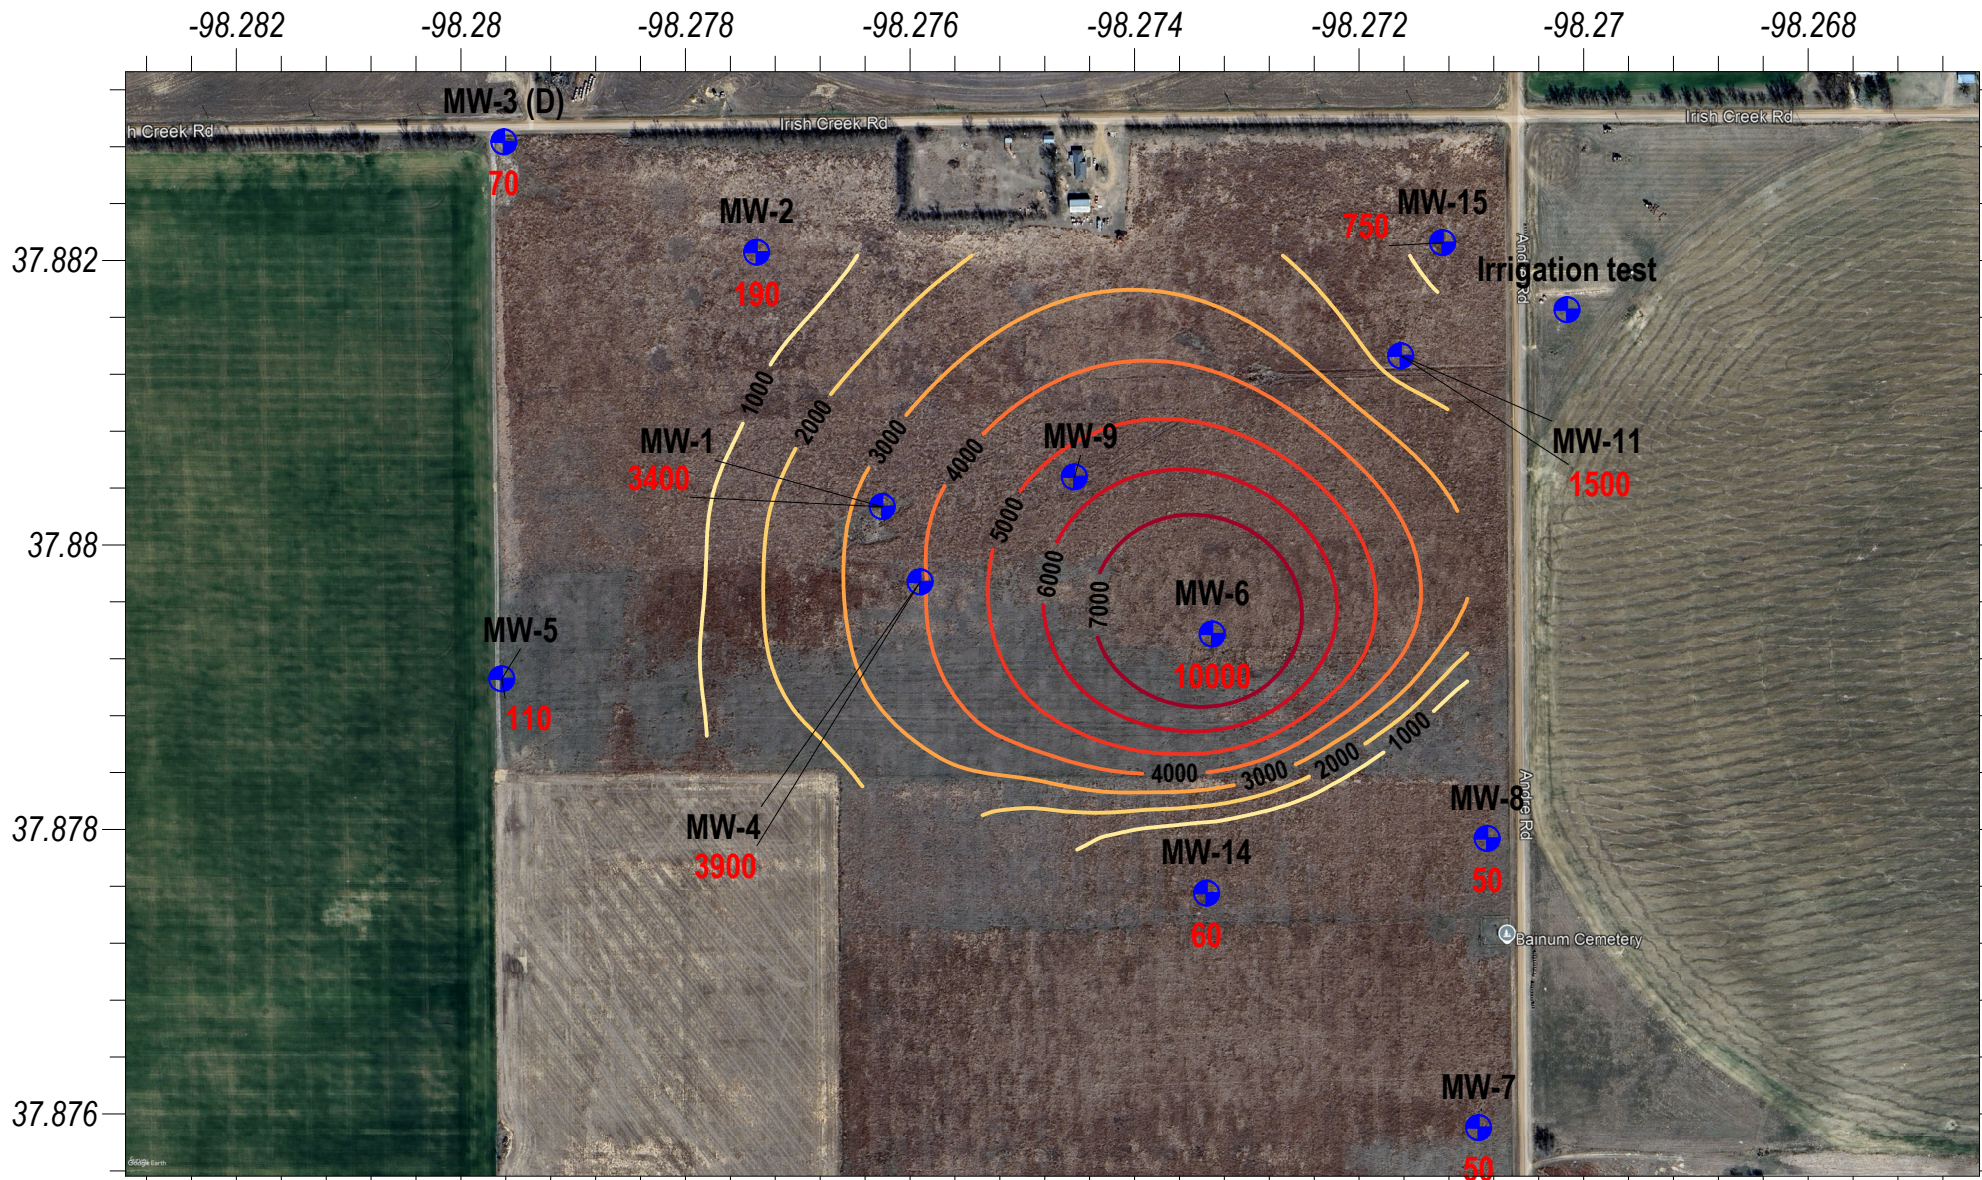
Impact/Immediacy: There are impacts on soil and groundwater locally due to a massive saltwater line leak in August 2000. Initially, the spill impacted irrigation wells in the SE/4 of Section 11 and a domestic well on the lease in late 2001. As a result, The PRP relocated the domestic well north of section 14. In addition, the irrigation well in Section 11 was taken out of use for several seasons, allowing the saltwater plume to migrate back to the southeast, where a remediation system was installed in the NE/4 of Section 14. KCC lists that this site has a moderate immediacy level.

chloride areas. With all active brine sources, i.e., lines, wells, etc., abandoned in section 14, KCC does not believe a new source or release exists. Low water levels and settling brine combined with bedrock traps may have caused the recent increase in chloride. All delineating wells to the north of the site have been destroyed or plugged over the years.

Recommendation for Future Work: As remedial efforts have stopped, some older recovery wells could be plugged by the PRP or used as monitoring wells. KCC recommends that the site be sampled biannually by the District #2 Office in 2025 and that Rama Operating Company be informed of any plume movement offsite. The irrigation wells in the northeast corner of section 13 should be sampled before the irrigation season. Though the wells have been resurveyed, exposed wells become parted easily during sampling, making the correct top-of-casing location identification difficult for some wells. Standard PVC glues that lock the casings in place do not withstand exposure to the elements above ground. KCC may add screws or other methods to these casing joints so that connections are more secure and remove any confusion during future gauging of the surveyed top of the casing.

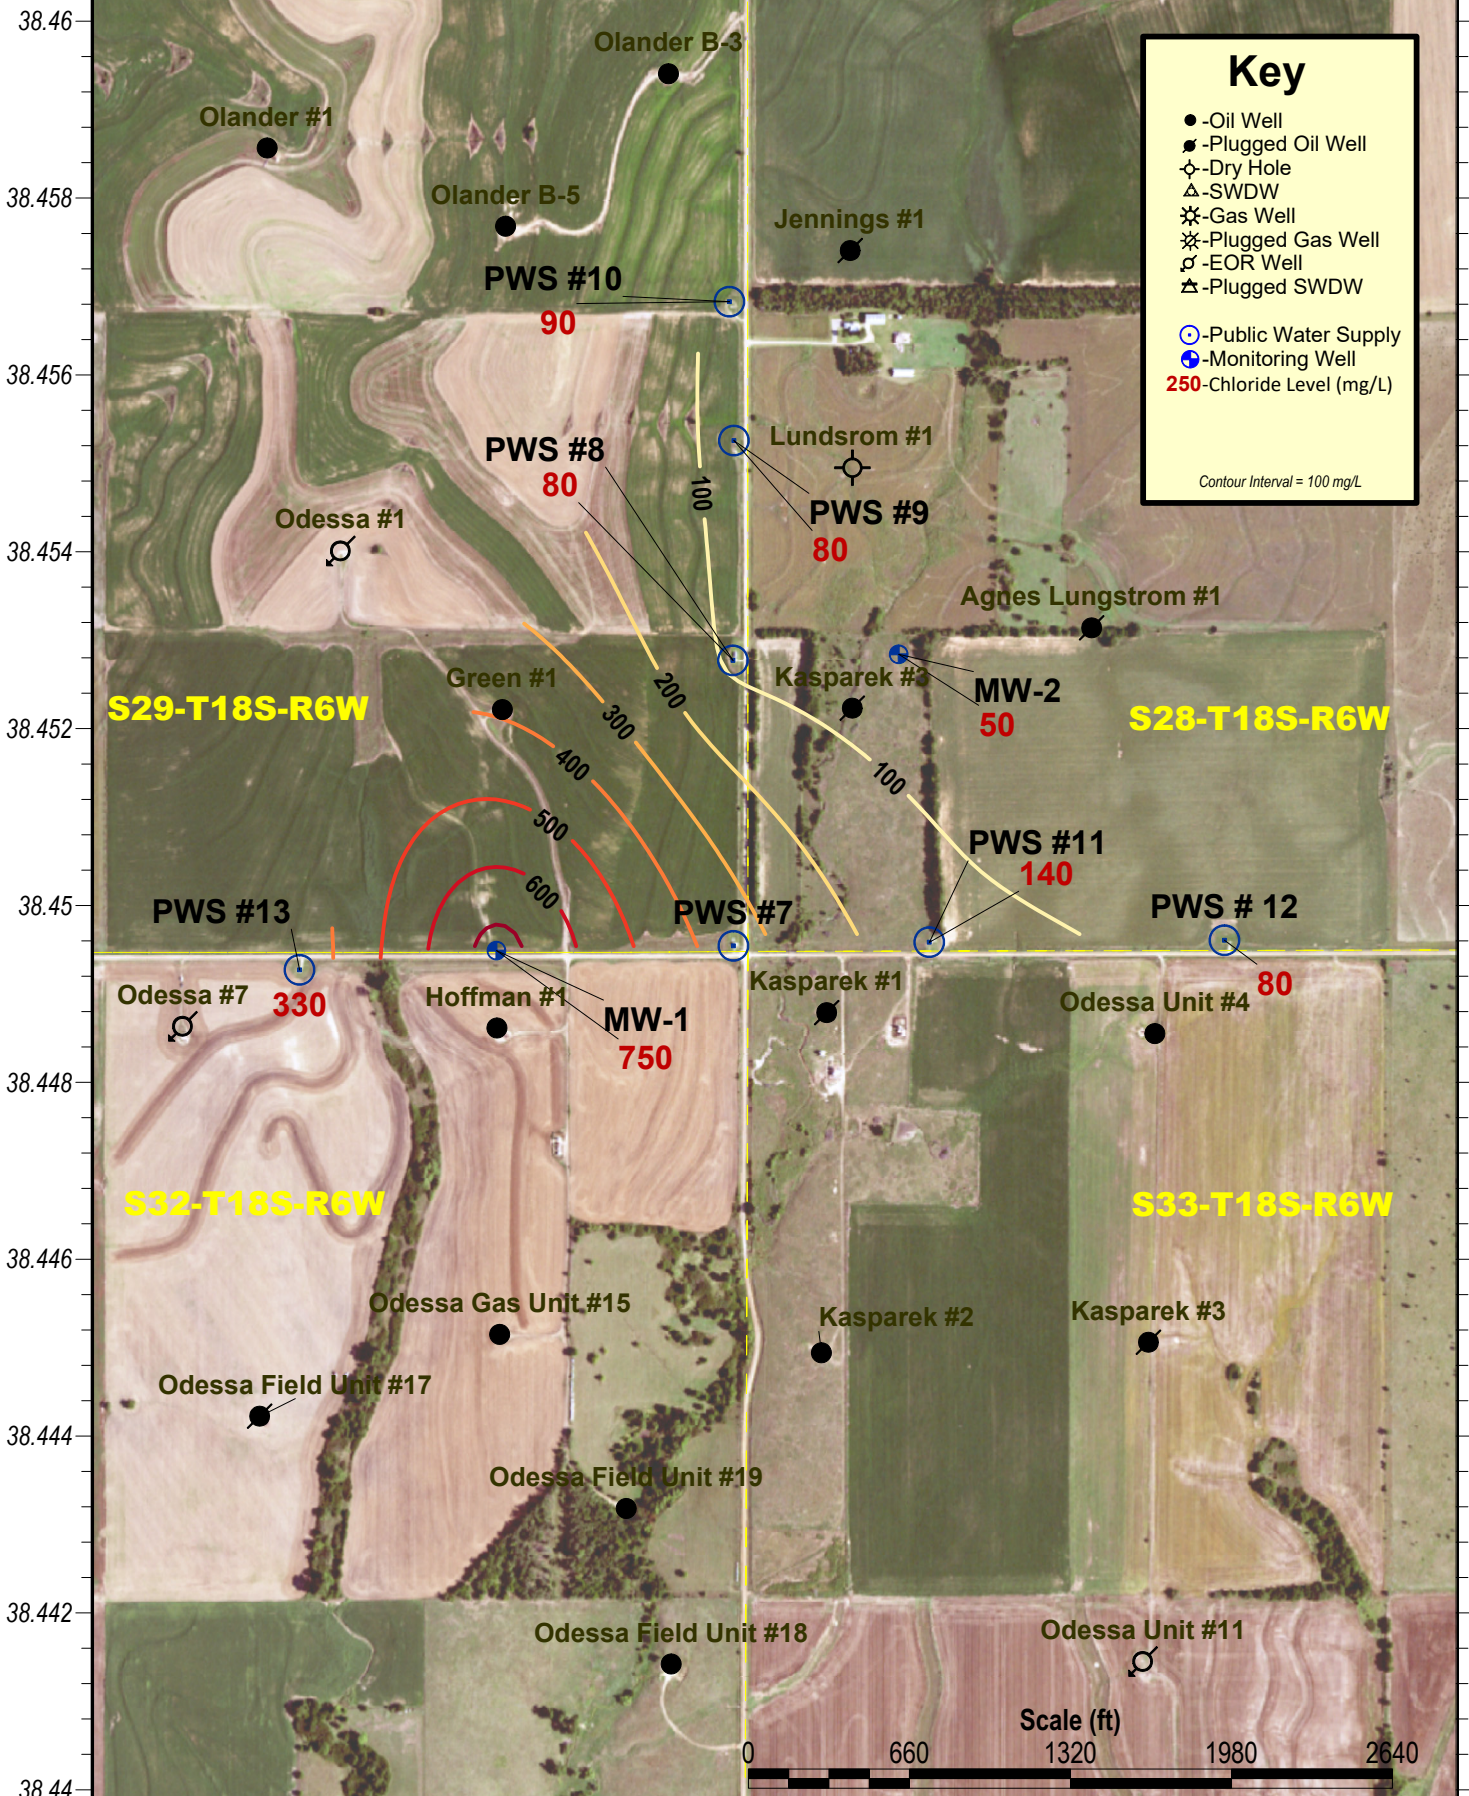
Site Description: The Little River water wellfield is part of the Odessa Oil Field. The groundwater table in this area is at a depth of thirty feet in the upper Kiowa Sandstone with an aquitard of a blue Kiowa Shale at fifty to sixty feet. Groundwater moves slowly toward the south-southeast. The source of the contamination may be old core soundings, spills, pits, or leaking lines.

Recommendation for Future Work: Due to the threat to the public water supply, KCC recommends annual sampling of the public water supply and monitoring wells for 2025. Remedial work is not economical as chlorides are too low for proper removal techniques, and the aquifer capacity dynamics are too low for recovery wells.

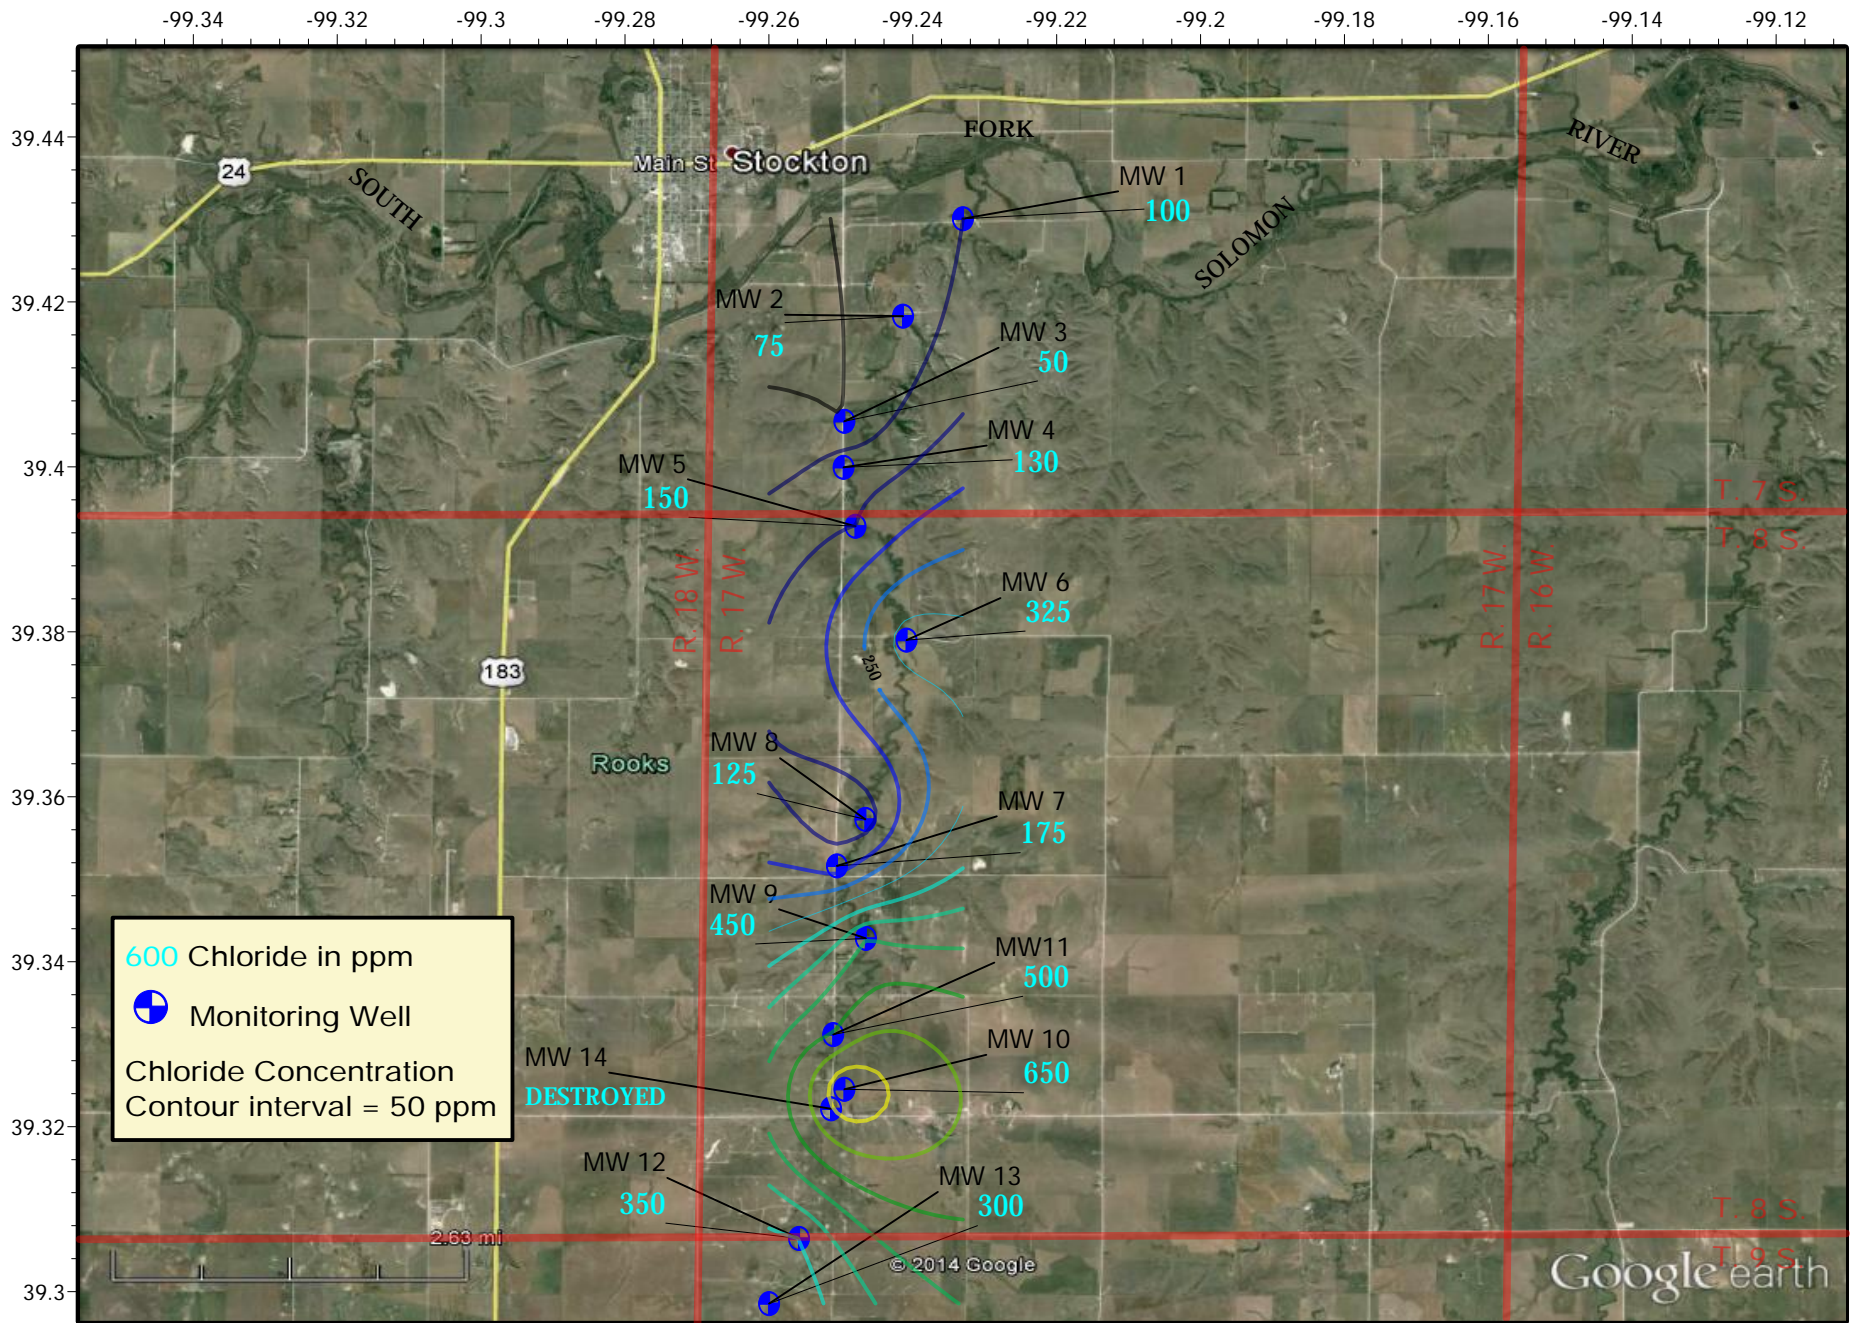
Elm Creek Groundwater Monitoring Site

Multiple Sections of Townships 7, 8, and 9 South, Range 17 West, Rooks County, Kansas
 2024 Groundwater Chloride Levels
 District #4 - Sampled 8/27/2024 and 8/28/2024 - Map Drawn on 10/14/2024 by C. Neeley

Recommendations for Future Work: While samples have been collected through existing wells, these do not meet quality control standards for groundwater sampling. A network of monitoring wells and exploratory test holes should be drilled at this site to delineate the extent of the pollution. The open wells will be pumped out on a periodic basis.

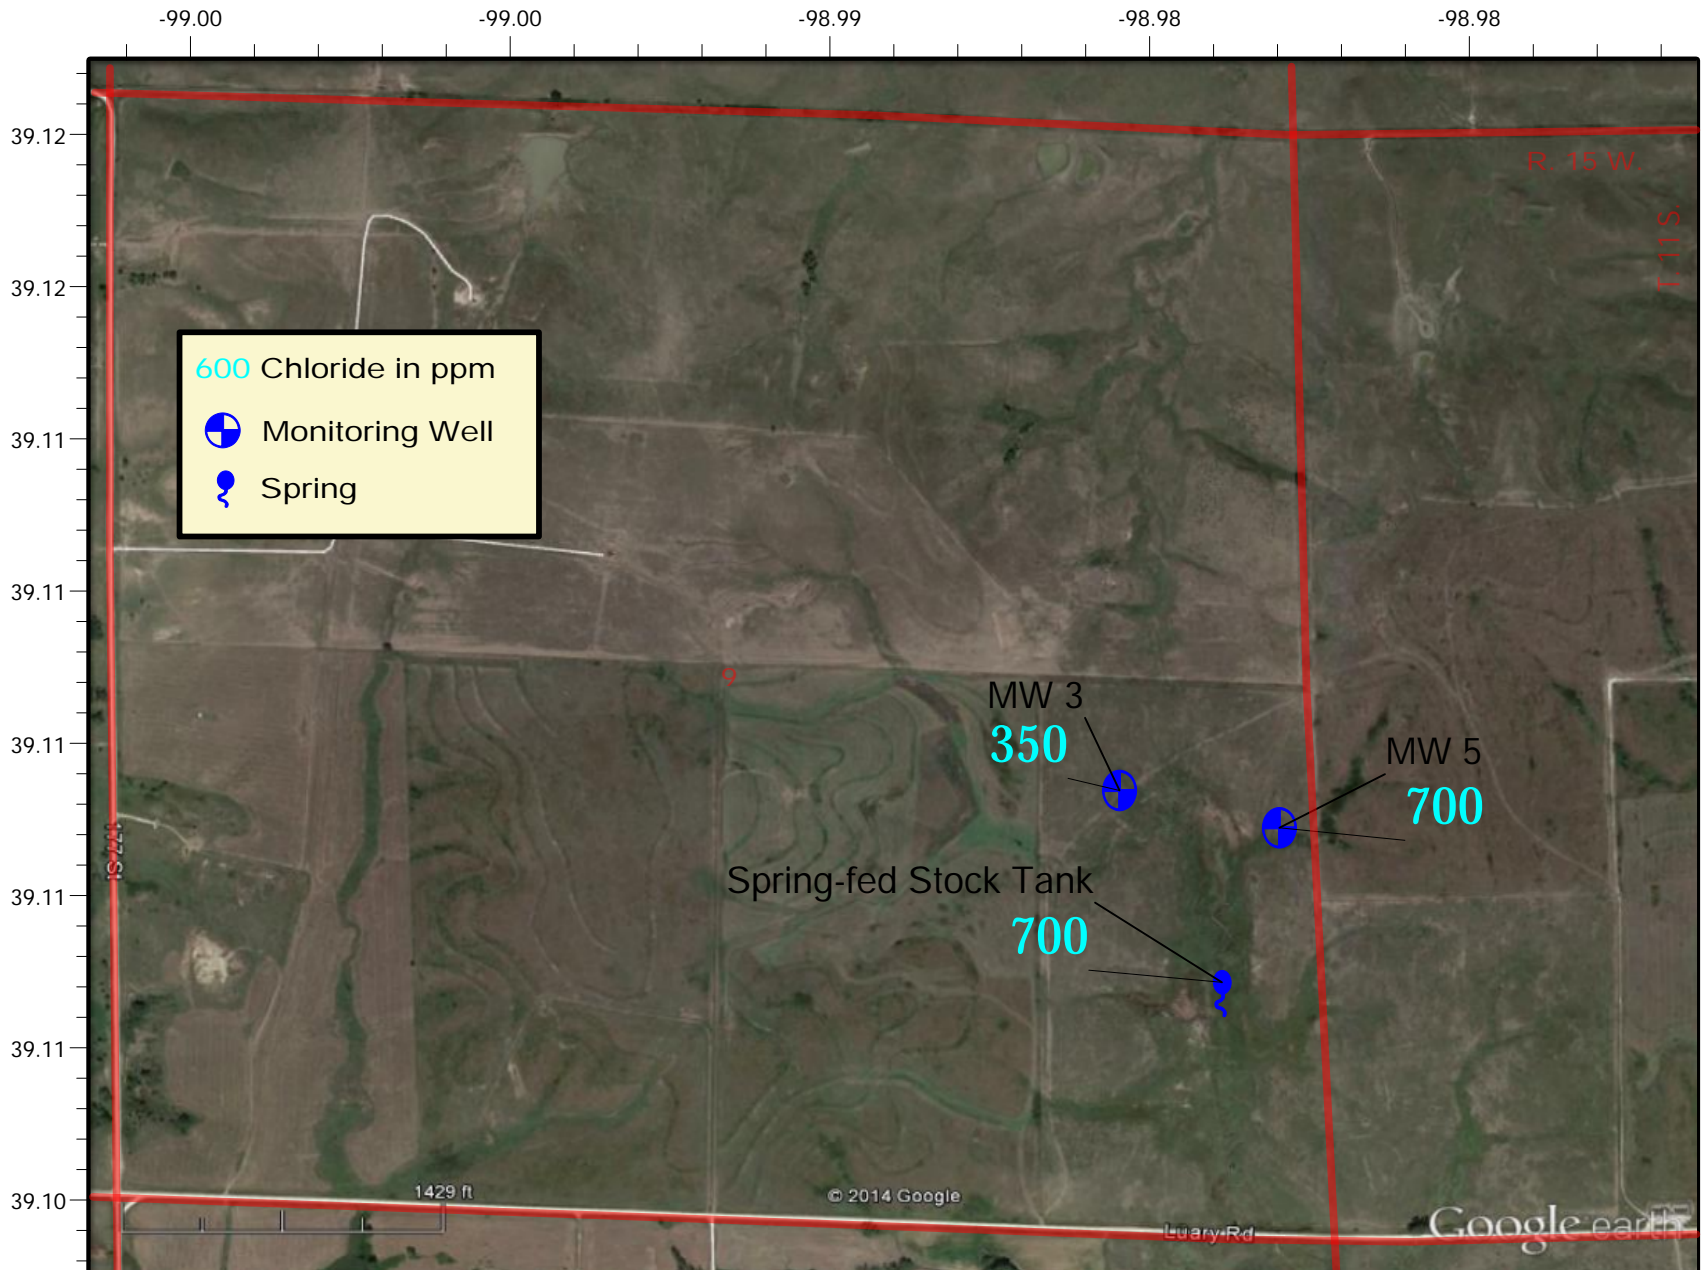
Maupin Groundwater Monitoring Site

Section 9, Township 11 South, Range 15 West, Russell County, Kansas

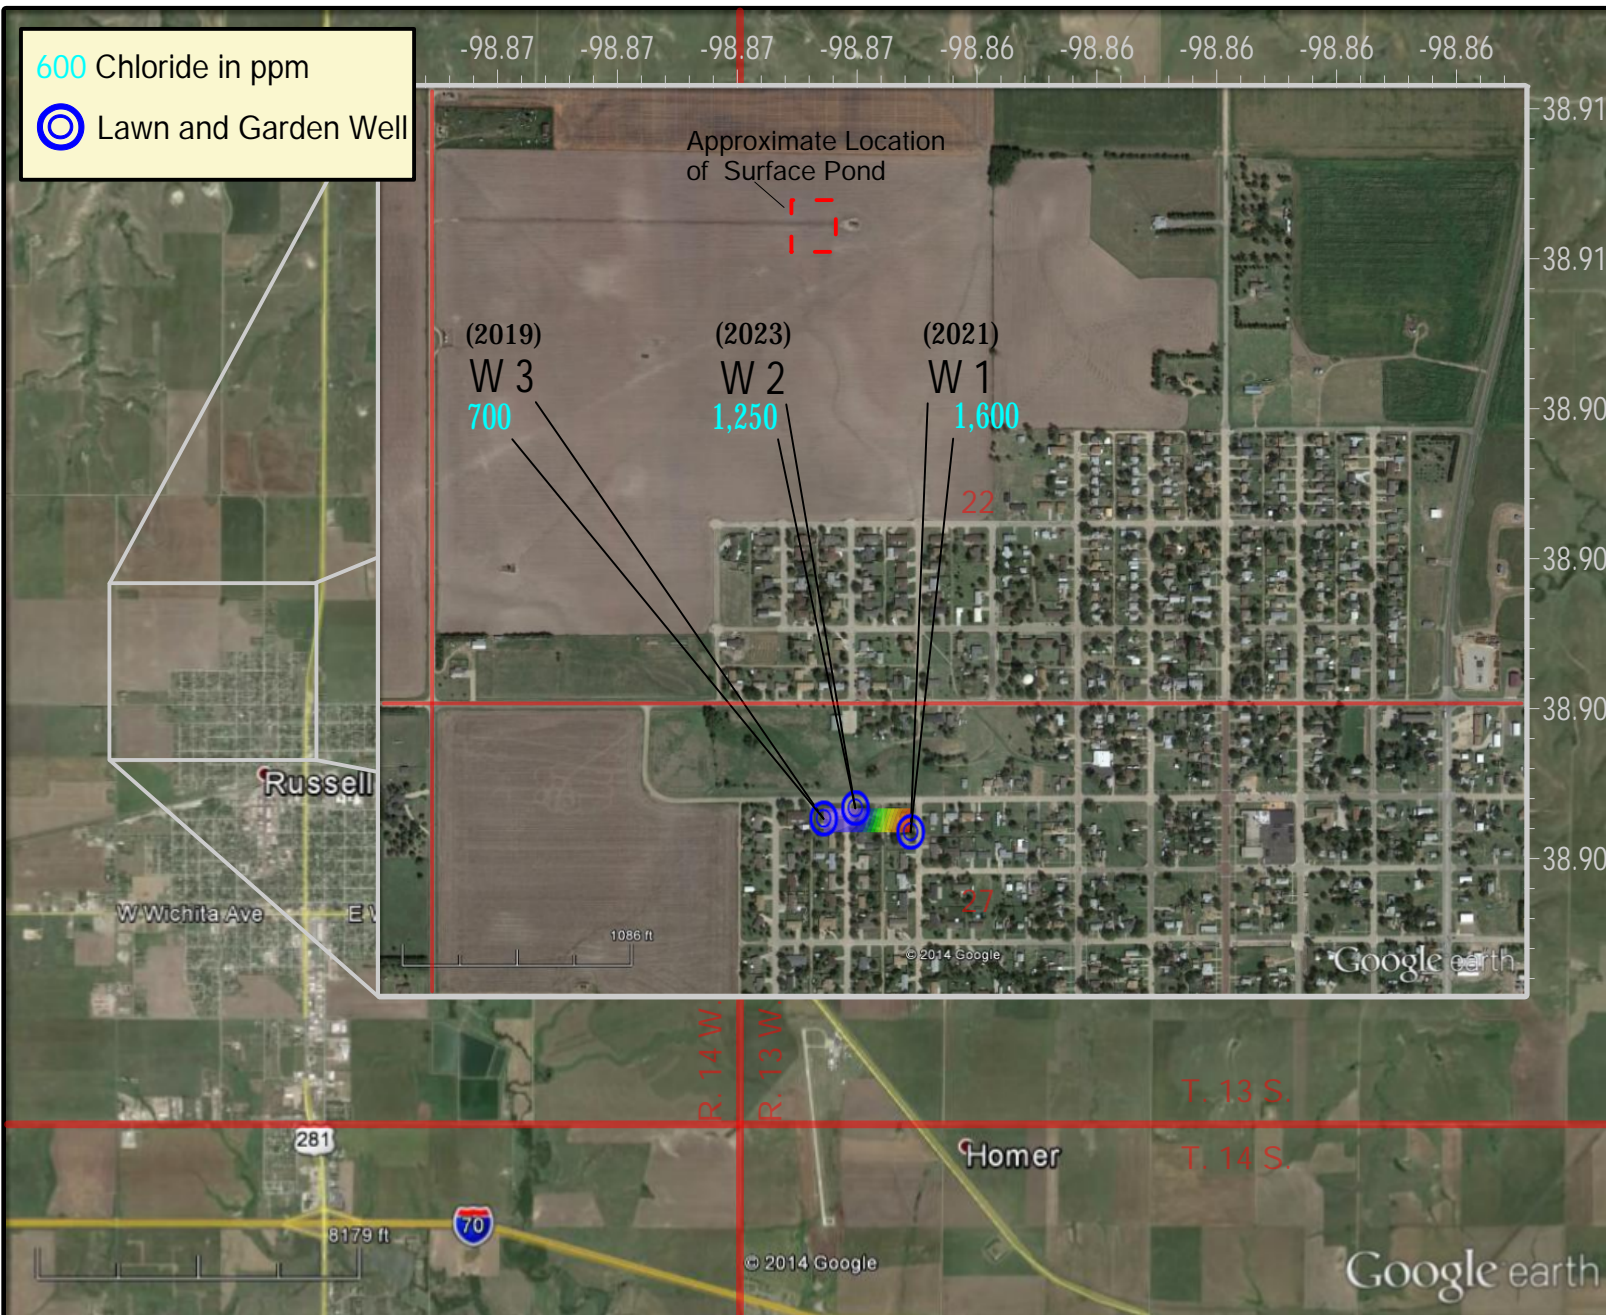
City of Russell Groundwater Monitoring Site

Sections 22 and 27, Township 13 South, Range 14 West, Russell County, Kansas
 2024 Contamination Site Update

Recommendations for Future Work: This site should be monitored on an annual basis.

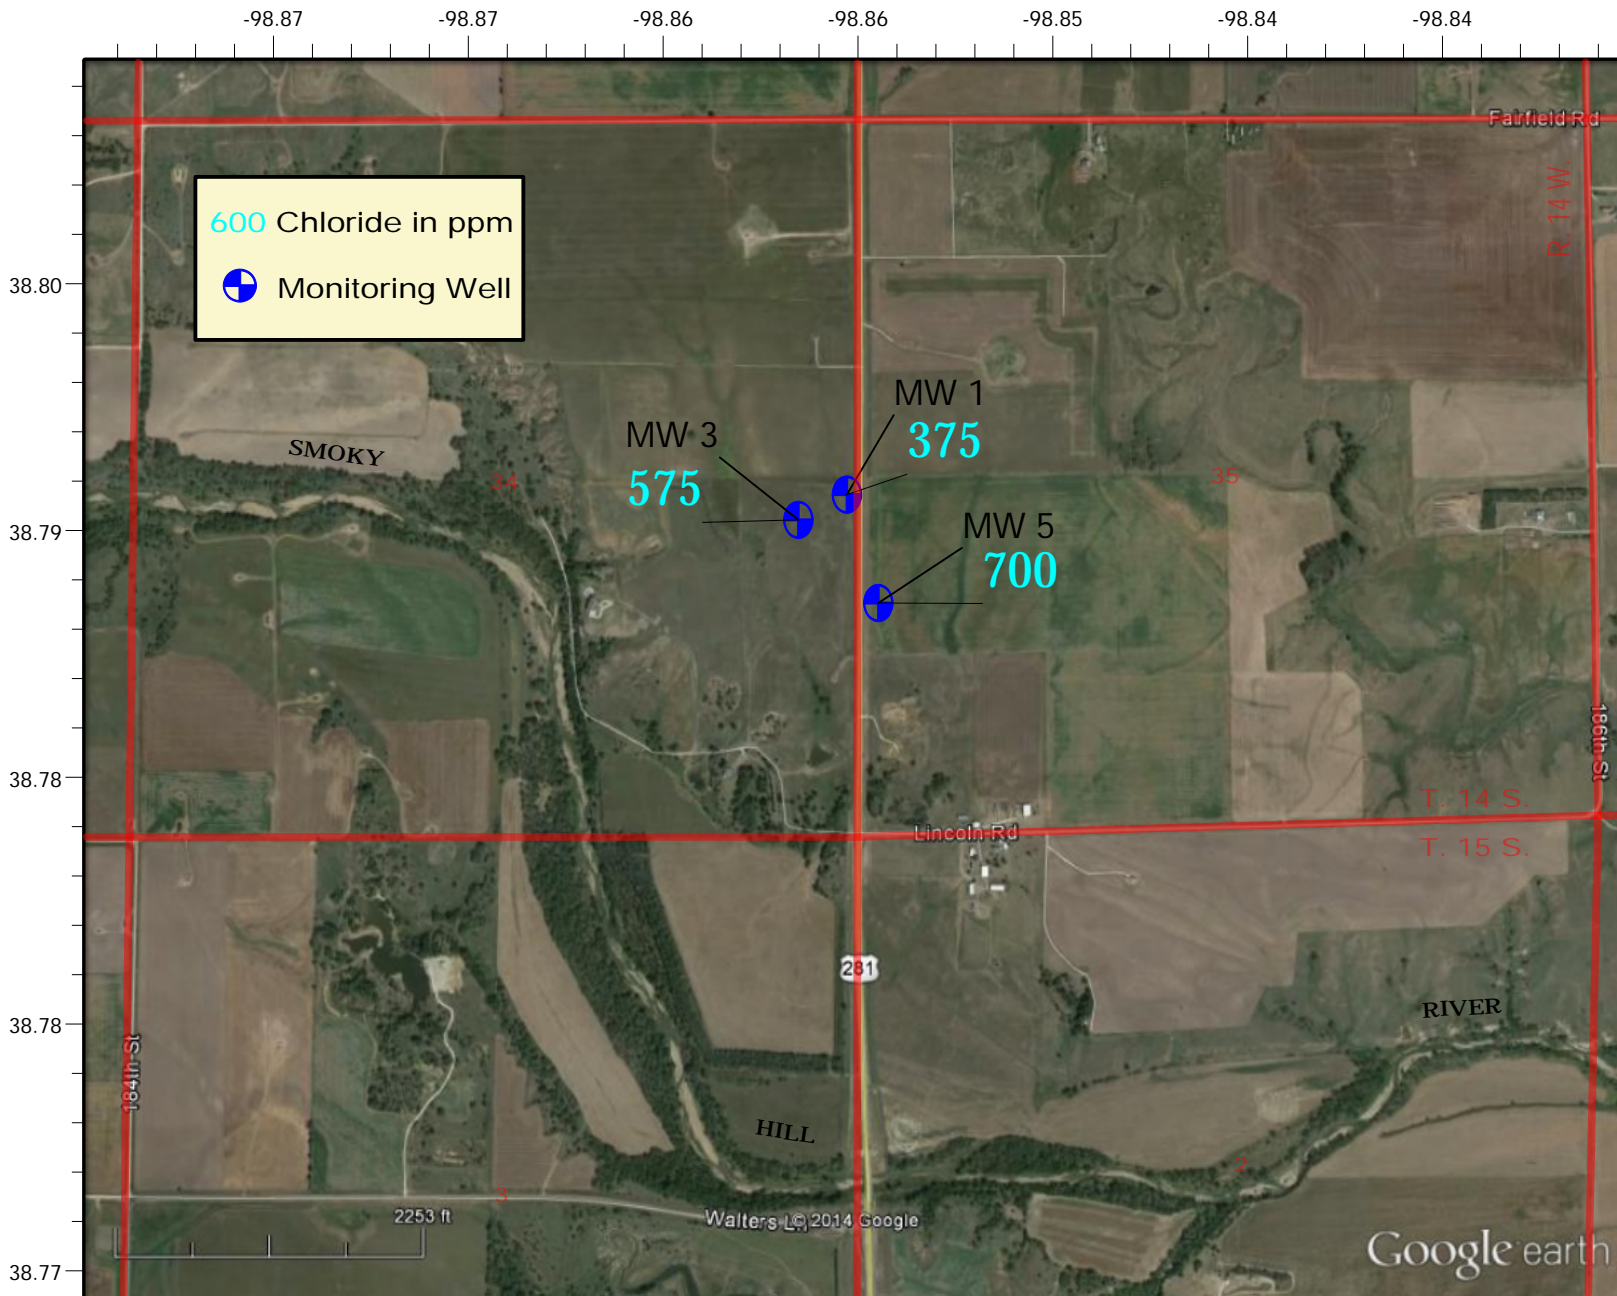
Russell Rural Water District #1 Groundwater Monitoring Site

Sections 34 and 35, Township 14 South, Range 14 West, Russell County, Kansas
 2024 Groundwater Chloride Levels

Recommendations for Future Work: Continue to monitor in the short term.
