2025

**OIL AND GAS
REMEDIATION SITE STATUS**

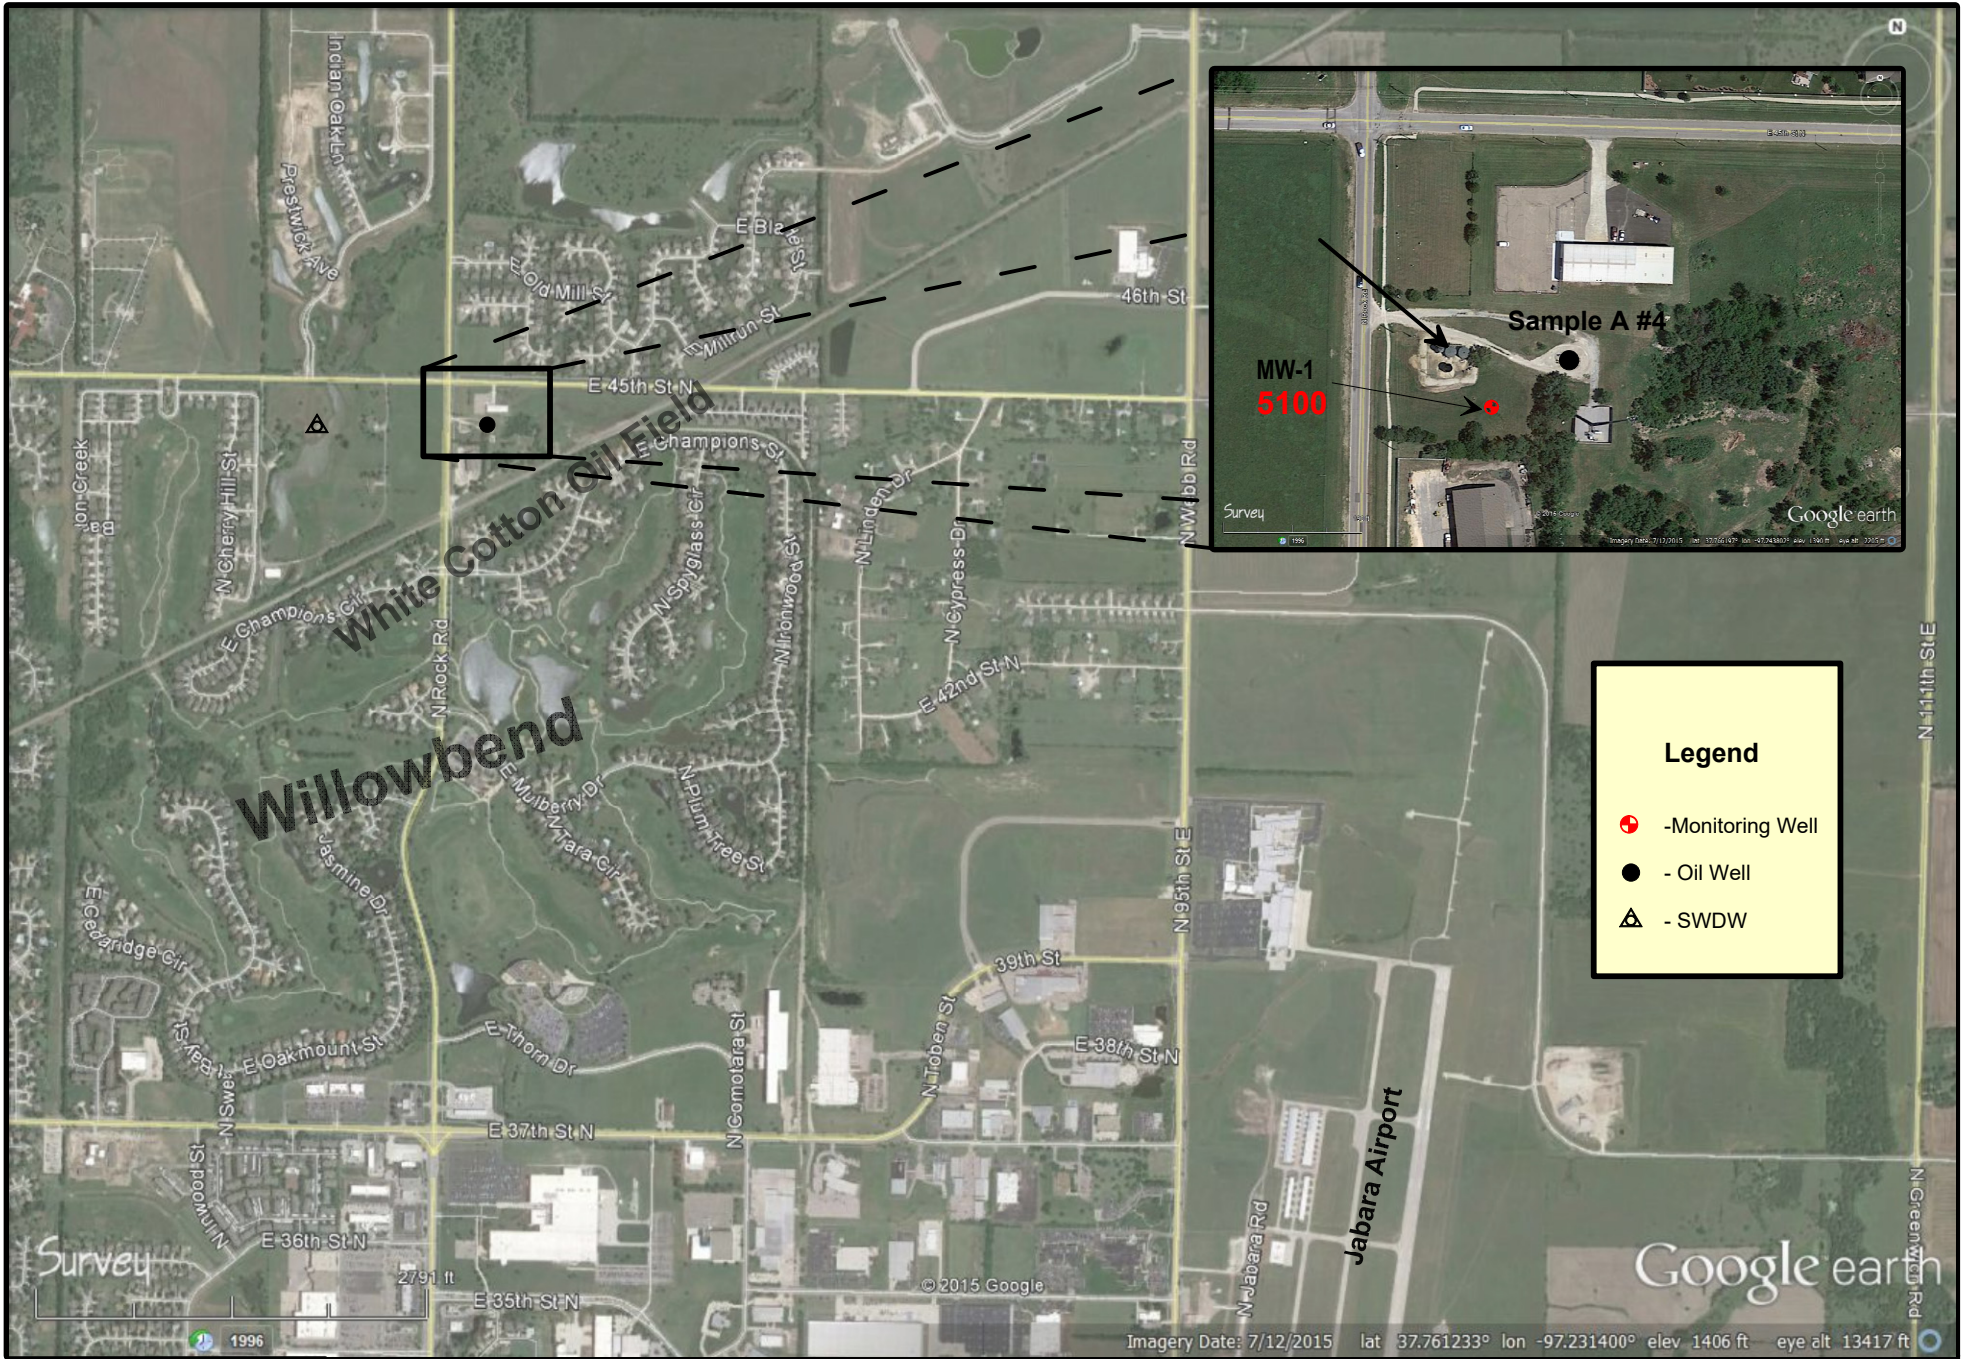
Sample 'A' Groundwater Monitoring Site

NW NW Section 29 of Township 26 South & Range 2 East, Sedgwick County, Kansas

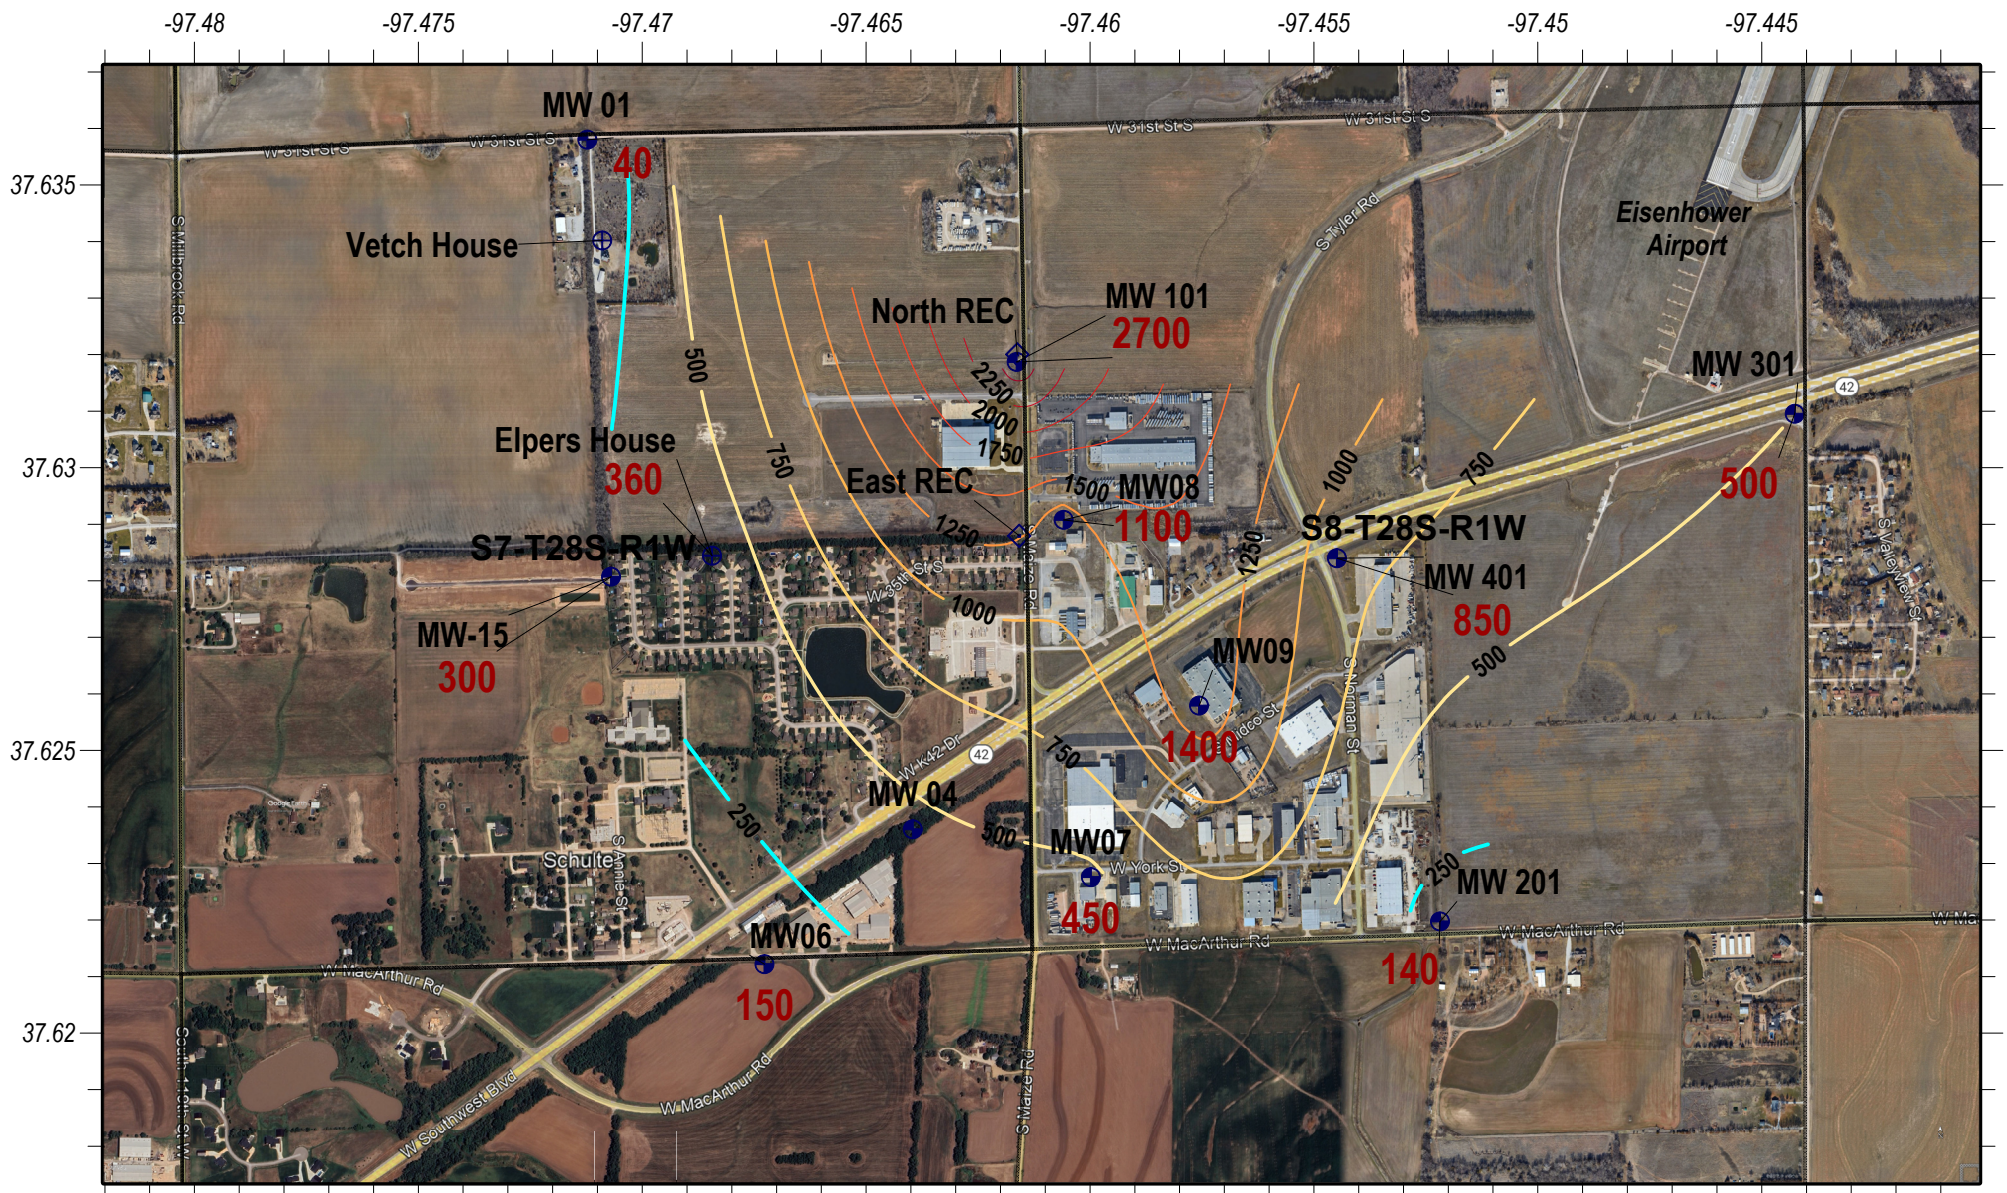
Chloride Levels 2024

*KCC Control #970015-00 - KCC District #2 Field Office
 Wells sampled on 8/29/2024 - Map Drawn by D Bollenback on 9/23/2024*

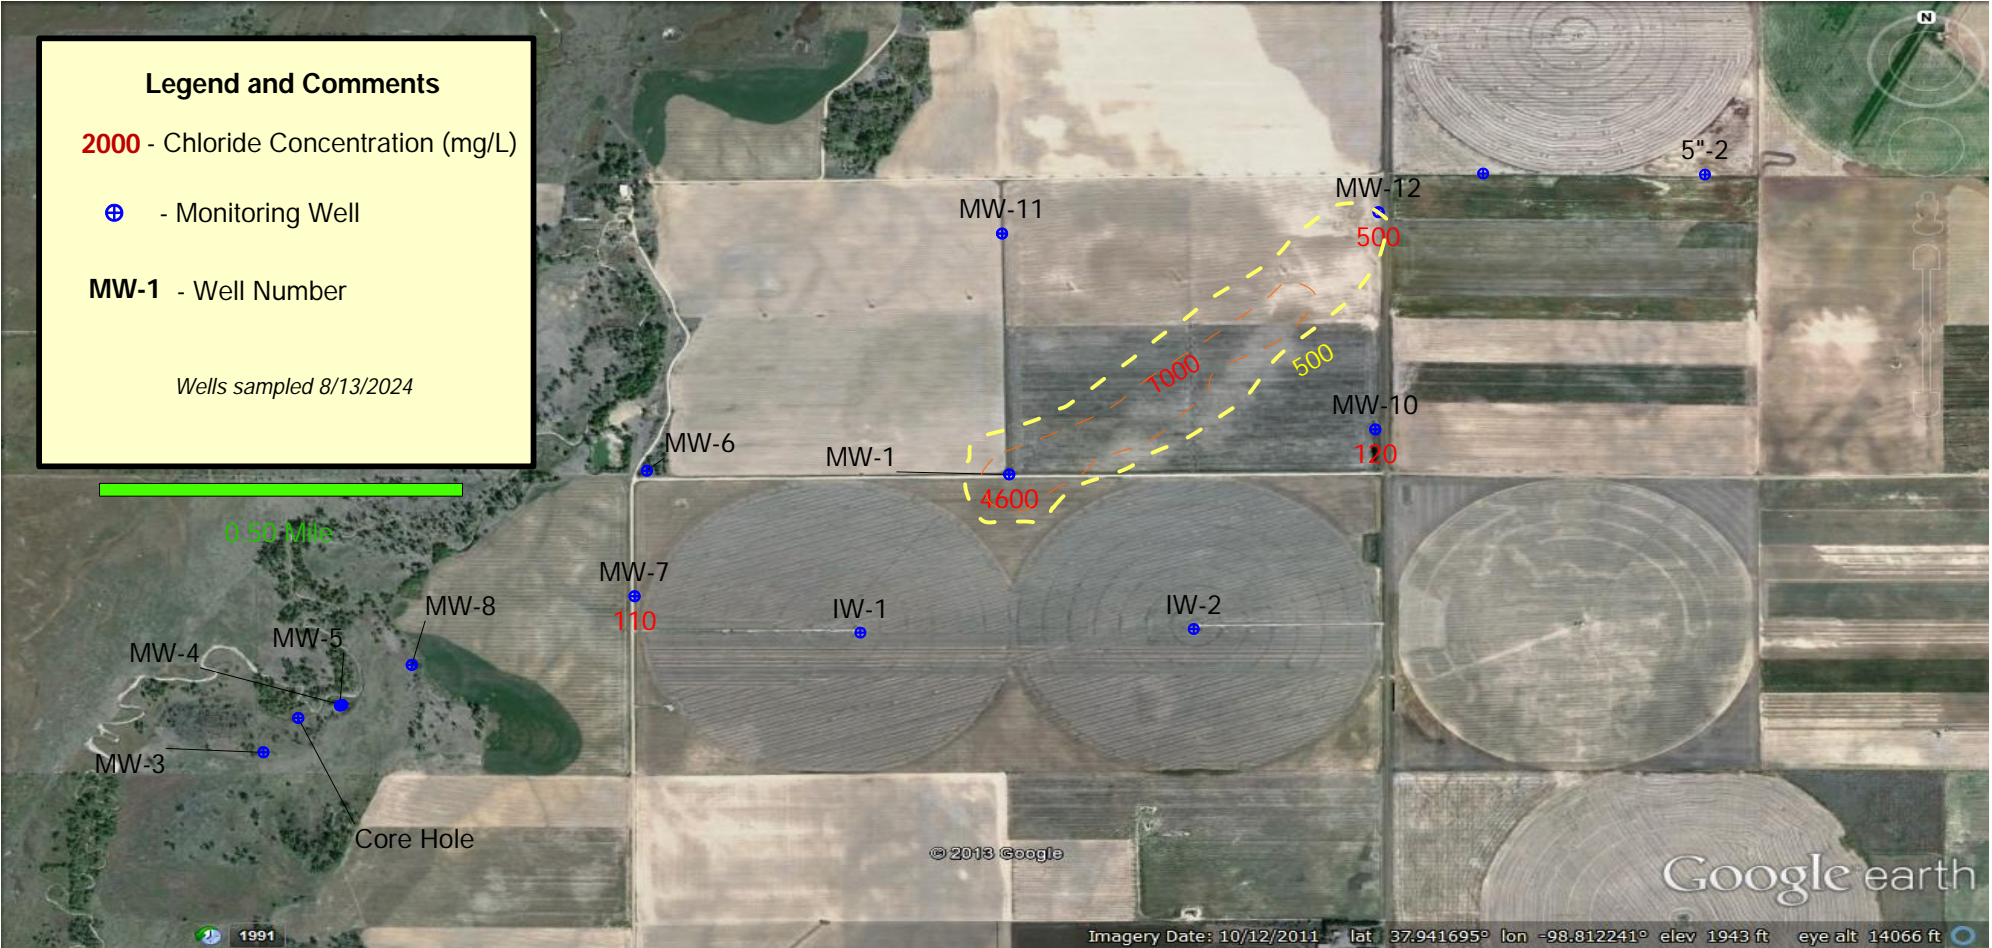
Curtis Site

Sections 19/23/24/25/26-T24S-R14W
Stafford County, Kansas
