Line #1 Dig Site #9
Near Miss Incident
09:00 September 3, 2005
West of Lajoya, Texas

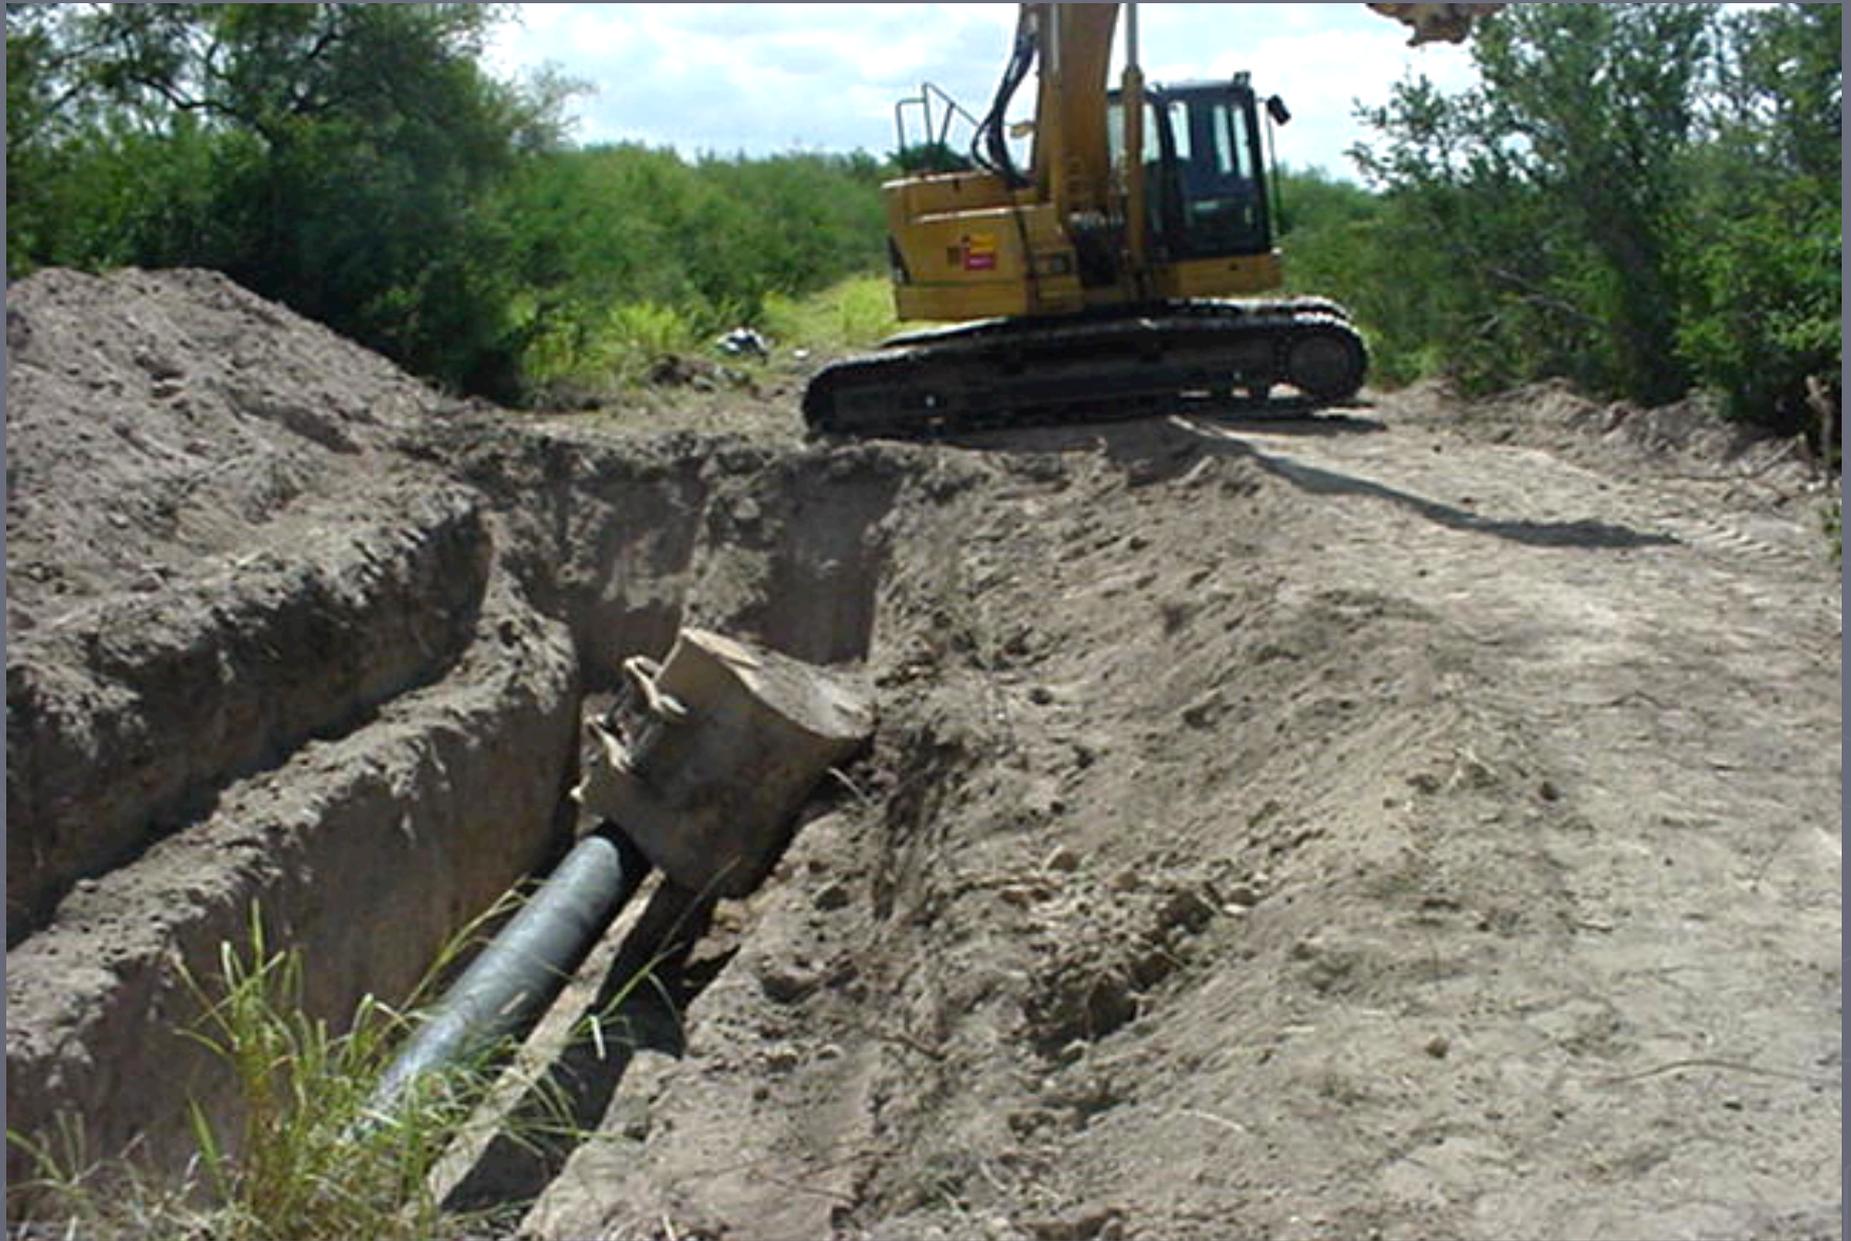
A Strike construction crew, working for Enterprise Products Operating LP, was repairing anomalies found on Line#1. At Dig Site #9 it was decided to bring in a rental Caterpillar 321C Track Hoe to lengthen the existing excavation, that had been dug the day before with a back hoe. The Track Hoe was at Dig Site #10 where it had been used for two days prior to excavate Dig Site #10. The track Hoe was loaded on to a low boy trailer by Strike personnel and transported to Dig Site #9, where it was unloaded off of the low boy by Strike personnel and “walked” into the Dig Site location. The Strike Operator set up the Track Hoe at the edge of the excavation, extended his boom from the travel position up ward when the bucket (approx. 1500 pounds) fell off of the boom to the ground where it rolled on to Enterprises’ previously excavated pipe line. Line pressure at the time of the incident was almost 800 psig.

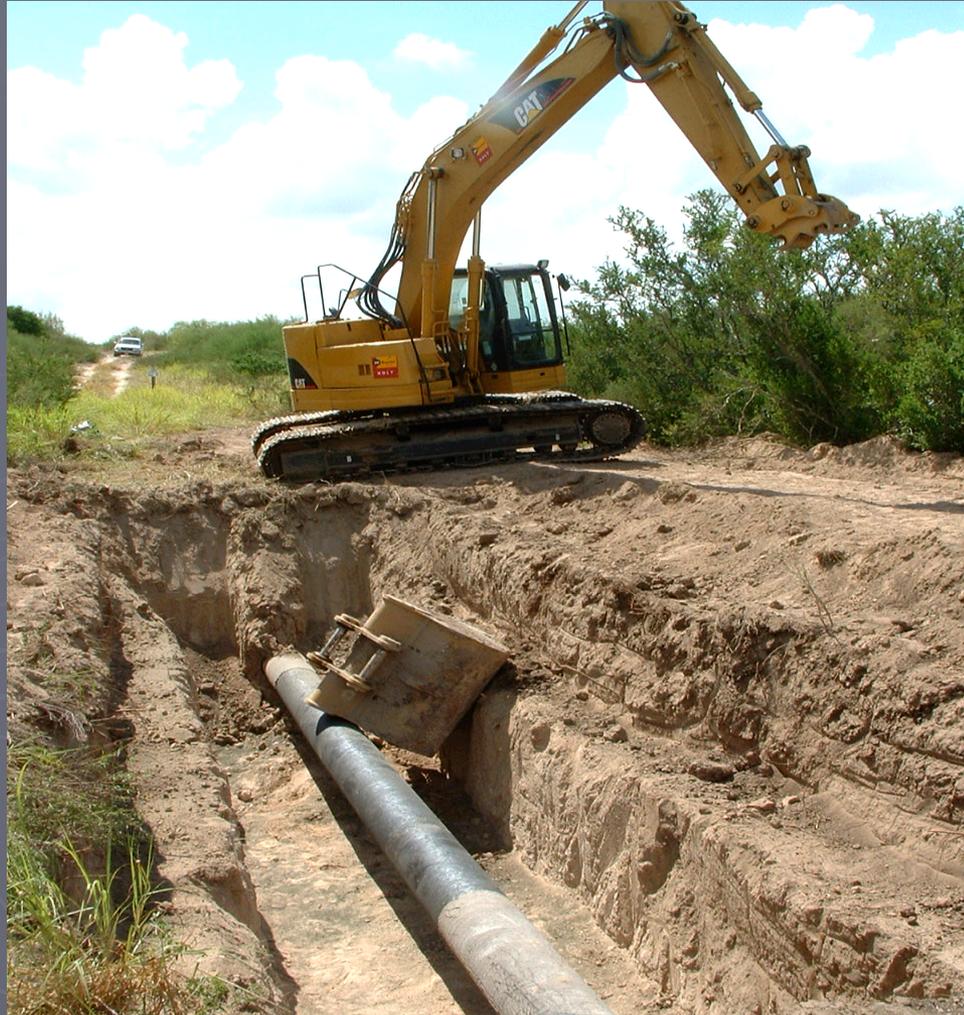
- ▶ The Strike Operator, Crew, Wilcrest Inspector, Longview corrosion specialist, and Enterprise employee immediately vacated the immediate area, accounted for all personnel, and alerted Management and Safety of the incident. There was no one injured or any gas release as a result of this incident.

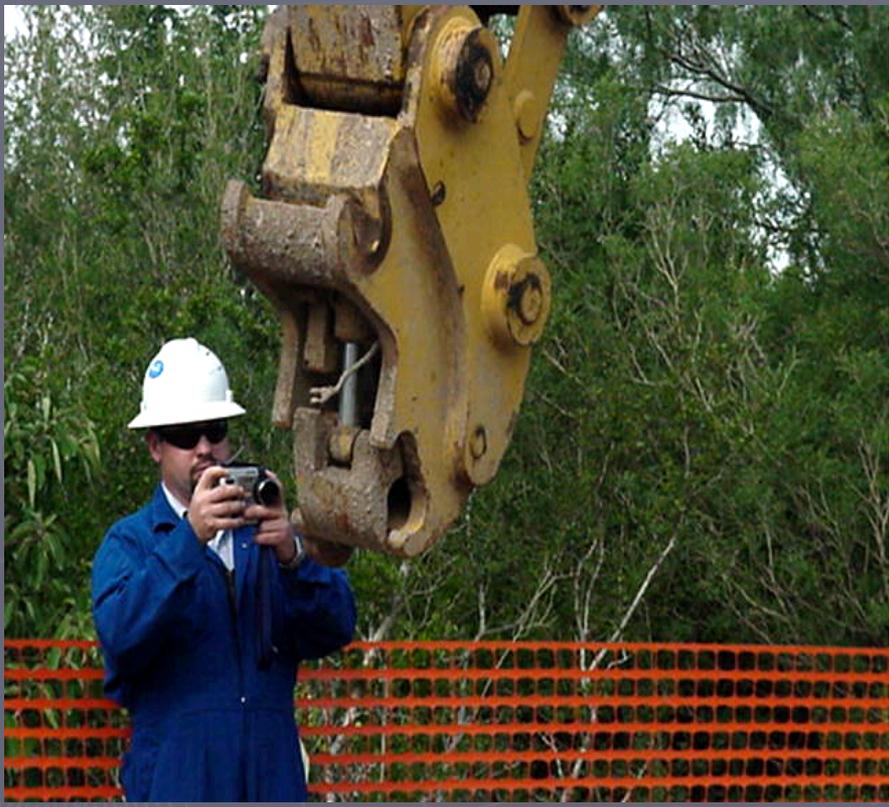
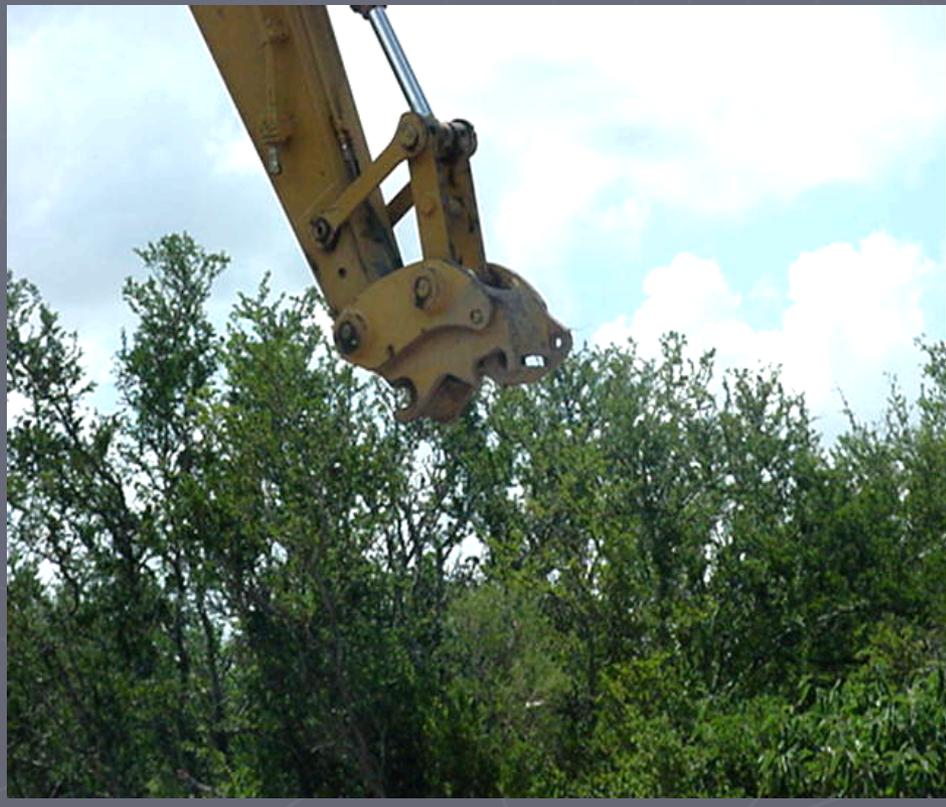
► After management and safety were on scene it was determined that the Track Hoe was equipped with a hydraulic quick coupler attachment for the bucket. This type of equipment is common in the utility excavation business, but not so common in the pipeline excavation business. After interviews were conducted, it was revealed that no one onsite had prior knowledge nor training about this feature.

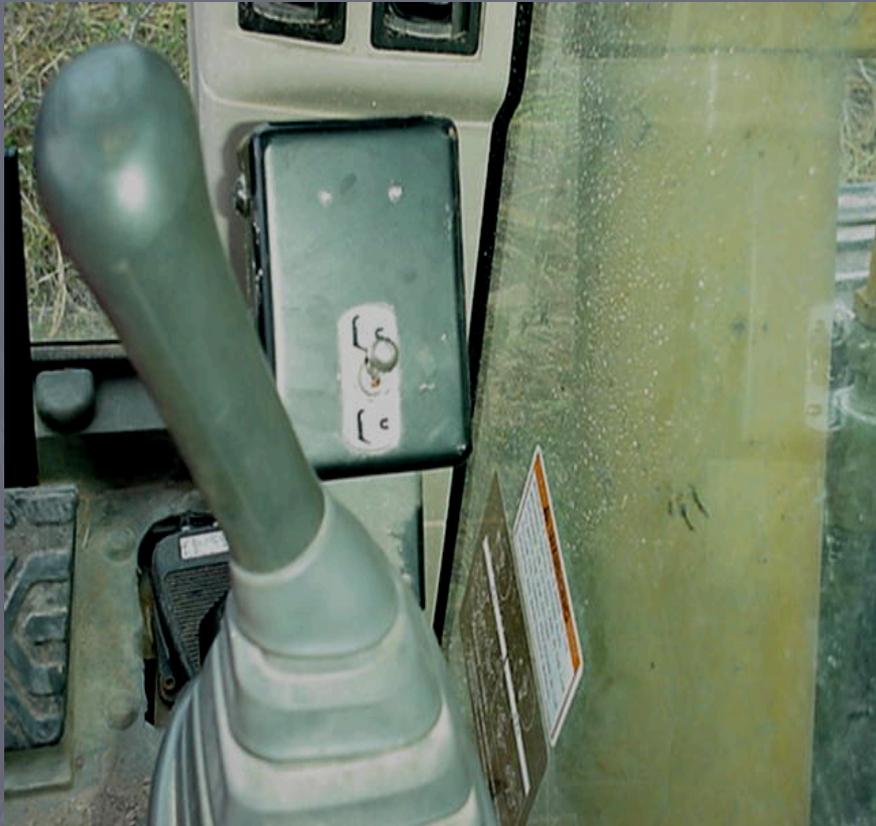
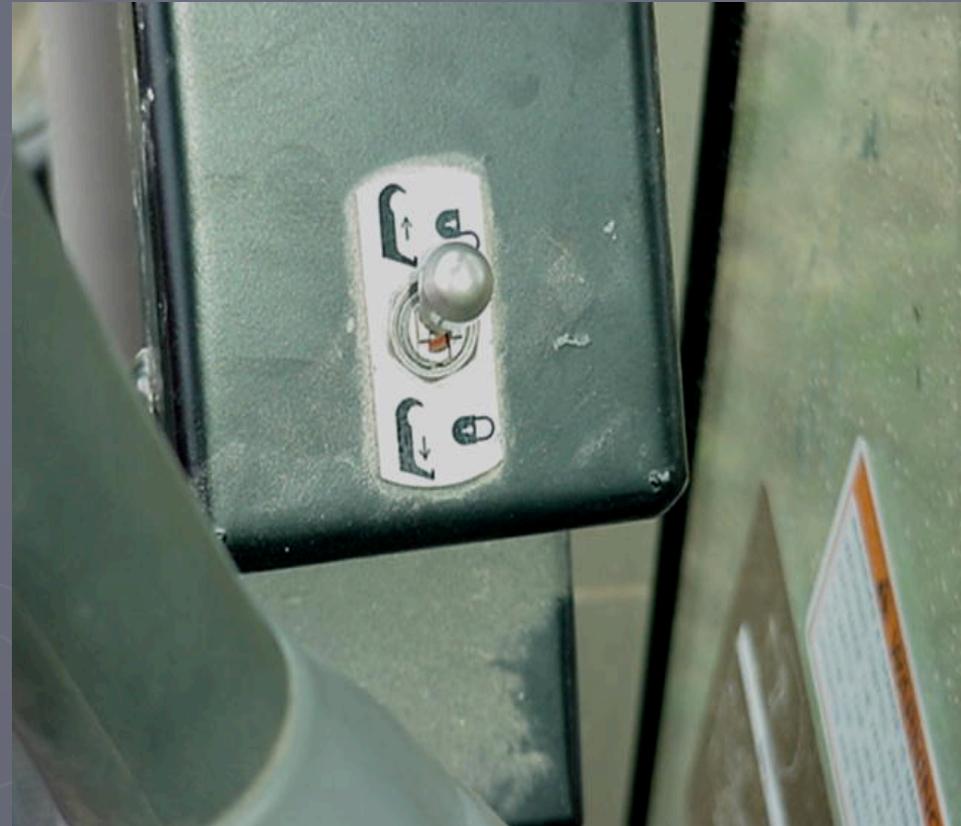
- ▶ A switch inside the operators cab operates a hydraulic ram that couples and uncouples various attachments. Safety features to prevent unintentional uncoupling include:
 - ▶ 1. A manual pull to activate switch in the cab.(This Safety Feature was functional)

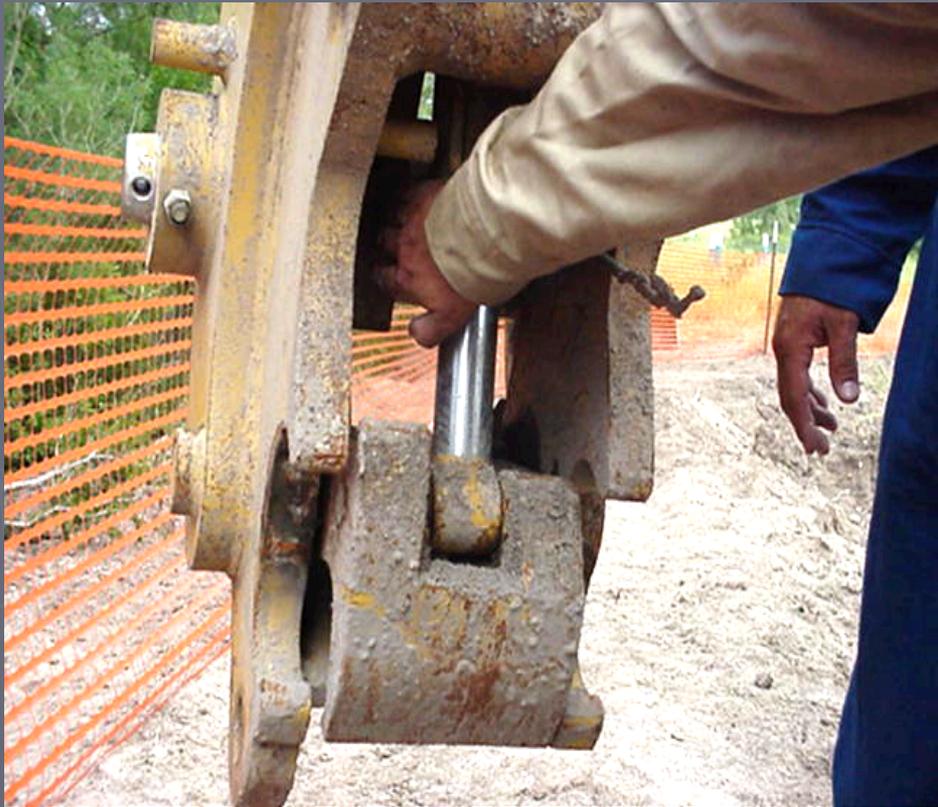
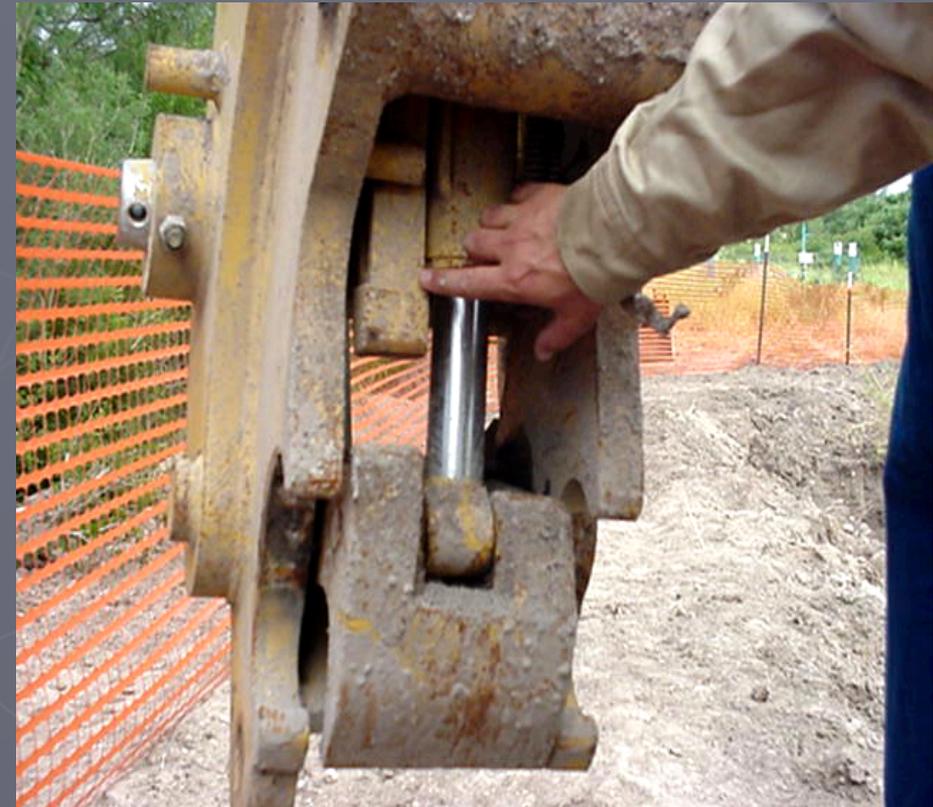
- ▶ Another safety feature is a pendulum like bar that when the Track Hoe extends its boom into the DIG position it swings into place preventing the Hydraulic ram from opening.
- ▶ This Safety feature was also functional.

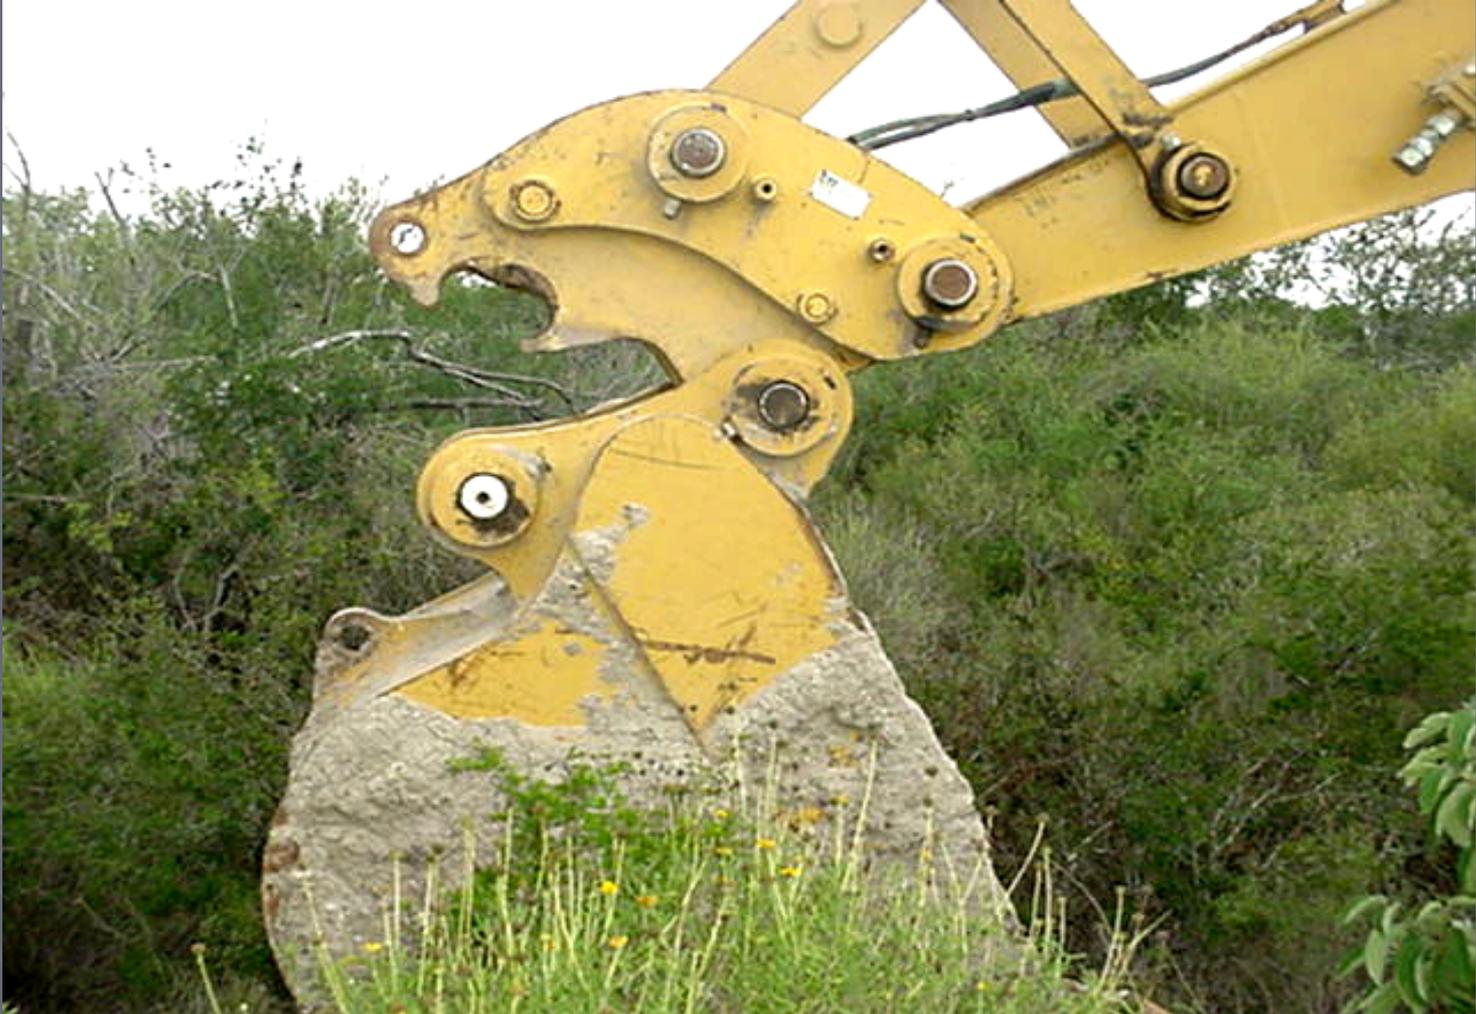
- ▶ Another safety feature is an audible alarm that sounds when the Hydraulic ram is switched into the open position, it sounds letting the operator know the Coupler is being OPENED.
- ▶ (This safety feature was found to be non functional on this Track Hoe)

- ▶ Inspect all quick couplers to determine if they are subject to unexpected release hazards. Determine whether a manually installed locking pin and installation procedures have been provided by the manufacturer
- ▶ If necessary , obtain and install retrofits recommended by the manufacture, including positive locking pins and other devices that need to be manually installed.
- ▶ Consider the use of newer models of quick couplers that have been specifically designed to prevent the unintended release of attachments.
- ▶ Follow the manufacturer's recommendations for maintenance and inspection of the coupler to prevent malfunction of the quick coupler that could cause an unintended release of the attachments
- ▶ Follow the manufactures' installation procedures and recommendations on testing quick coupler and attachments and attachment connections every time an attachment is made.

- ▶ Training employees in: proper use of quick couplers ; making visual inspections; procedures for engaging attachments; and methods for testing connections.
- ▶ Requiring employees to use the proper procedures for engaging excavation attachments and incorporating the procedures into the company's safety and health program.
 - ▶ Electronic Library of Construction Occupational Safety and Health
