# Kansas Incident Investigations

Investigation Techniques & Lessons Learned

# 728 Minnesota, Wichita KS

- 12-KGSG-490-GIG
- House fire and explosion
  - 3 victims burned, house destroyed.
- Staff determined break in low pressure cast iron piping led to house explosion.

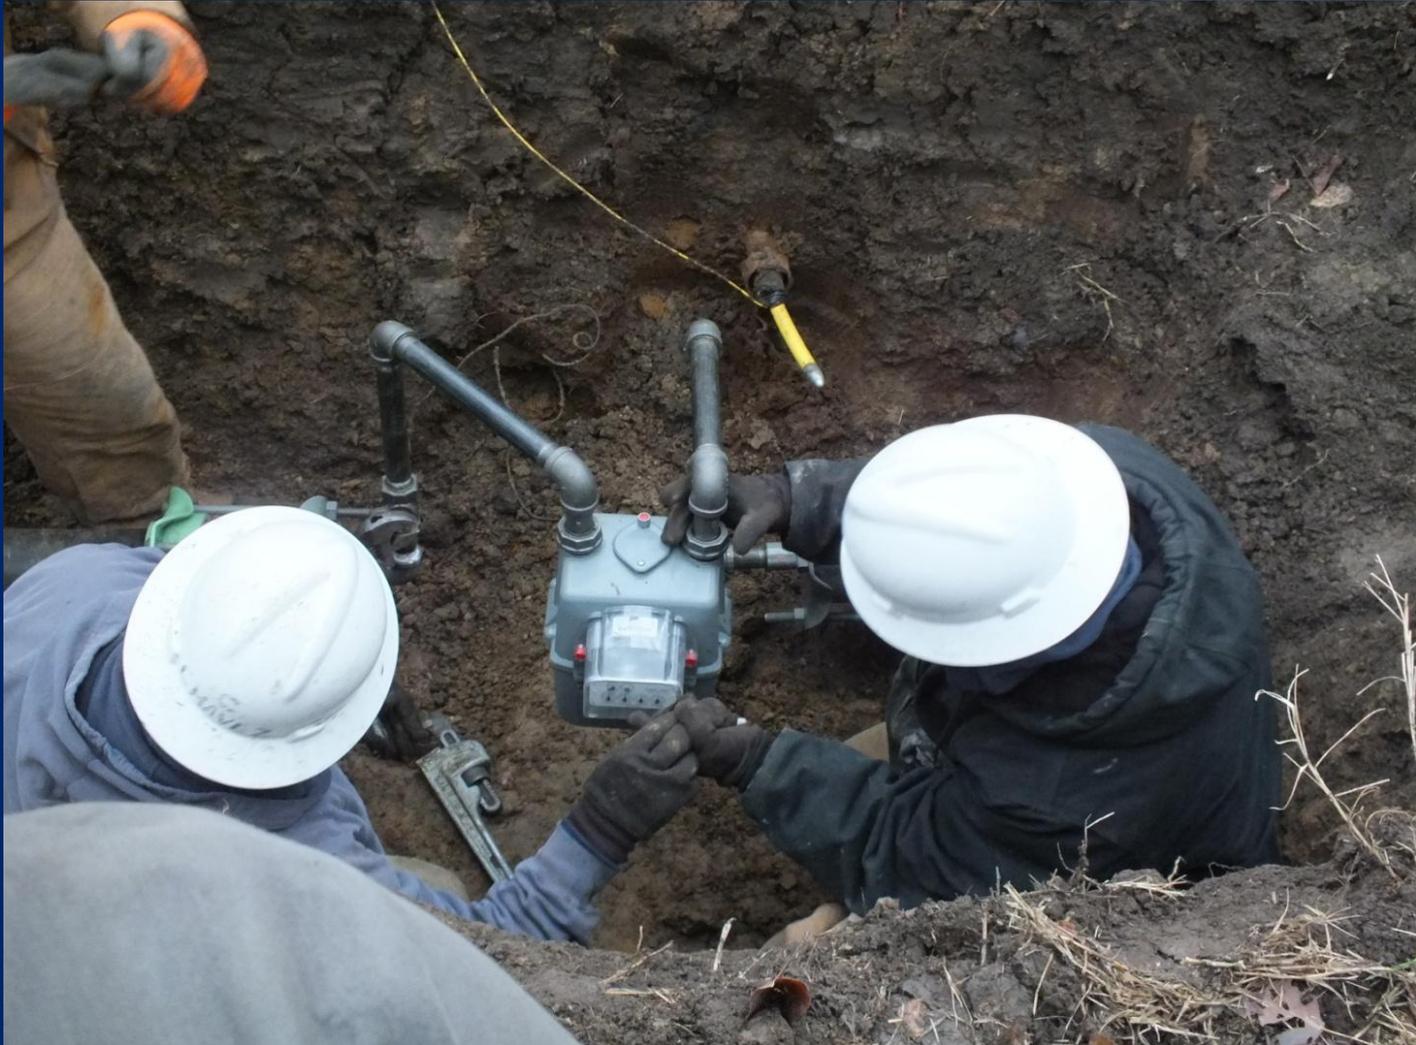
# Small meter/ 9oz cast iron

No vent to surface; pressure/flow test only way to determine leak

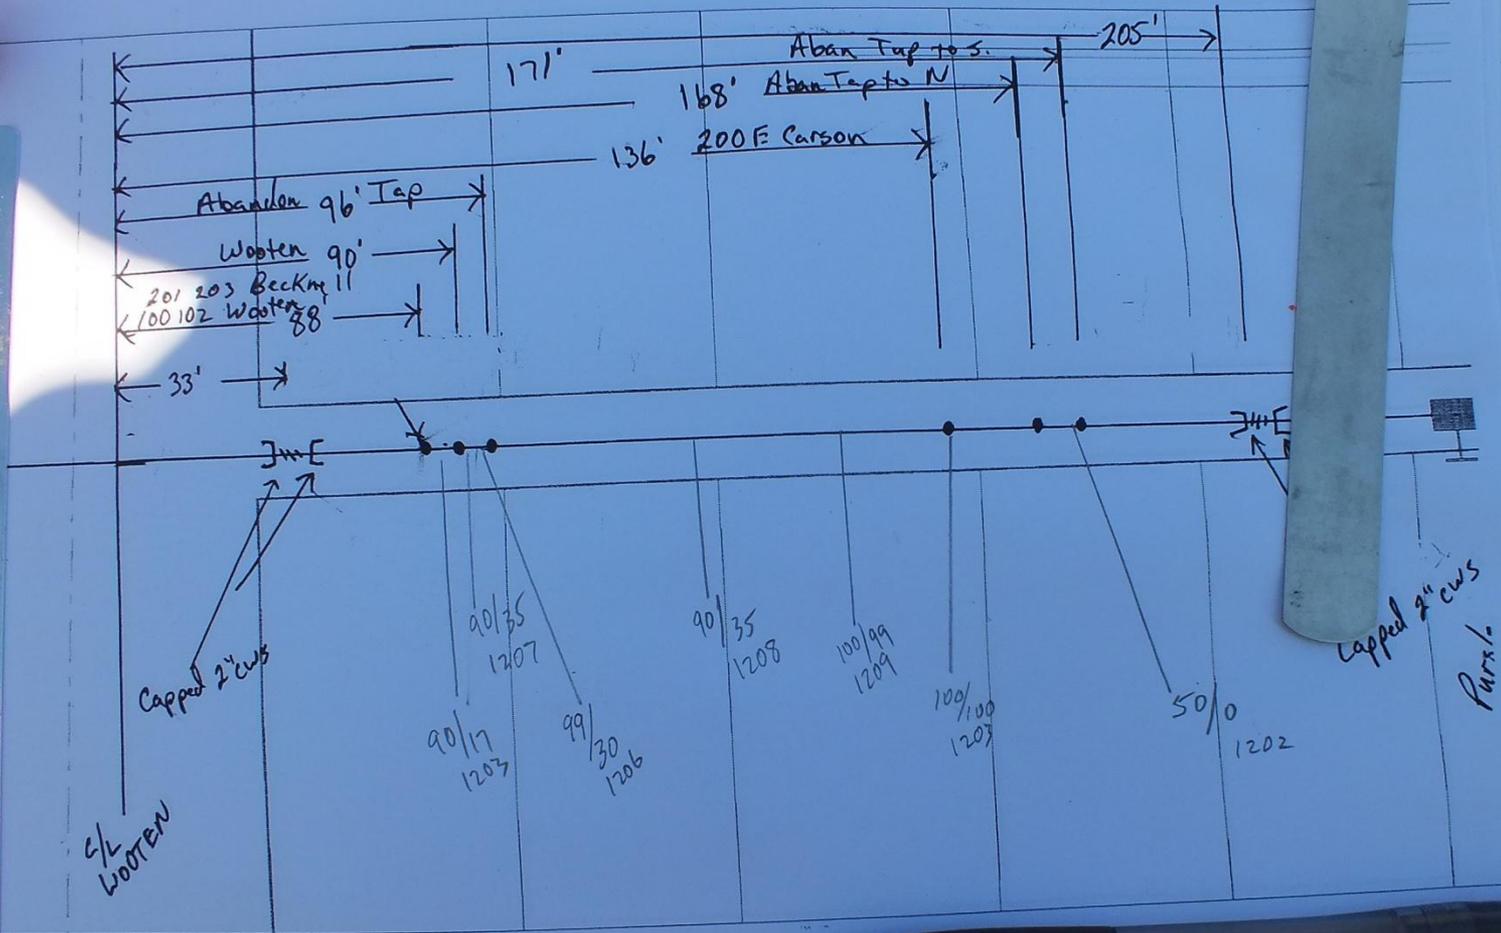
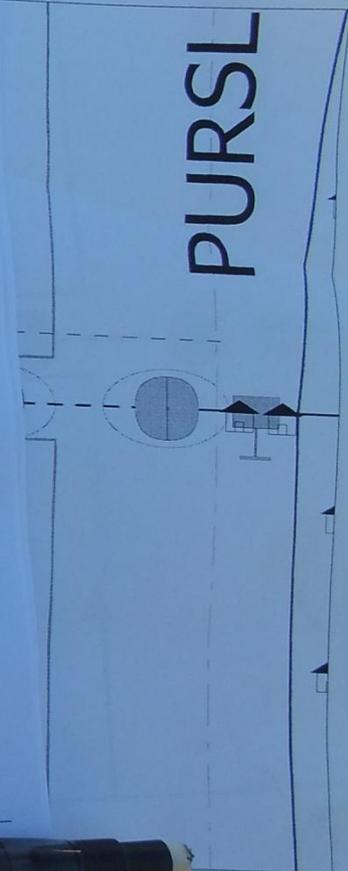
**Example of migration documentation in alley**

- Prioritize testing to determine safety of remaining structures.
- Have a helper draw map and record data.
- Make a master copy of map for later updates.
- Draw additional maps to show area of leak.
- Use flags with numbers to show barhole locations.

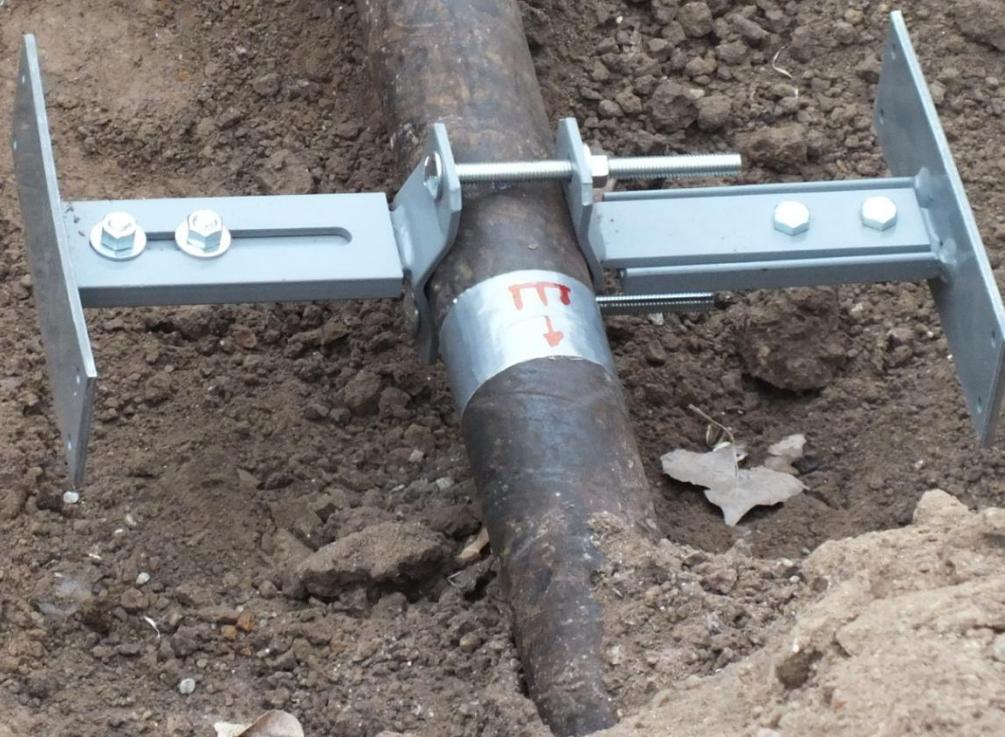
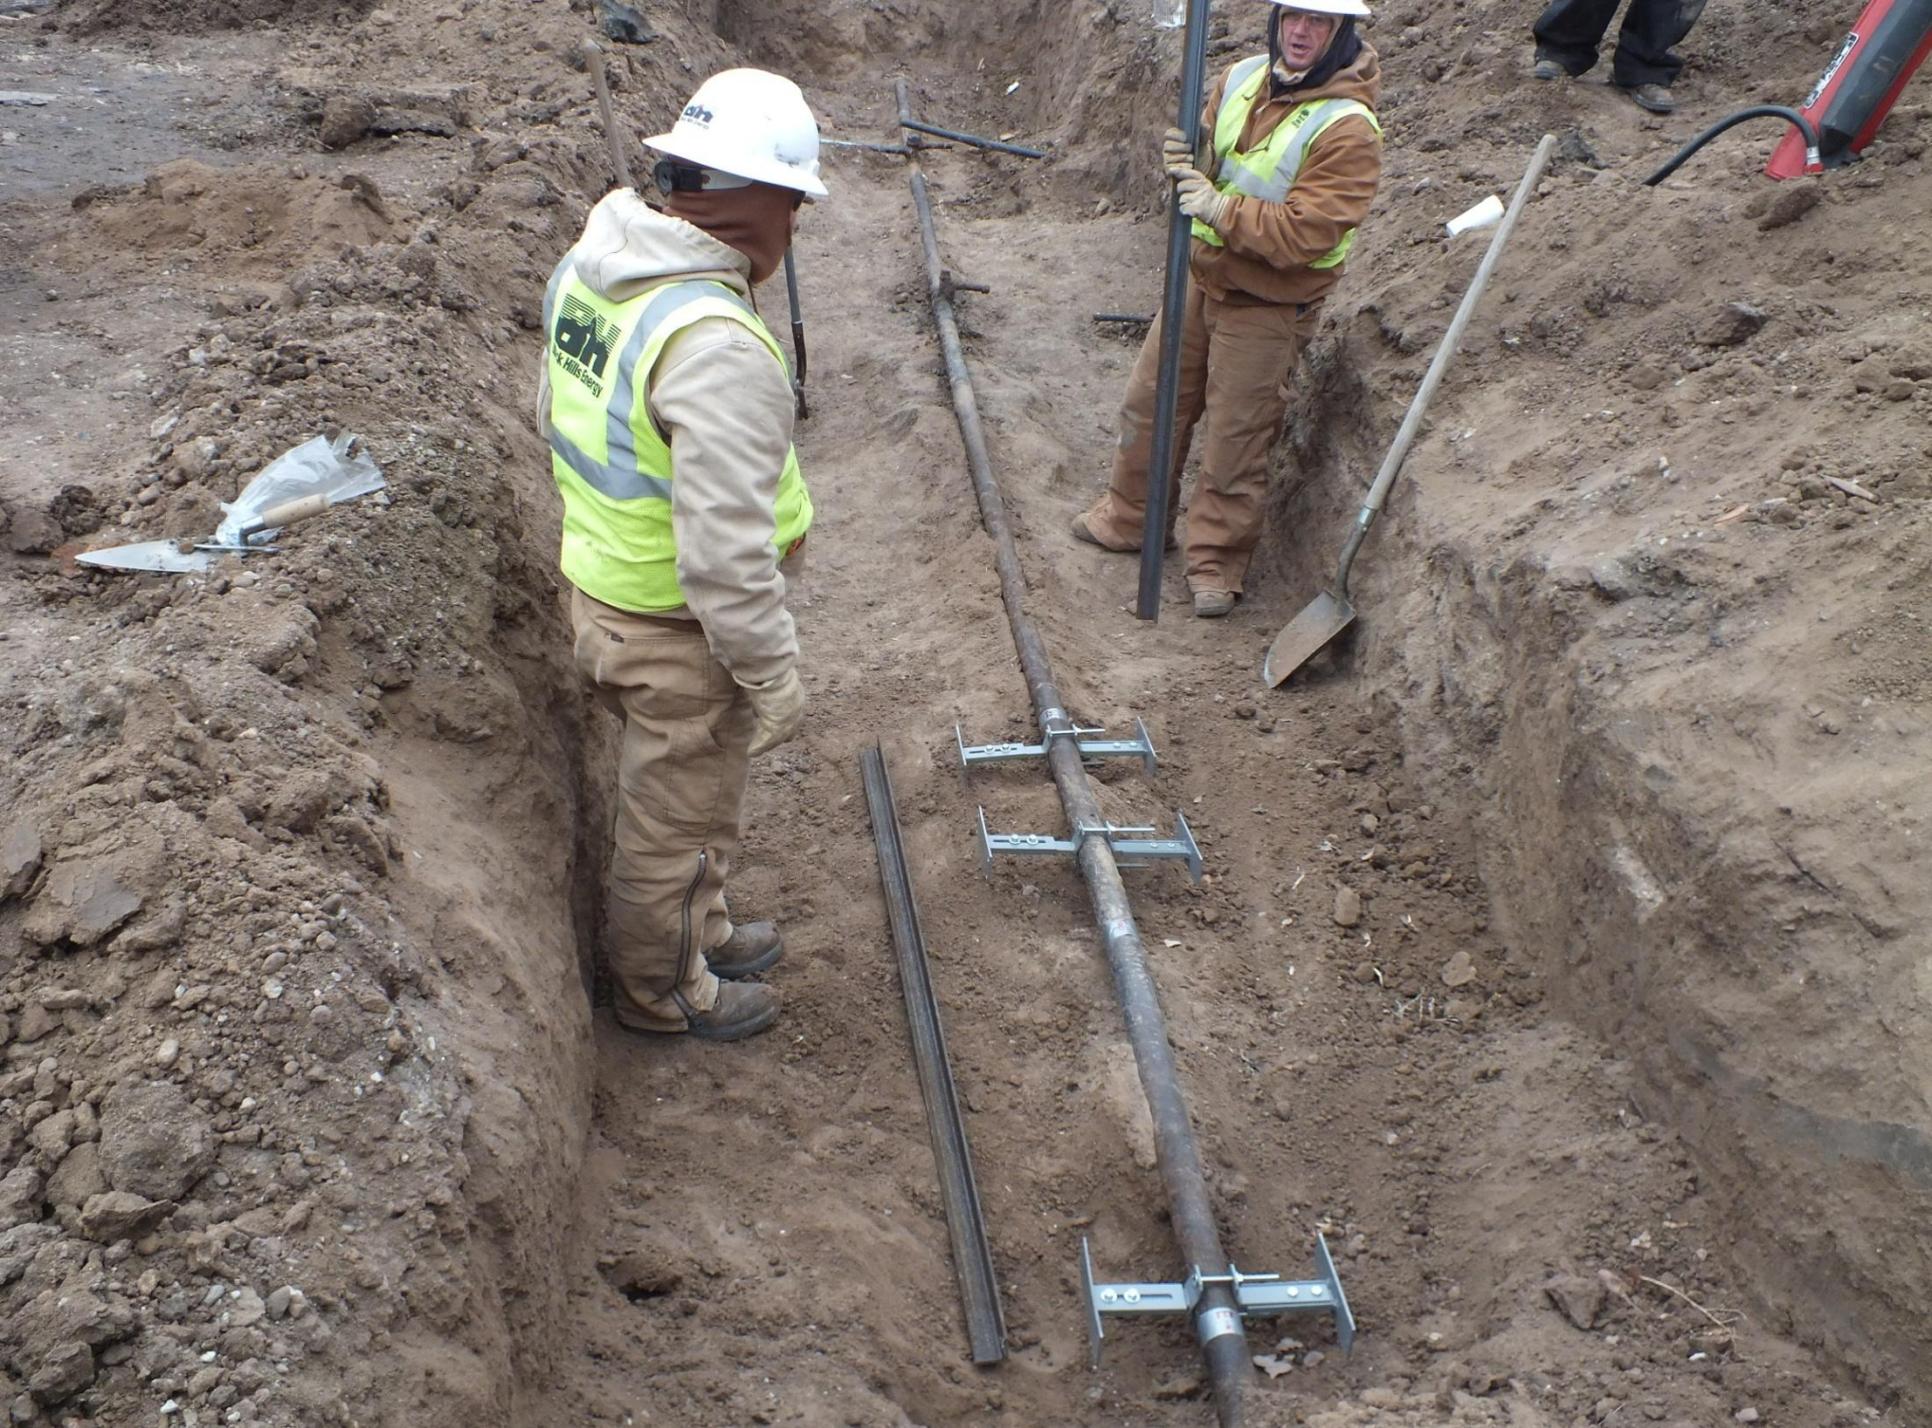
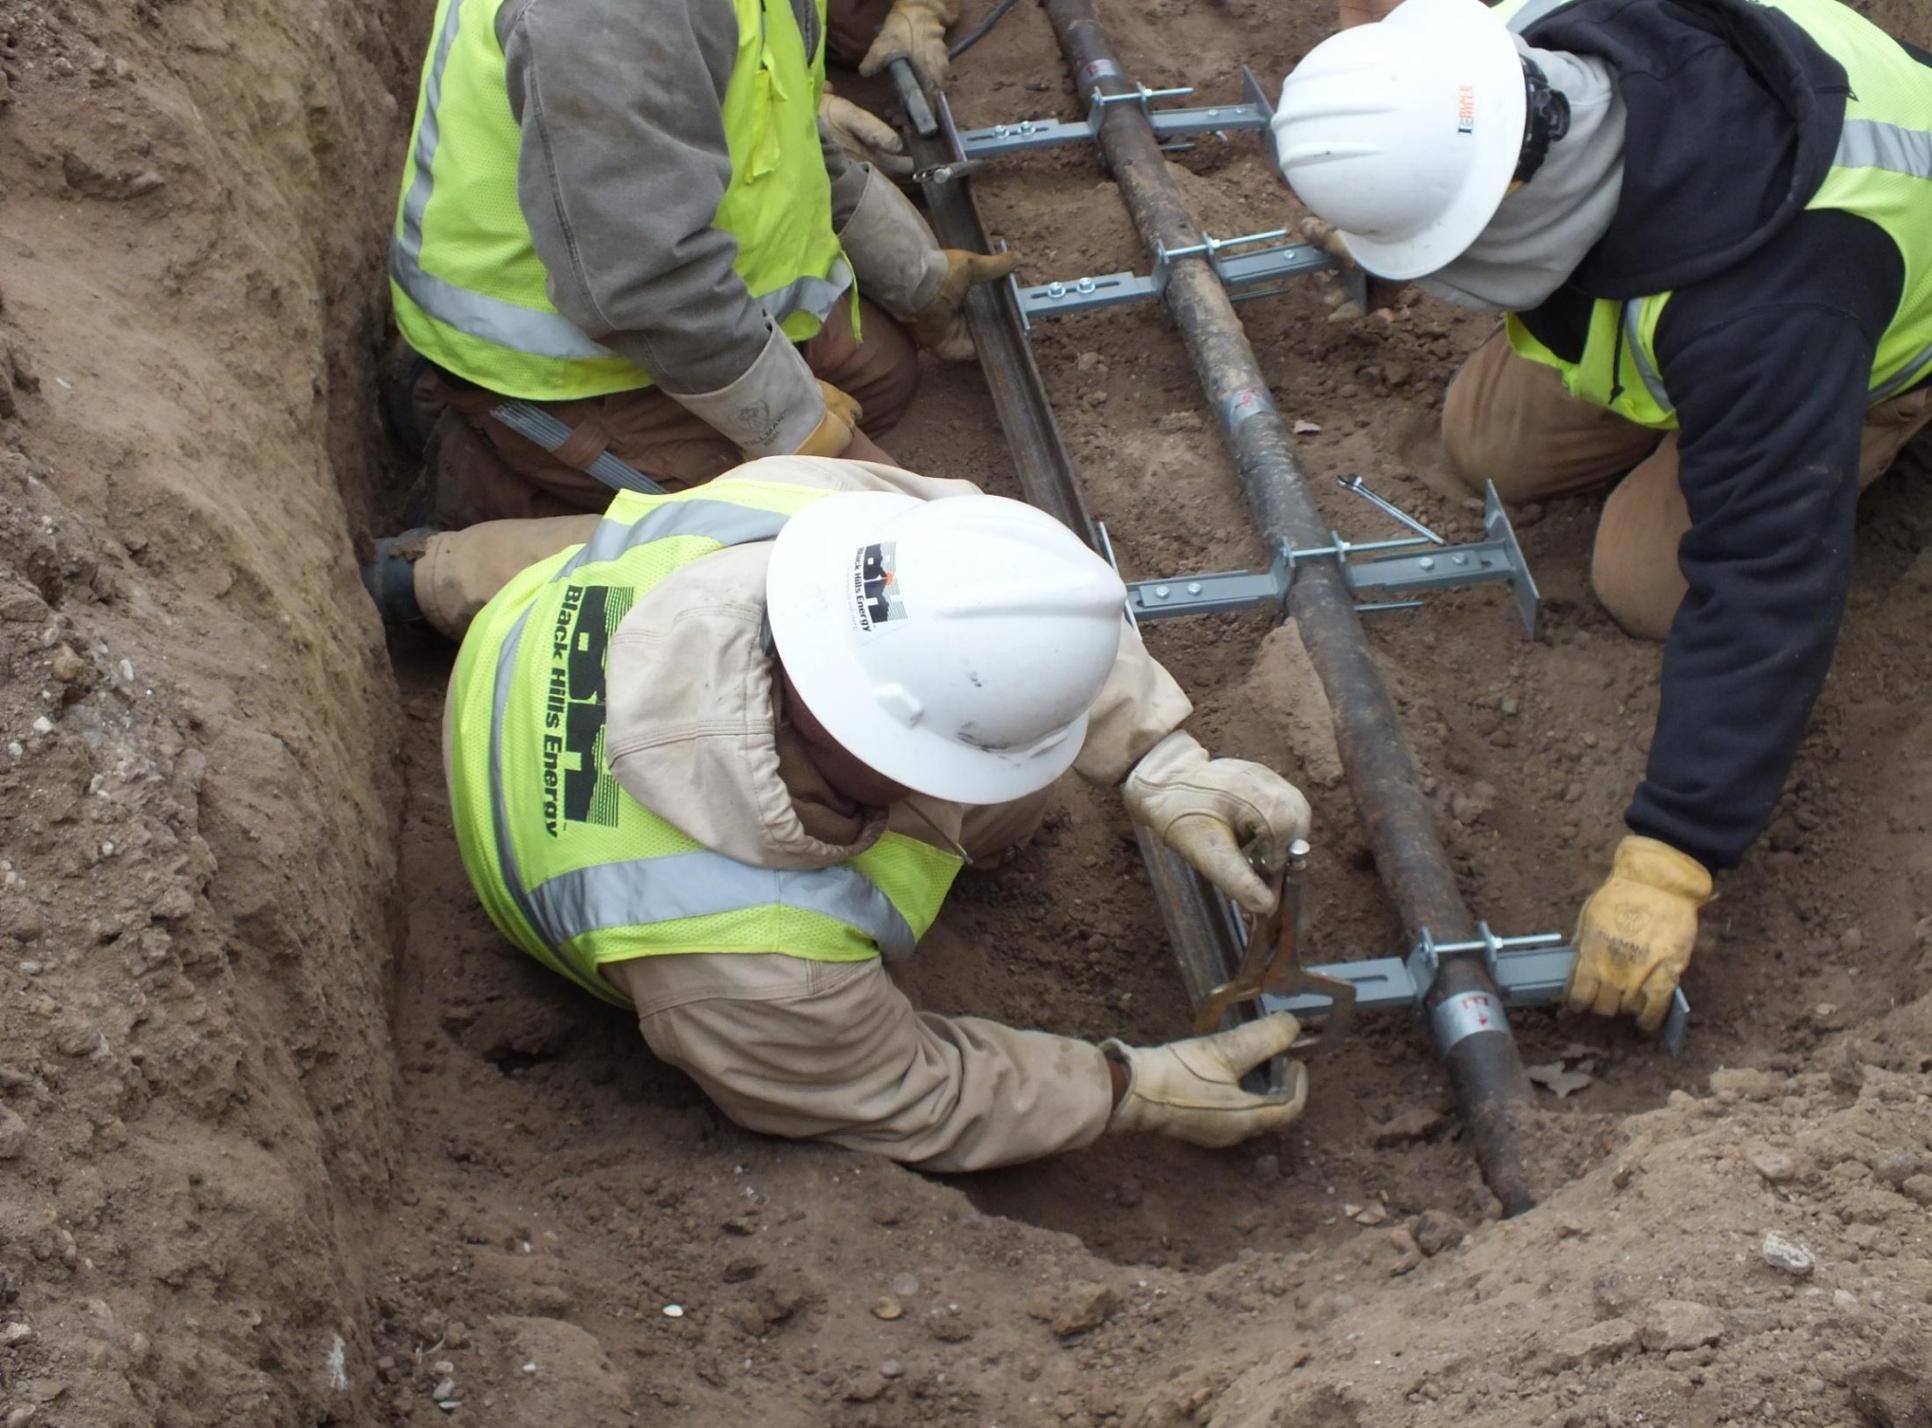
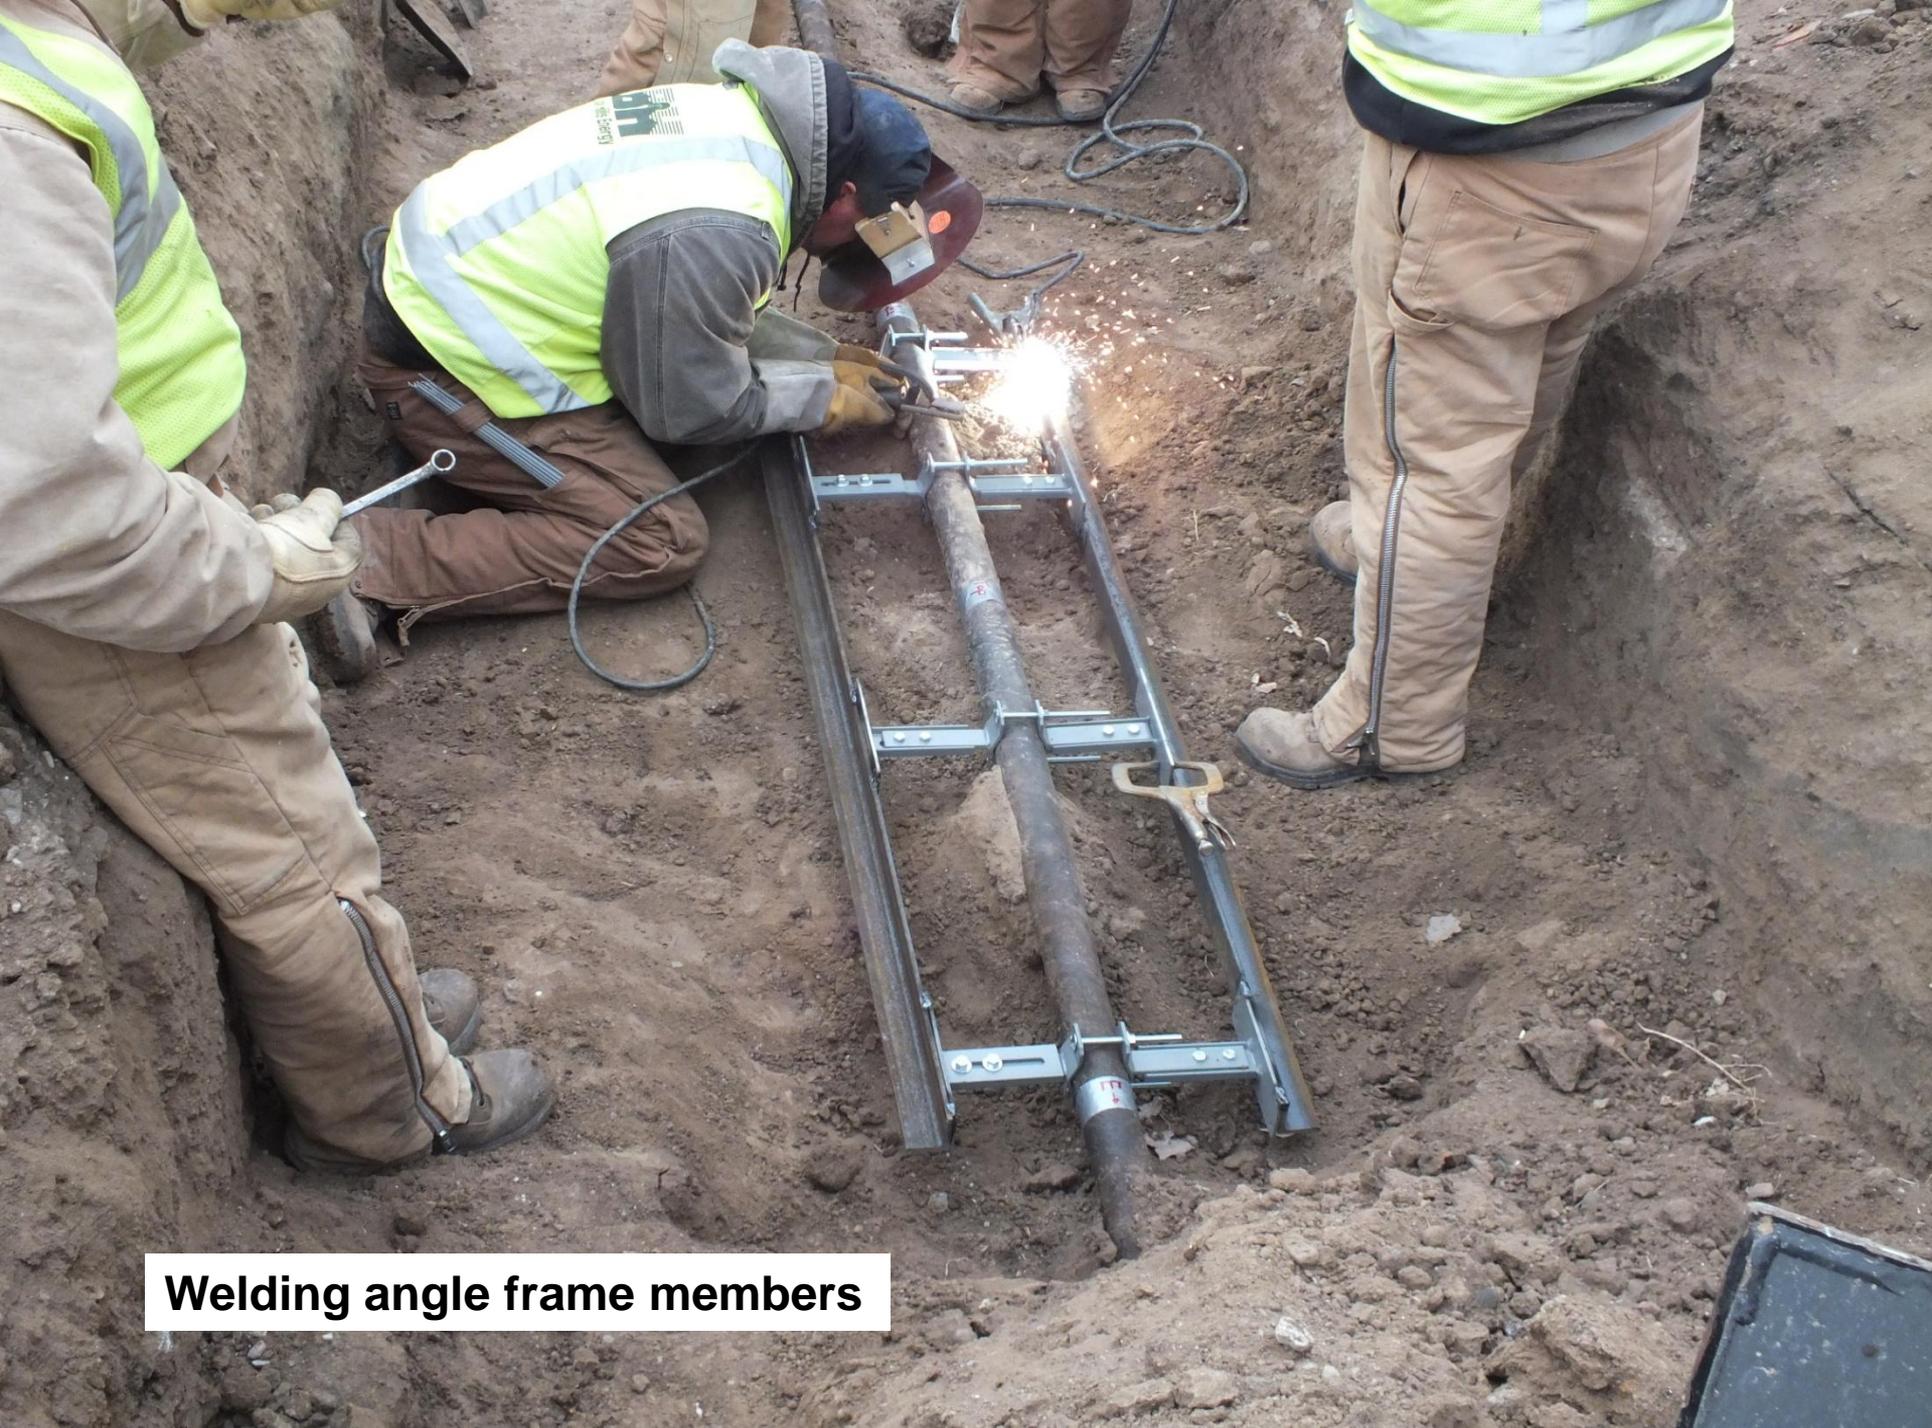
**This and the following pictures  
Are of the device crafted to maintain  
support of the damaged main.**

**Welding angle frame members**

- Build substantial structure;
- adjust with bolts and clamps;
- weld structure in place.

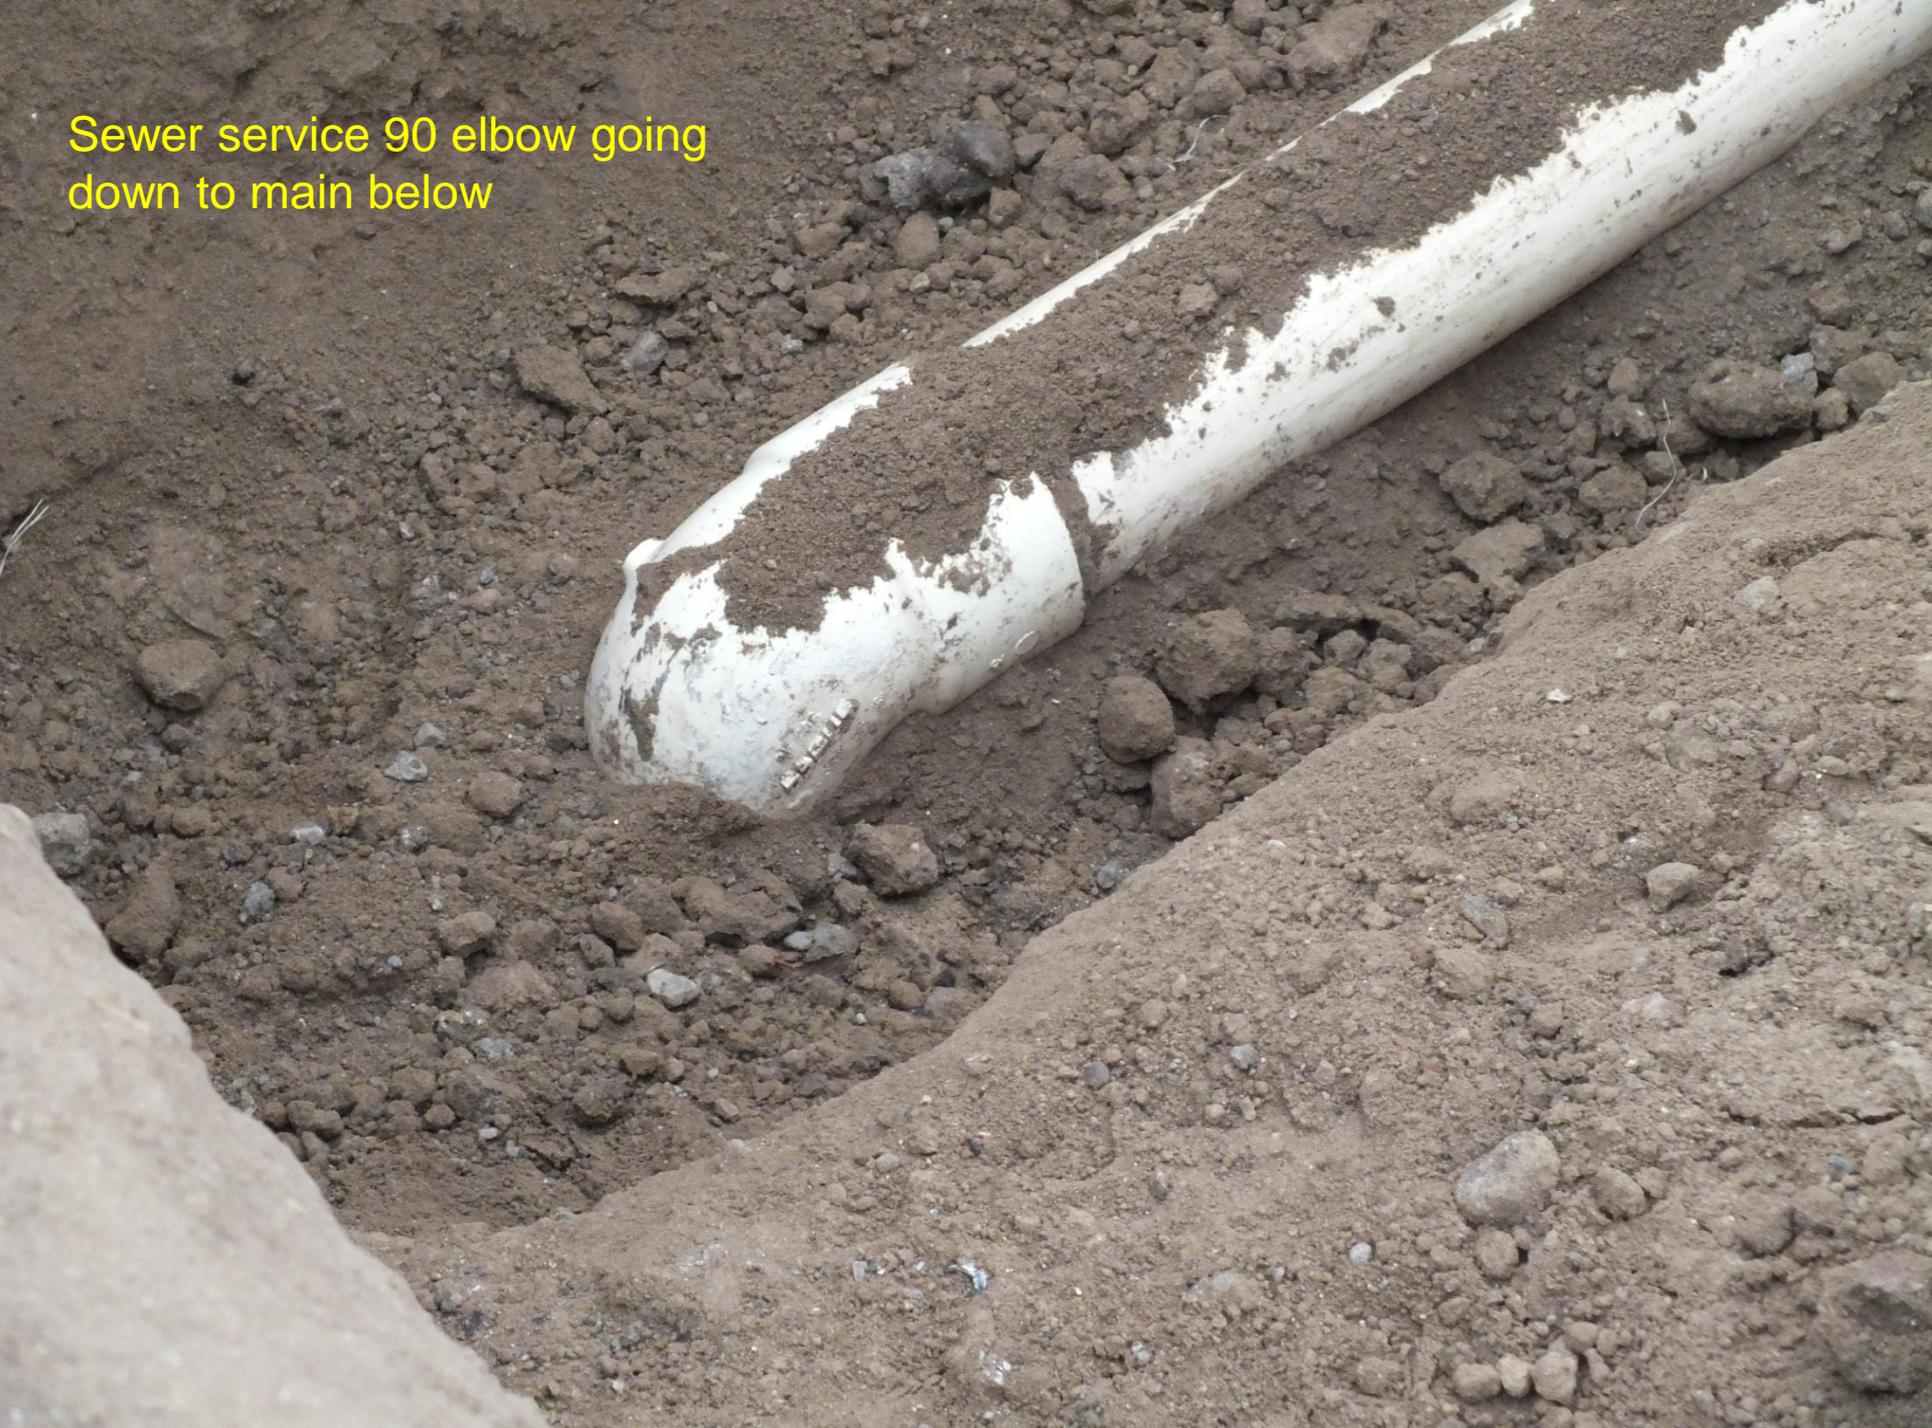
Sewer service 90 elbow going  
down to main below

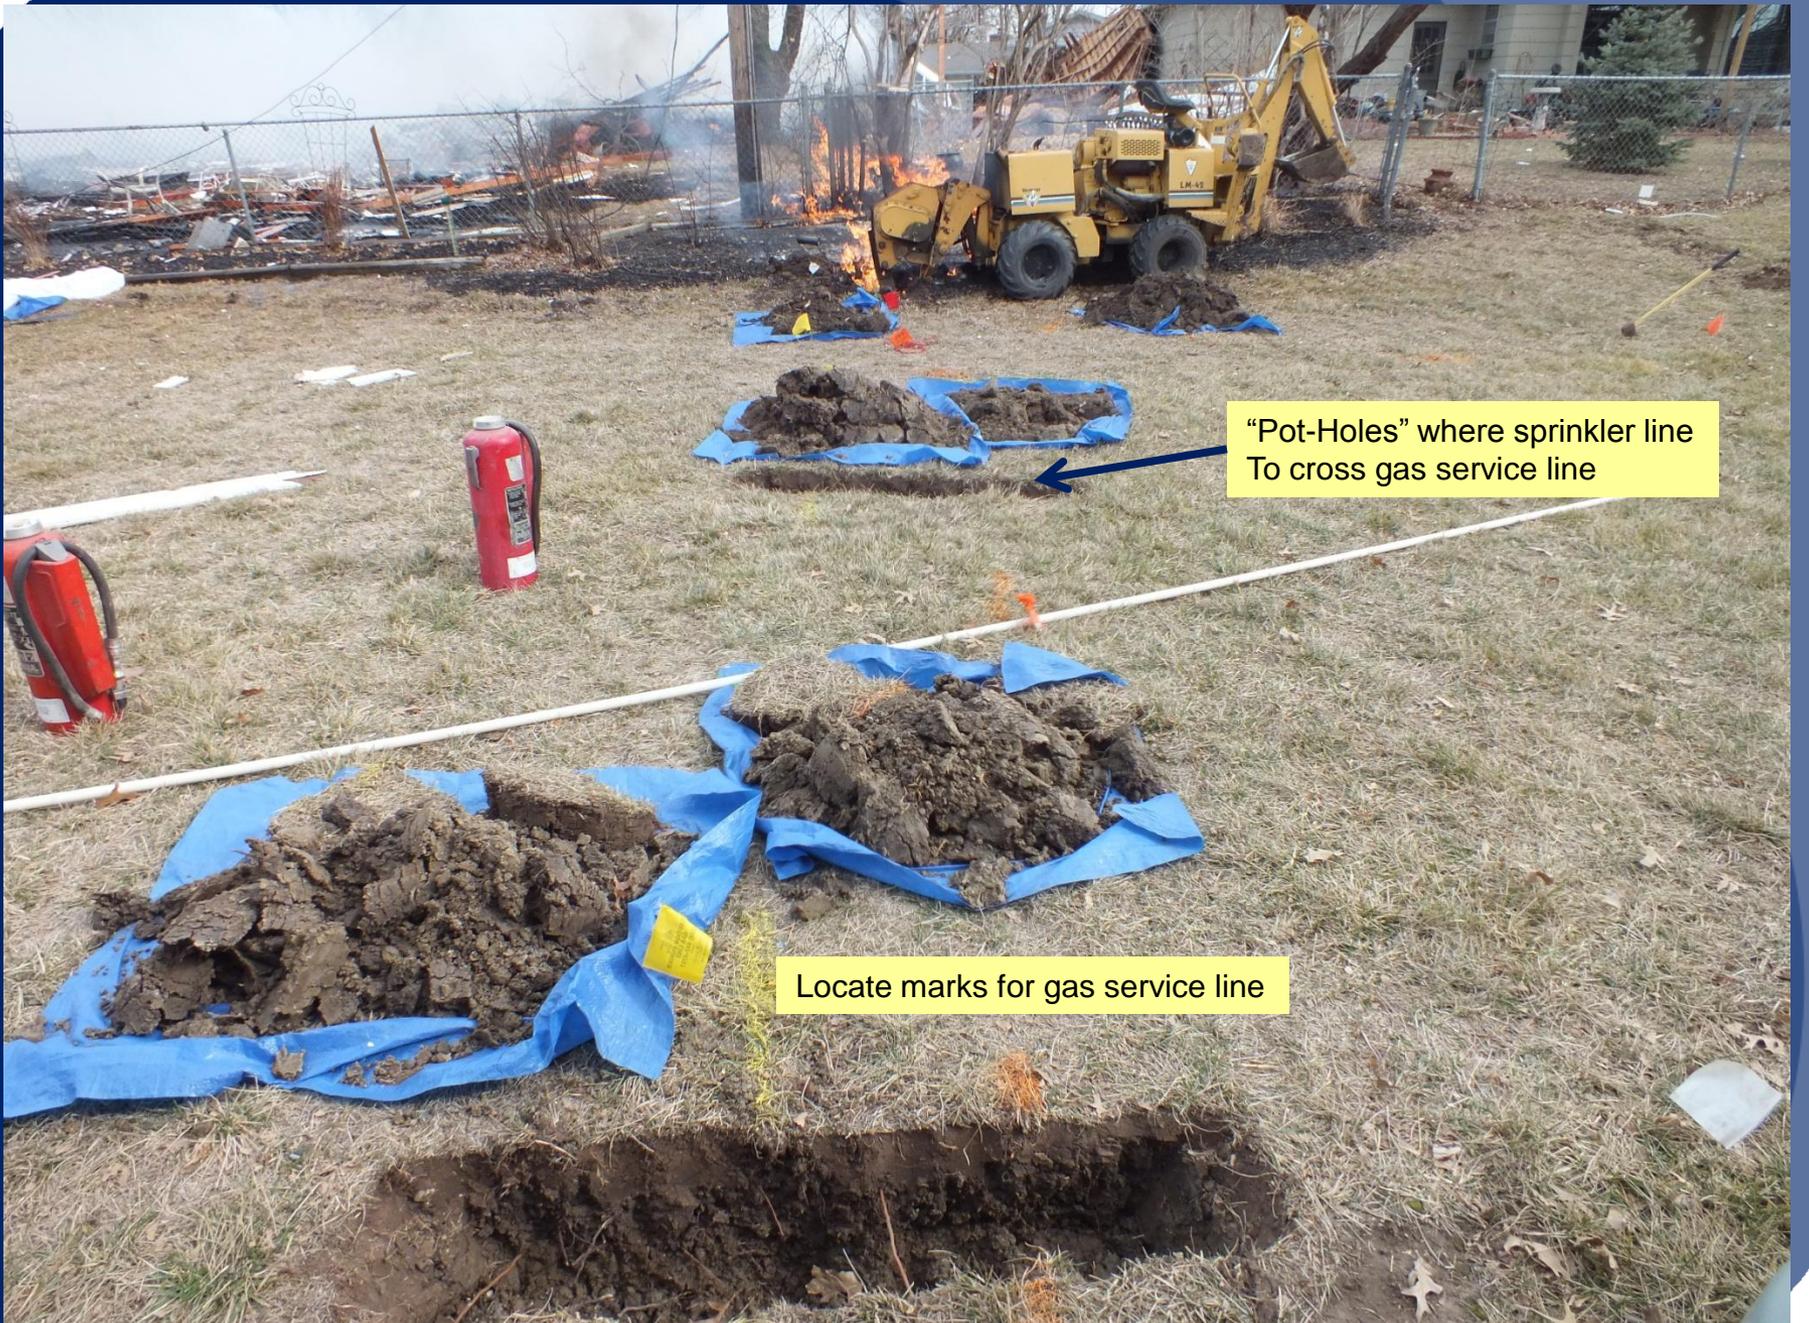
Service Line Damage Site

“Pot-Holes” where sprinkler line  
To cross gas service line

Locate marks for gas service line

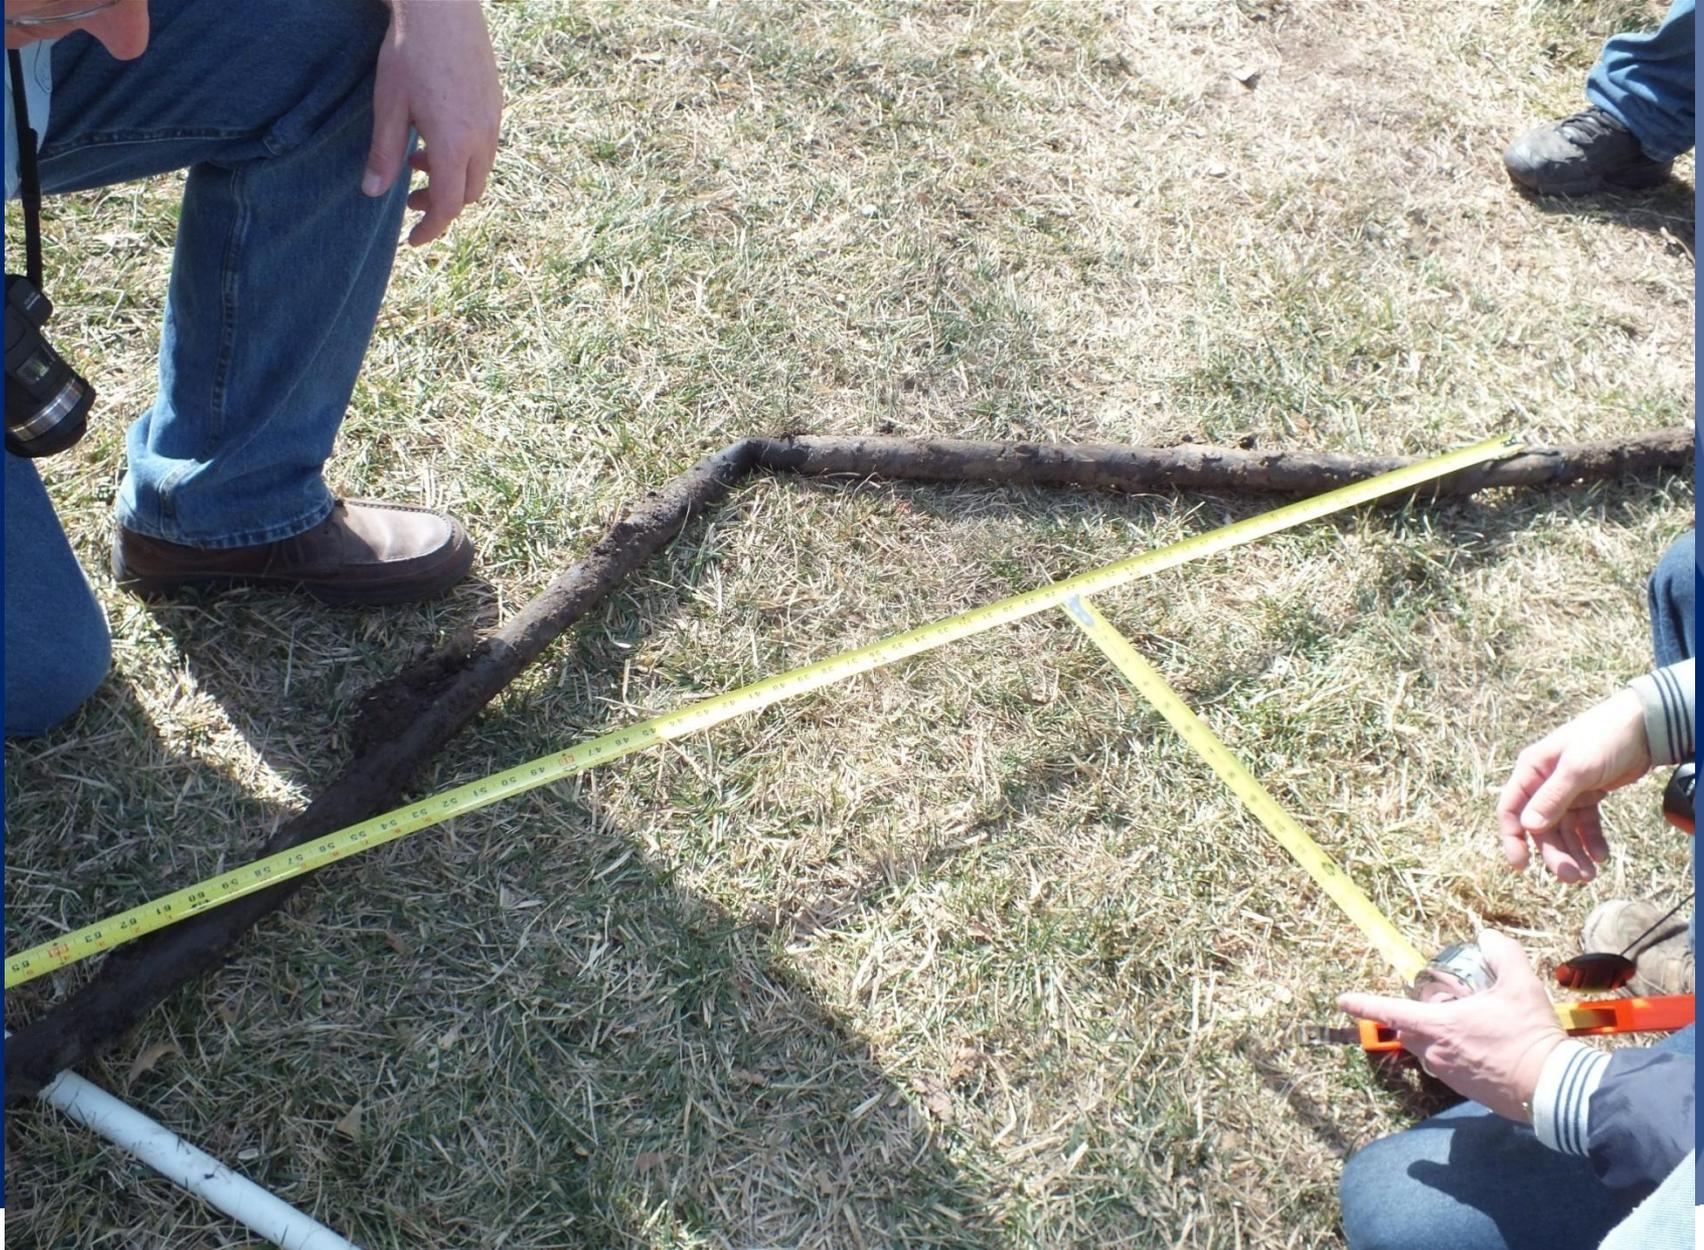
## Service Line After Removal from Ground

- 12-GIMG-584-GIP
- House destroyed; One fatality.
- Staff determined excavator damage caused explosion by pulling pipe out of compression fitting.
- Recommended excavator be cited for failure to call 9-1-1.
- Recommended operator be cited for ineffective emergency plan.

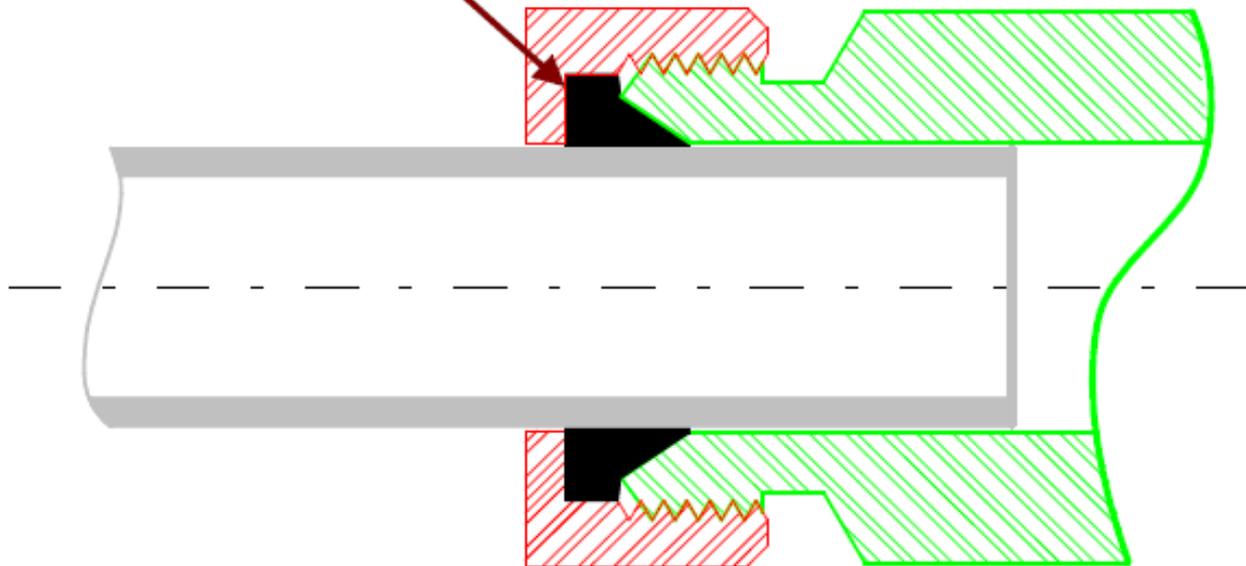
## Schematic of Compression Fitting

Tighten Nut or Follower  
– Crush Gasket Against Pipe

Hydraulic pressure in gasket creates seal

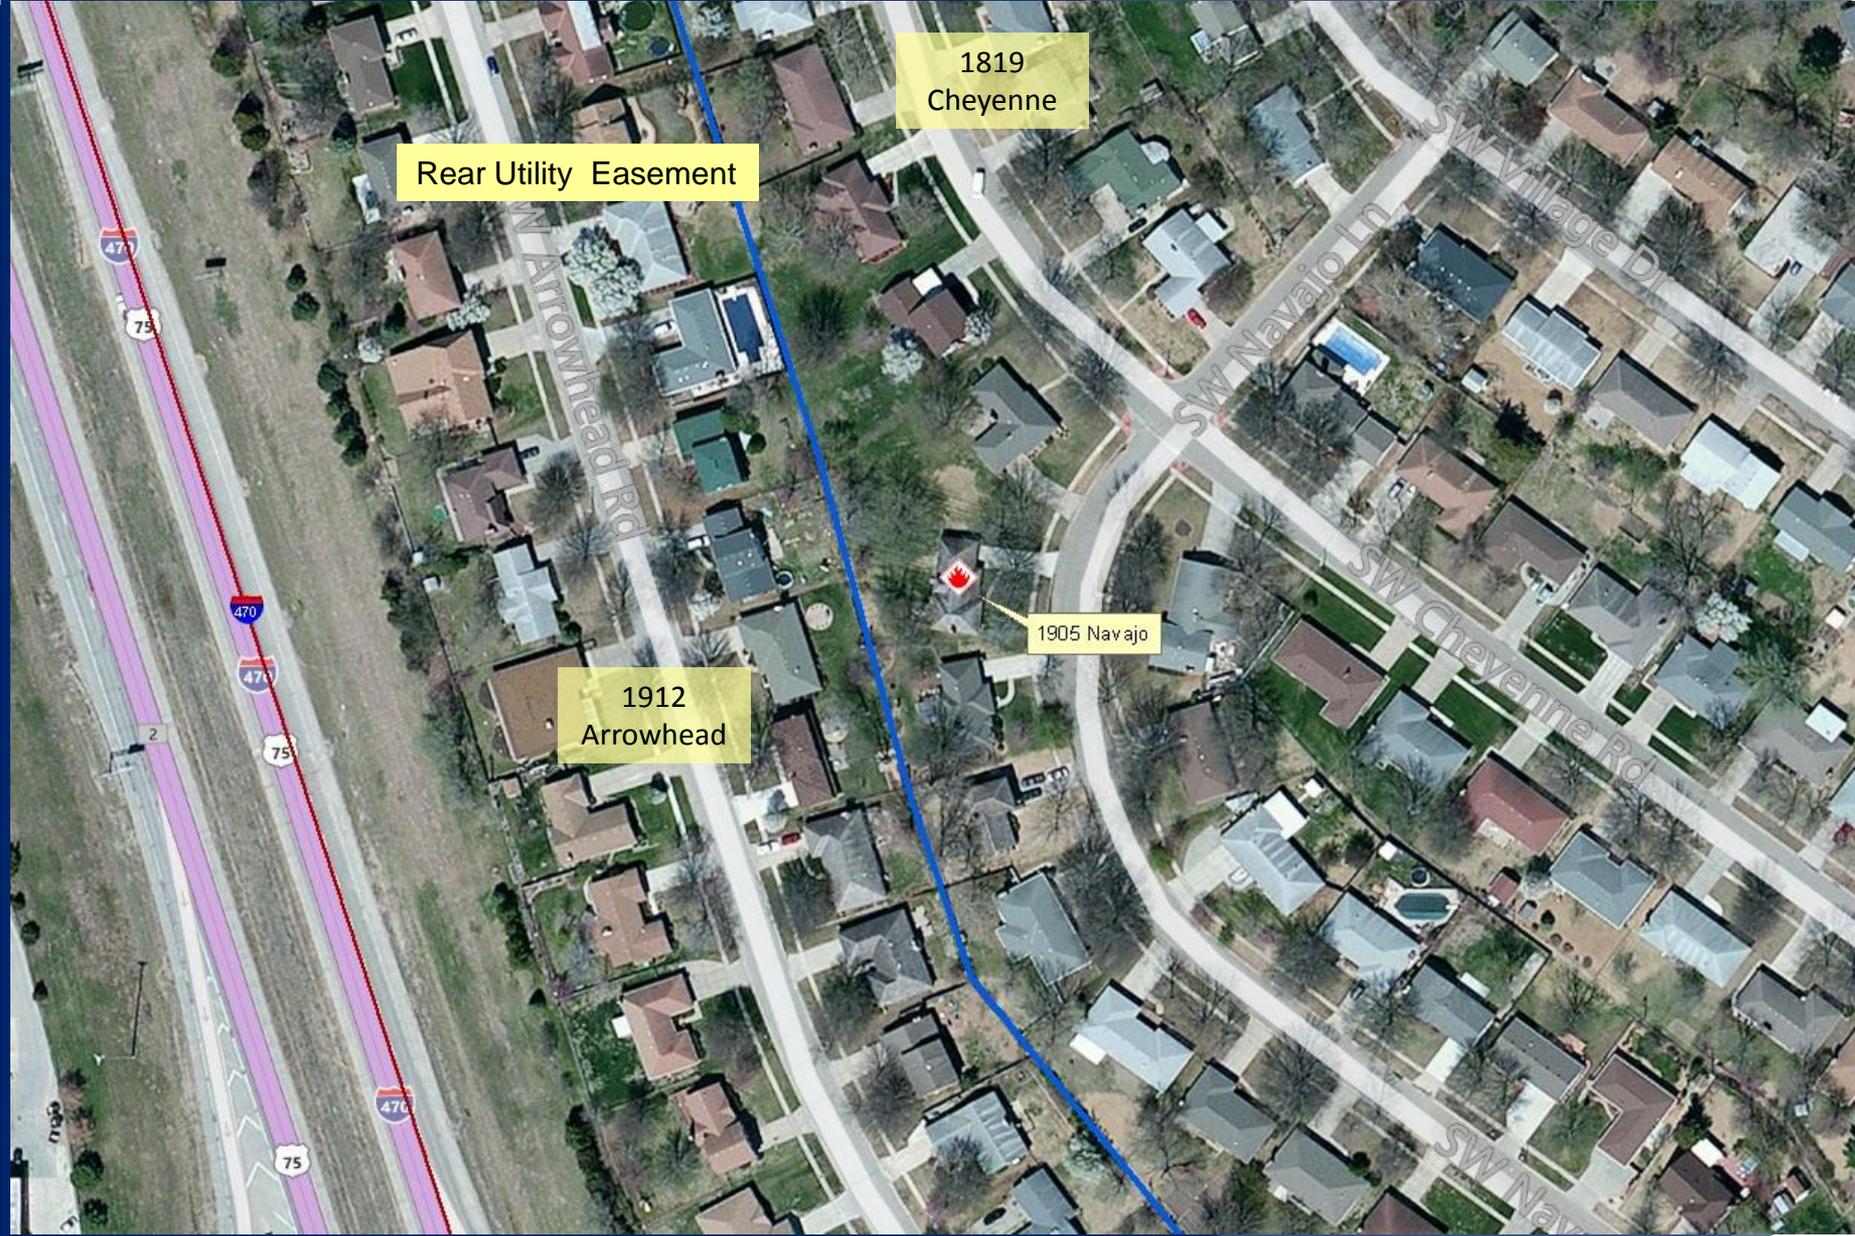
# Congested Rear Easement shared by gas and sanitary sewer

- Liaison with emergency responders so they understand operator's role.
  - Protect evidence while making system safe as soon as possible.
  - Rear Easements with limited access can delay your response.
