# Kansas Incident Investigations

Investigation Techniques & Lessons Learned

# 728 Minnesota, Wichita KS

- 12-KGSG-490-GIG
- House fire and explosion
  - 3 victims burned, house destroyed.
- Staff determined break in low pressure cast iron piping led to house explosion.

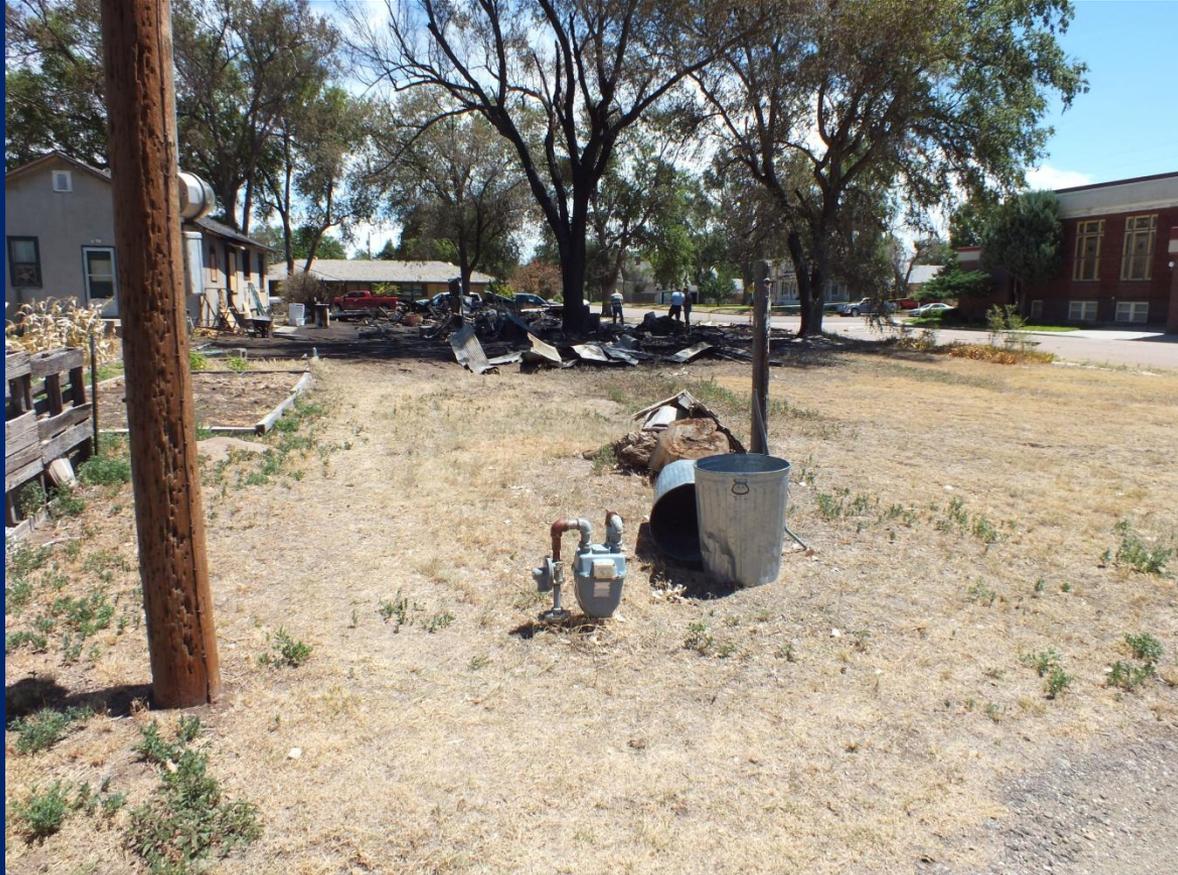
# Meter Location and yard line

- Meter reading zero usage since locked off.
- Meter registered usage after fire.
- 192.727(d)(1): Valve that is closed to prevent flow of gas to a customer must be locked.

- If gas suspected, routine investigations should include:
  - Meter readings with witnesses at time of arrival.
  - Pressure test of piping to the building wall.
  - Lockup check of service regulator.
  - Leakage and flow test of meter if leaking past valve.
  - Witnessed odor check with calibrated odorometer.
- Use blinds or plugs to shut off gas to customers.

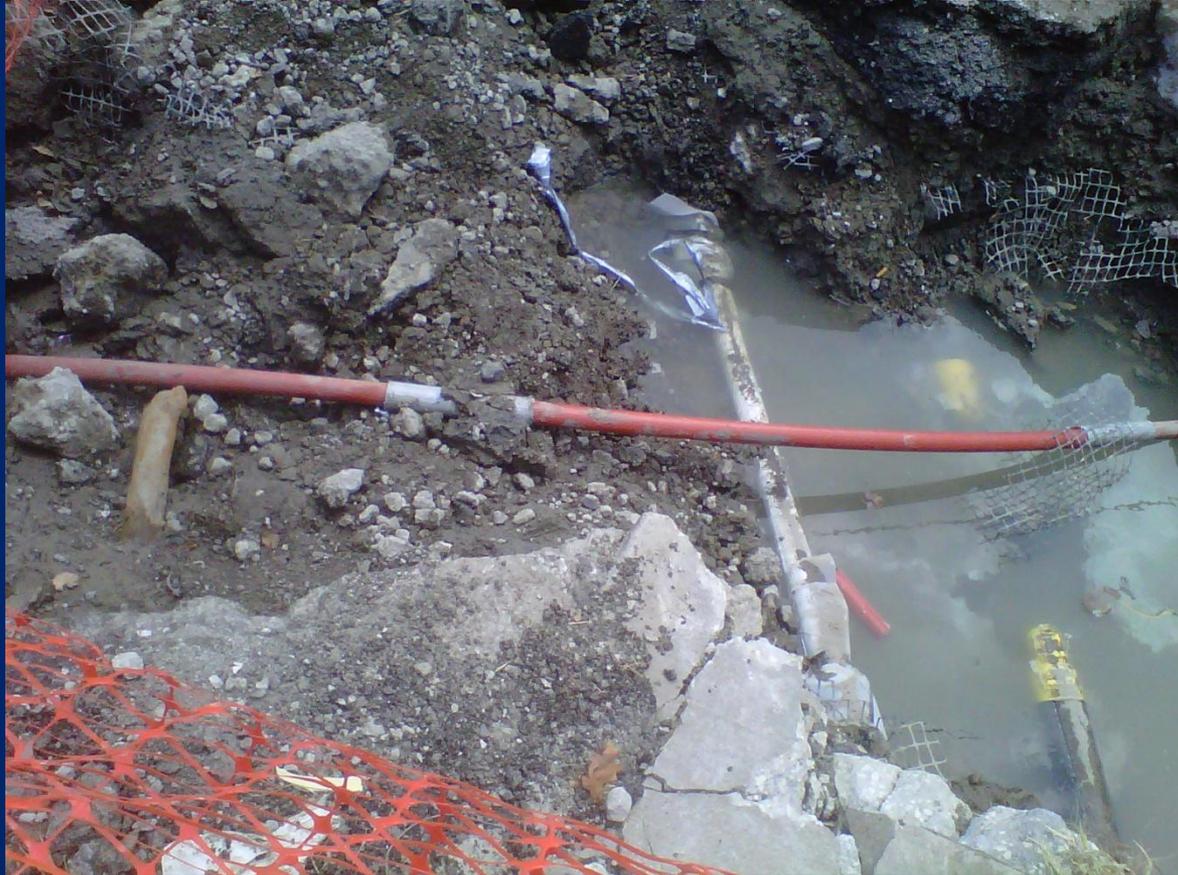
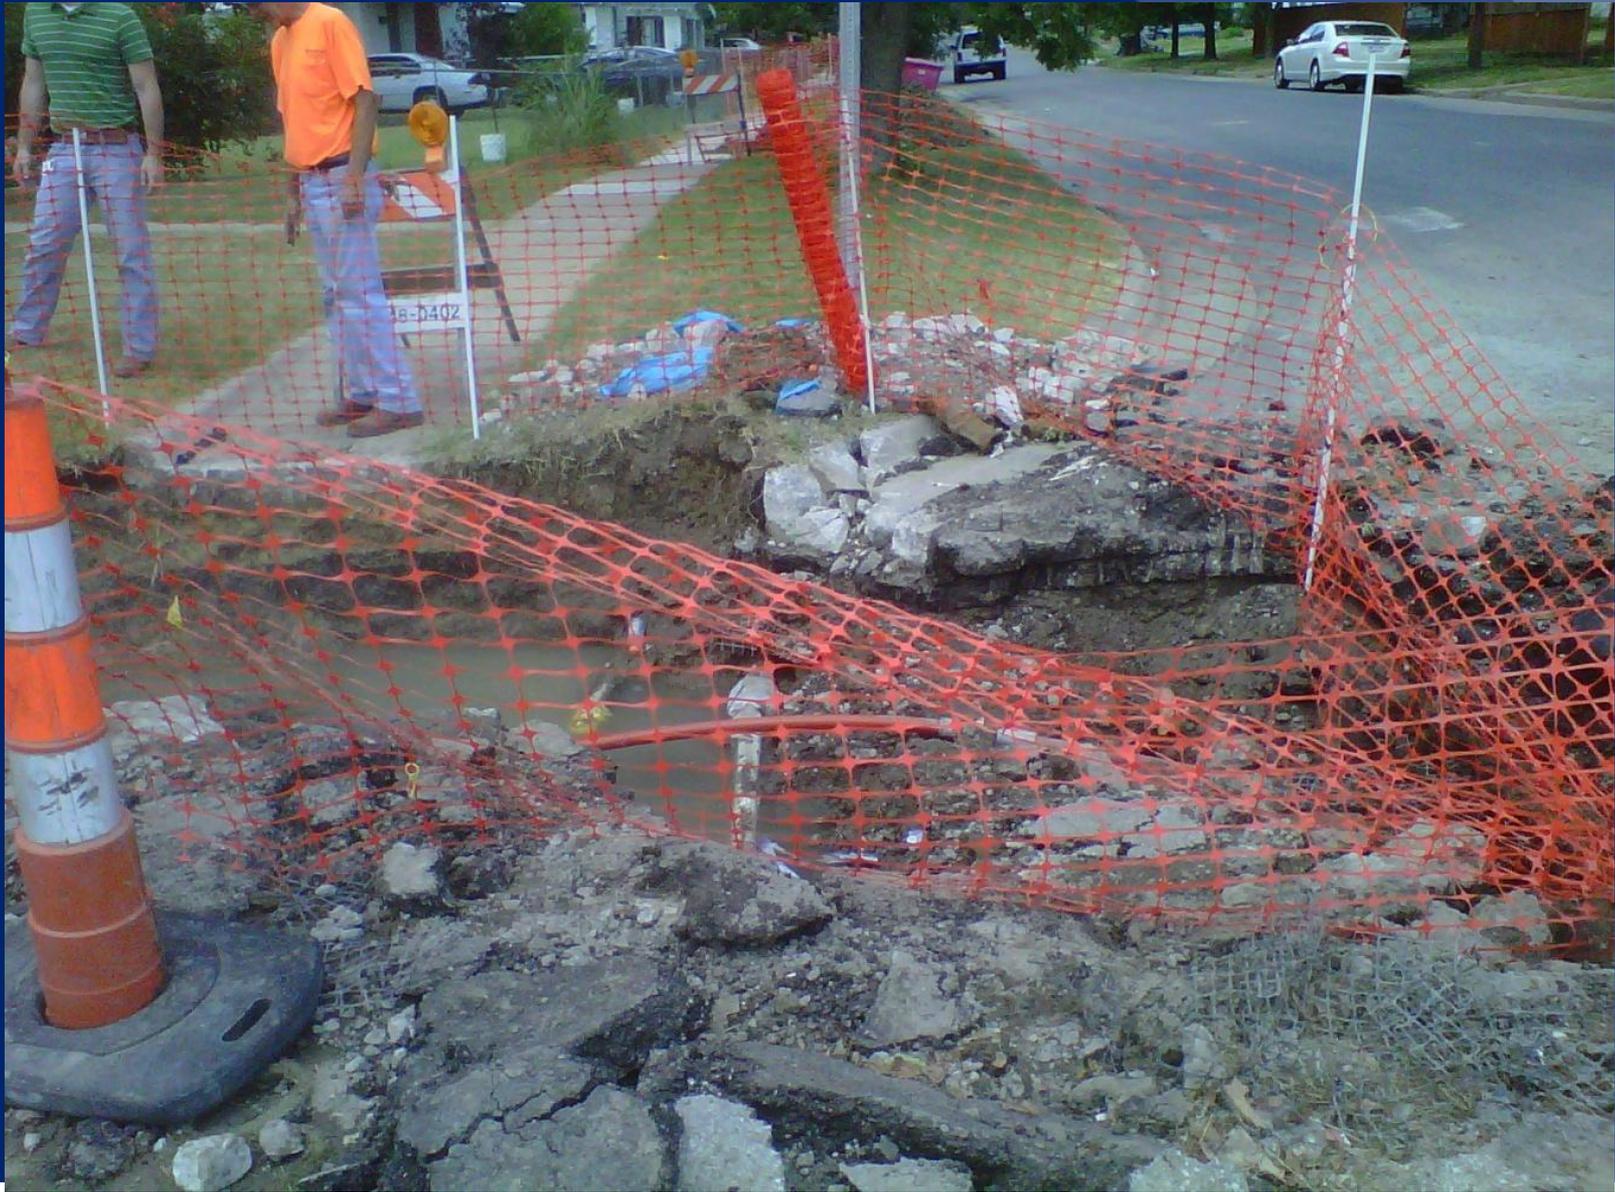
# Proximity of Gas and Water Mains

- Driller installing telecom lines struck water main and parallel low pressure gas main.
- Didn't realize gas main was cut until bubbles showed up as water was removed from hole – 4 hours later.
- Over 600 customers without gas service; dewatering main took days.
- Estimated costs: More than \$500,000.

- Accurate Locates?
- Reasonable Care when excavating?
- Public Awareness Liaison with water department ?
- If water line hit adjacent to gas line, train excavators to notify gas company as well?
- How to monitor gas system during winter weather?
